7<sup>th</sup> December 2012

**Re: Investigation of Total Suspended Particulate Trigger at Three Kings Quarry**

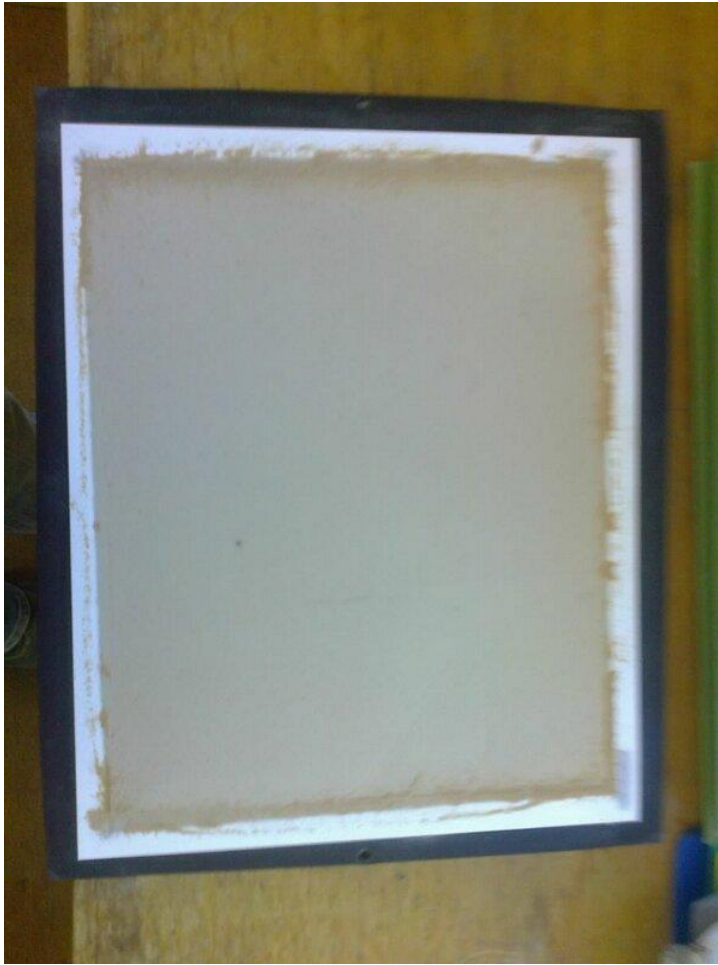
- When the filter from the Northern Boundary HiVol was collected it was noted that there was concentrated amounts of fine saw dust visibly present on the filter. A photos were taken prior to the filter being prepared for laboratory analysis as per our standard procedures. Attached is a photo taken of the filter when it was removed on 14<sup>th</sup> November 2012.

It is noted that the wind direction would suggest that the effects of activities on a property adjacent to the Northern Boundary HiVol would be in the opposite direction of the quarry. However, because of the close proximity of the neighbouring site, the sheltered location of the activity and the nature of the activity it is (in this case) considered appropriate that the Northern Boundary HiVol could be subject to influence from activities at the adjacent property. Again, this is supported by the fact that fine saw dust generating activities are not undertaken at the quarry and are at the adjacent property. Also, that the material present on the filter that has caused the elevated result recorded on 13<sup>th</sup> November 2012 was clearly fine saw dust.

Photo of Northern Boundary filter upon collection on 14<sup>th</sup> November 2012

As the cause of the exceedance has been determine to be from a source outside of the quarry and its control no further actions are required from Winstone Aggregates.

However, following the 27<sup>th</sup> November 2012 incident the neighbouring property was contacted to explain our site monitoring. We also noted the effects the activity they were undertaking was having on the results of this monitoring. They indicated, during this discussion, that this was not part of their normal activities and that the work would be completed on this date. It was also detailed that the work as a result of an issue with some imported stock.
