23rd December 2016

Re: Investigation of Total Suspended Particulate Trigger at Three Kings Quarry

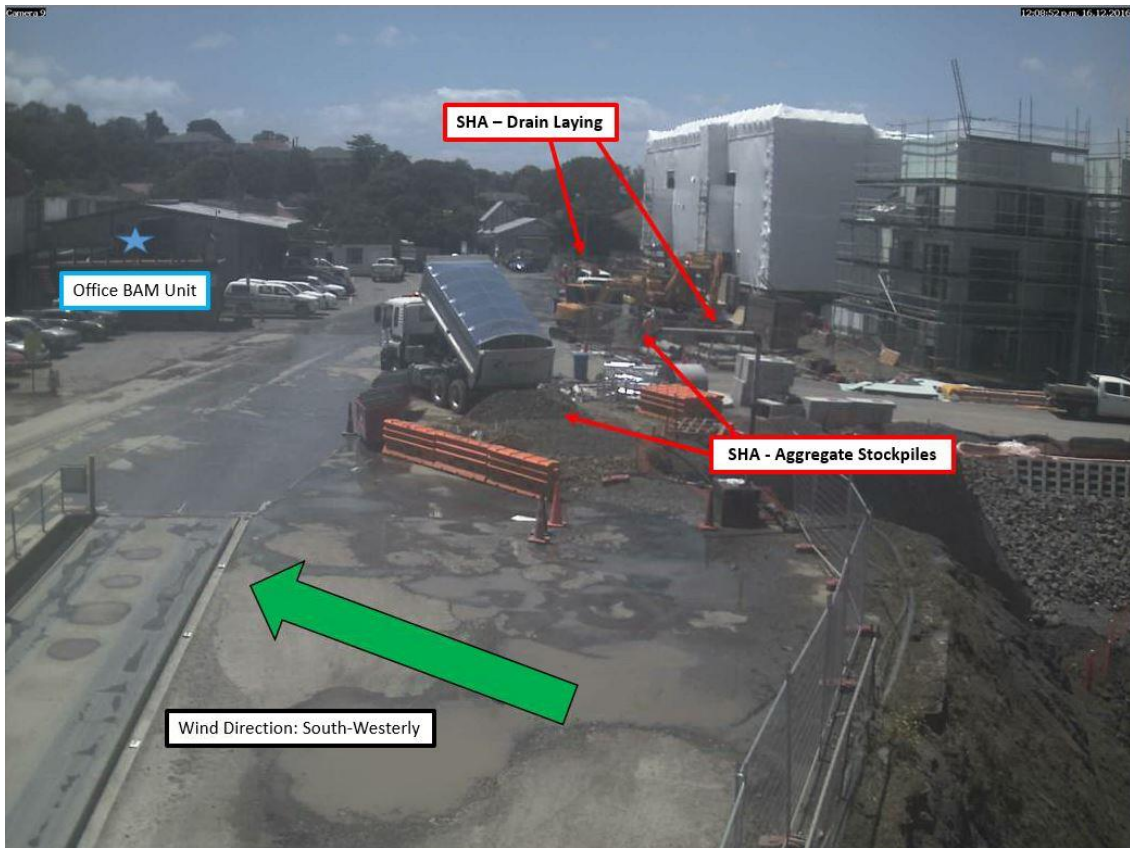
- Drain laying earthworks were taking place in the adjacent SHA site at two locations along the Three Kings Quarry entranceway (refer to Appendix 1 for photos)

- Two SHA stockpiles of aggregate were being utilised and replenished throughout the day at two locations along the Three kings Quarry entranceway (refer to Appendix 1 for photos)

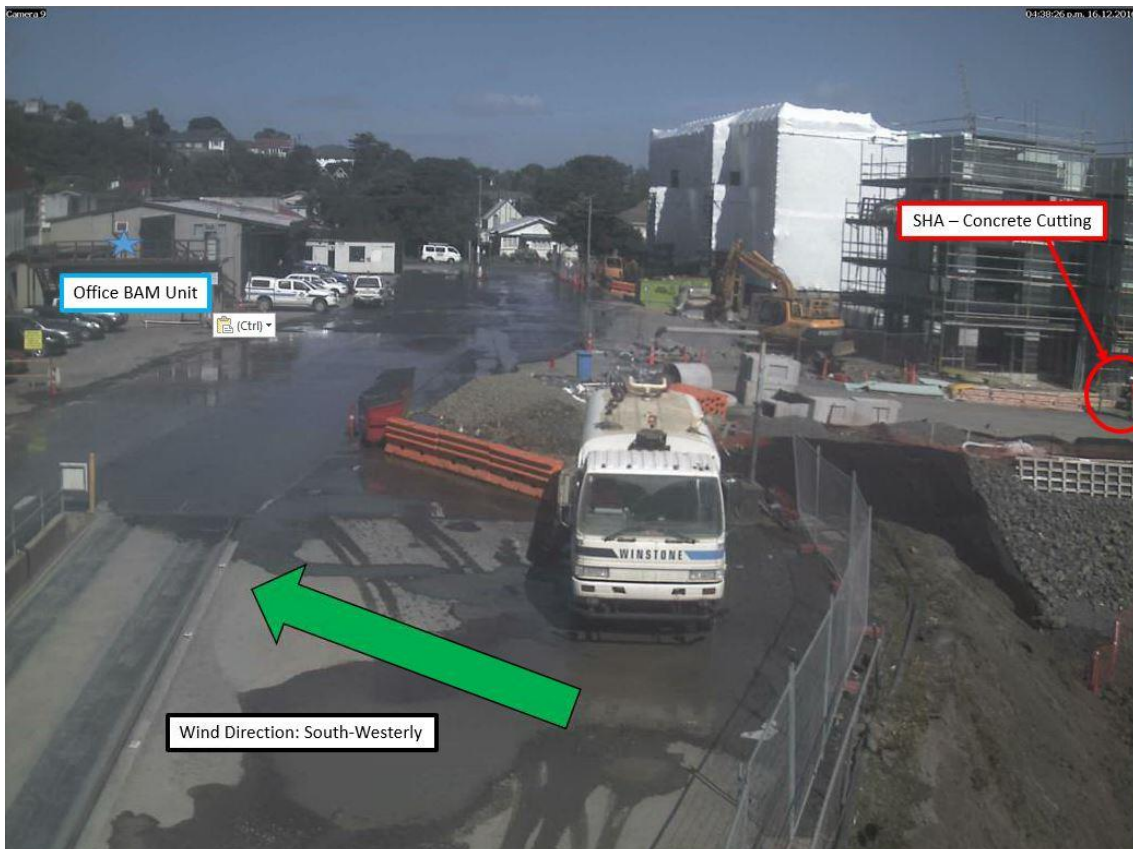
- Concrete cutting took place in the SHA site from approx. 3:30pm onwards on the day of the exceedance (refer to Appendix 1 for photo)
- Video monitors of the site have been reviewed and confirmed that there were no specific areas or activities observed within Three Kings Quarry that were significant generators of dust on the day of the trigger.
