22nd November 2012

Re: Investigation of Total Suspended Particulate Trigger at Three Kings Quarry

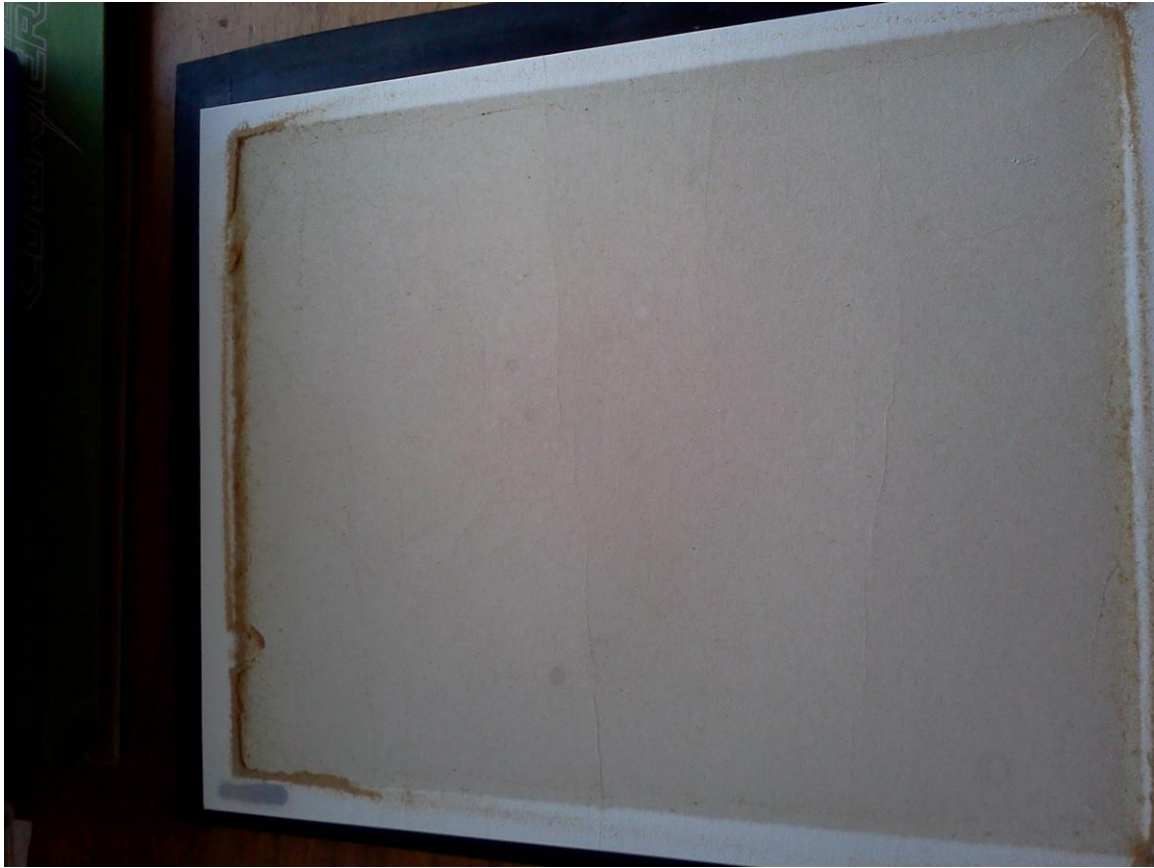
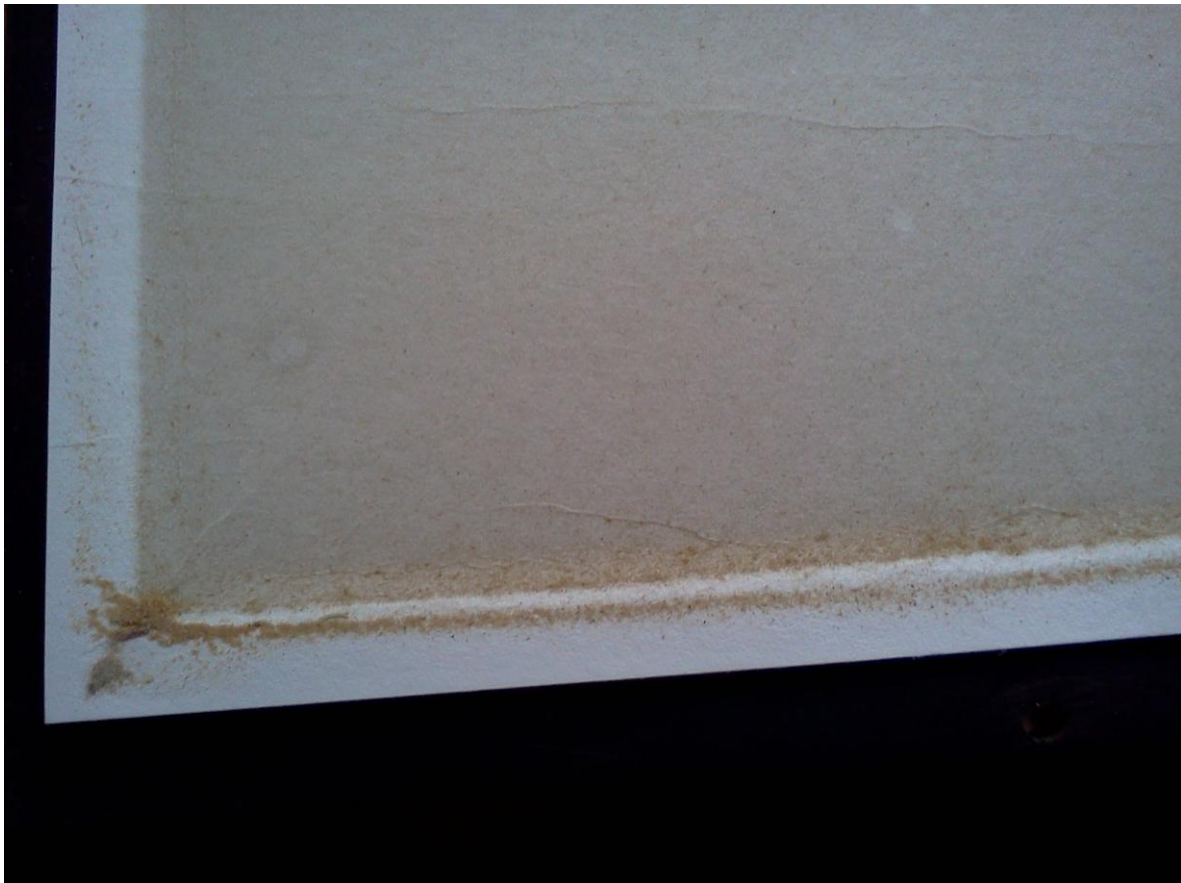
Photos of Northern Boundary filter upon collection on 19th October 2012

- When the filter from the Northern Boundary HiVol was collected it was noted that there was concentrated amounts of fine saw dust visibly present on the filter. Photos were taken prior to the filter being prepared for laboratory analysis as per our standard procedures. Attached are two of the photos taken of the filter when it was removed on 19th October 2012.

It is noted that the wind direction would suggest that the effects of activities on a property adjacent to the Northern Boundary HiVol would be in the opposite direction of the quarry. However because of the close proximity of the neighbouring site, the sheltered location of the activity and the nature of the activity it is (in this case) considered appropriate that the Northern Boundary HiVol could be subject to influence from activities at the adjacent property. Again, this is supported by the fact that fine saw dust generating activities are not undertaken at the quarry and are at the adjacent property. Also, that the material present on the filter that has caused the elevated result recorded on 18th October 2012 was clearly fine saw dust.

As the cause of the exceedance has been determine to be from a source outside of the quarry and its control no further action are required from Winstone Aggregates.
