Three Kings Quarry Air Quality Investigation of Triggers

Sept-Dec 2009 Air Quality Monitoring Triggers

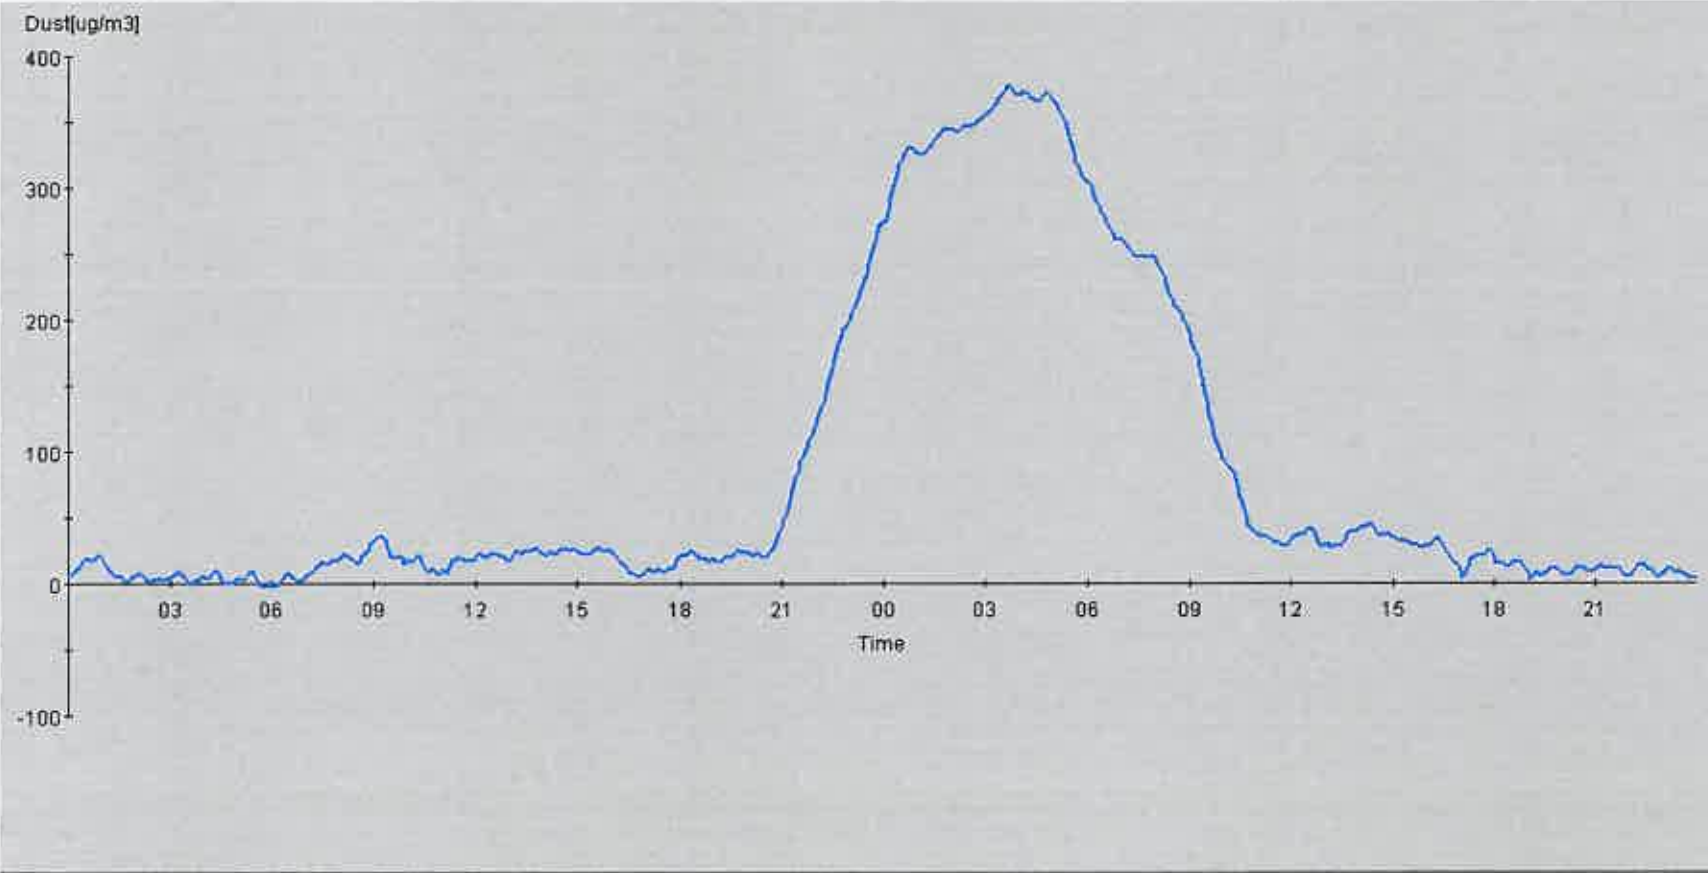
Dust($\mu\text{g}/\text{m}^3$) Periodic Report Winstone 2
23/09/2009 24:00 - 25/09/2009 24:00 Interval 5 Min

25/9/09 Trigger – 136.7 $\mu\text{g}/\text{m}^3$ – BAM Continuous Monitor

- Peak dust reading of 377 $\mu\text{g}/\text{m}^3$ was recorded between midnight and 6am.
- 24 hours average was 136.7 $\mu\text{g}/\text{m}^3$ which compares with measurements recorded in other Air Quality Monitors throughout the Auckland Region.
- Not recorded in the TSP monitors as it was outside the 1 in 3 and 1 in 6 sampling interval of these monitors.
- The dust trigger was a result of the dust cloud that drifted over New Zealand from the Australian dust storms.
- Elevated dust levels from the Australian dust storms were also recorded by the BAM dust monitor on the 28/29 September.

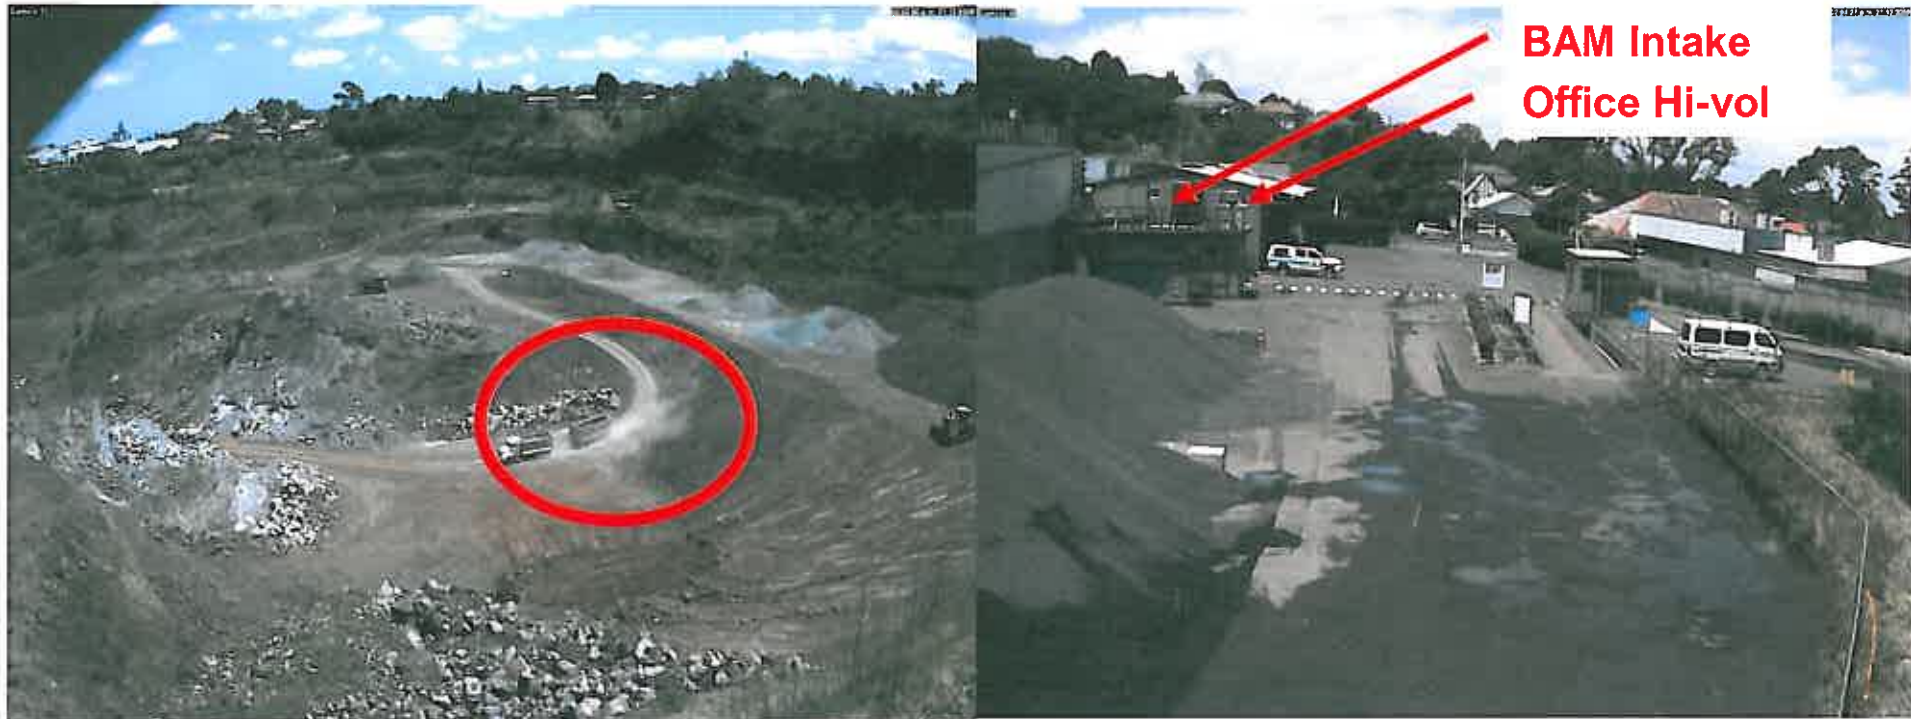
Video Monitoring – 21st December 2009

21/12/09 Trigger – 84.8 $\mu\text{g}/\text{m}^3$ - Office Hi-vol TSP Monitor

- On this day there were 4 loads (48m³) of water applied to the site roads and the sprinkler system was working normally.
- The crushing plant was not operating on this day. There was only sales loadout activity.
- The camera footage on this day for the site showed one significant dust emission from a truck that used a wrong site road that had not been watered. This was a very short emission is unlikely to have been the main reason for the trigger. Road management practices have been improved to ensure that only roads that have been watered are accessible to traffic.
- There was no visual dust on the office view camera that includes the office Hi-vol TSP monitor and the BAM Continuous Dust Monitor.
- Relatively strong wind from the south-west of the site may have contributed to the trigger.
- The BAM recorded 27.9 $\mu\text{g}/\text{m}^3$.

- Picture on left shows only significant dust emission for the day.
- Picture on right shows office view with monitors. There was no visual dust seen in this view all day.

- Ensure that one-off and unusual tasks undertaken in the future have sufficient measures taken to make sure there is no dust emission while the task is being undertaken.
- Camera archive has been expanded to ensure the video history is available when air monitoring results are received.
- Road management has been improved to ensure that roads not required for use and that have possibly have not been dampened are blocked off and not accessible to traffic.
- Reinforced with site staff the need for extra focus on dust suppression particularly in dry, high wind weather conditions.

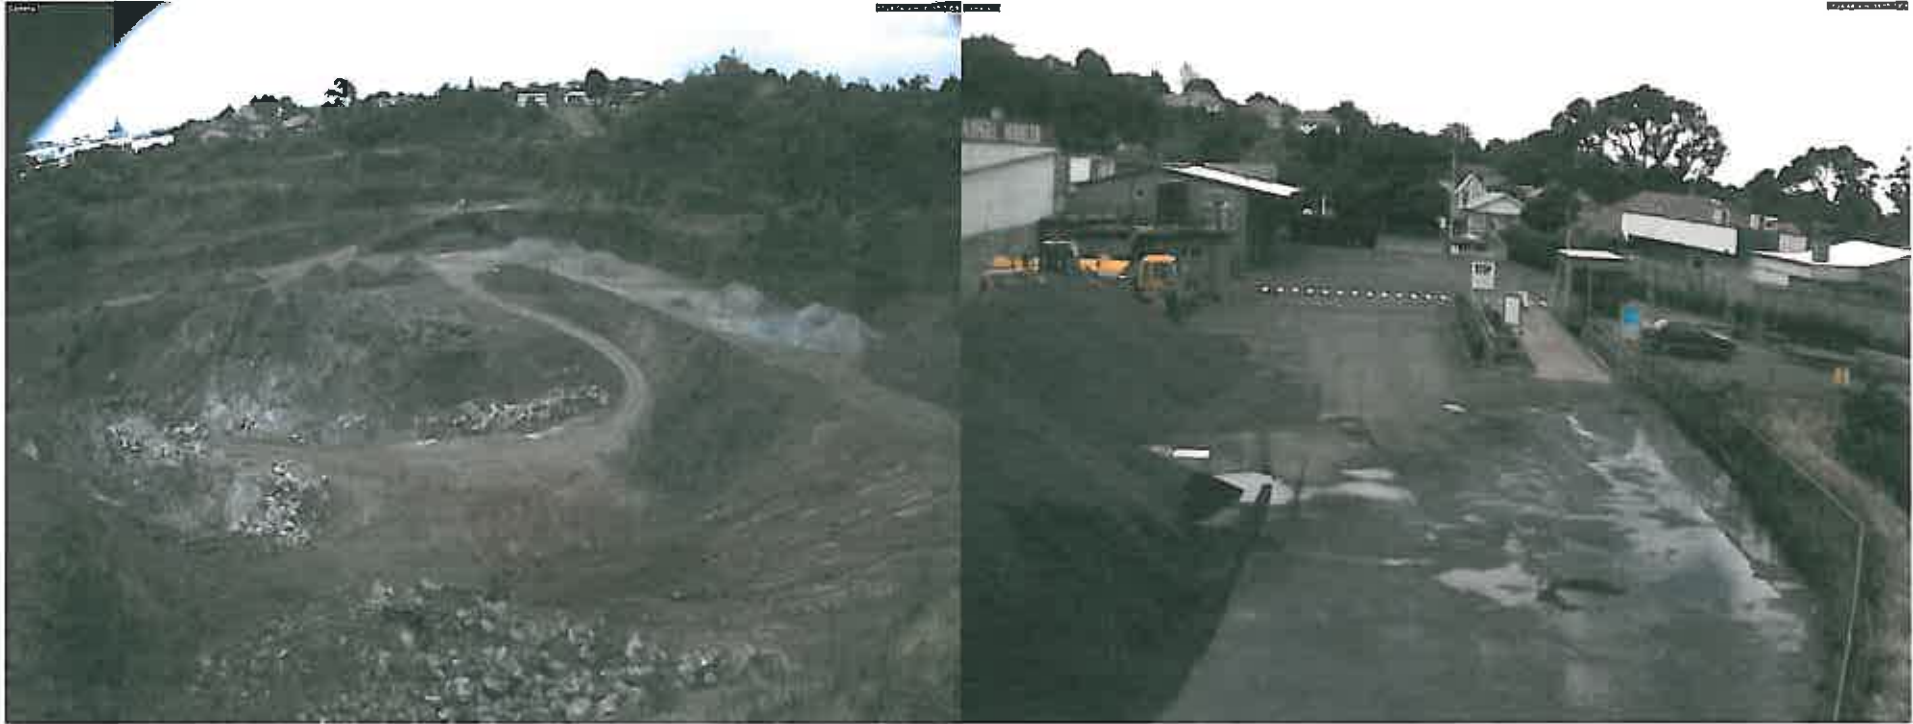
Video Monitoring – 31st December 2009

31/12/09 Trigger – 86.1 $\mu\text{g}/\text{m}^3$ - Office Hi-vol TSP Monitor

- On this day there was no activity as the site was closed for the Christmas/New Year period.
- The site sprinklers were operating normally.
- The camera footage for this day show no signs of visual dust being present on the site.
- Relatively strong south-west wind may have contributed to the trigger.
- The BAM recorded 32.2 $\mu\text{g}/\text{m}^3$ for the 24 hour period.

- Both views from near office show no sign of any visual dust emission all day.
