THREE KINGS QUARRY

RESOURCE CONSENT 12977

ANNUAL DEWATERING MONITORING REPORT

May 2013

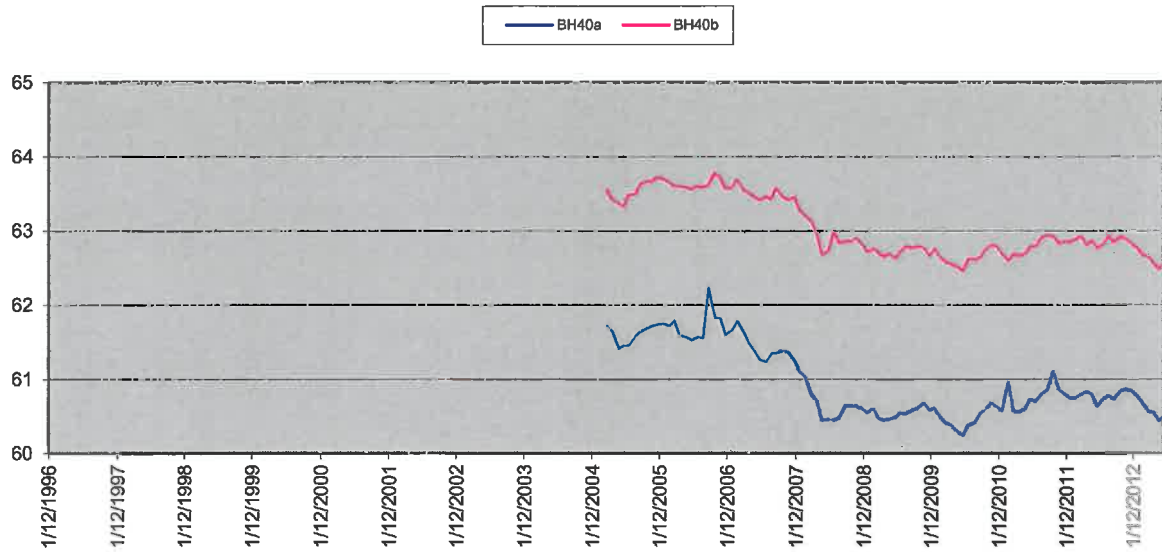
Borehole 40

The groundwater levels in BH40a and BH40b have been in excess of seasonal variation trigger since early 2008. BH40 is the southern most of the Three Kings Quarry groundwater monitoring bores located on Hillsborough Road just to the north of the SH20.

The groundwater level in BH40a (deep piezometer) has fallen approximately 0.85metres from an average level of approximately RL61.65m (to March 2007) to an average level for the year ending 31 March 2013 of approximately RL60.80m.

The groundwater level in BH40b (shallower piezometer) has also fallen 0.85m from an average level of approximately RL63.6m (to March 2007) to an average level for the year ending 31 March 2013 of approximately RL62.75m.

The groundwater levels in BH40a and BH40b are currently recording seasonal variation (refer attached graphs).

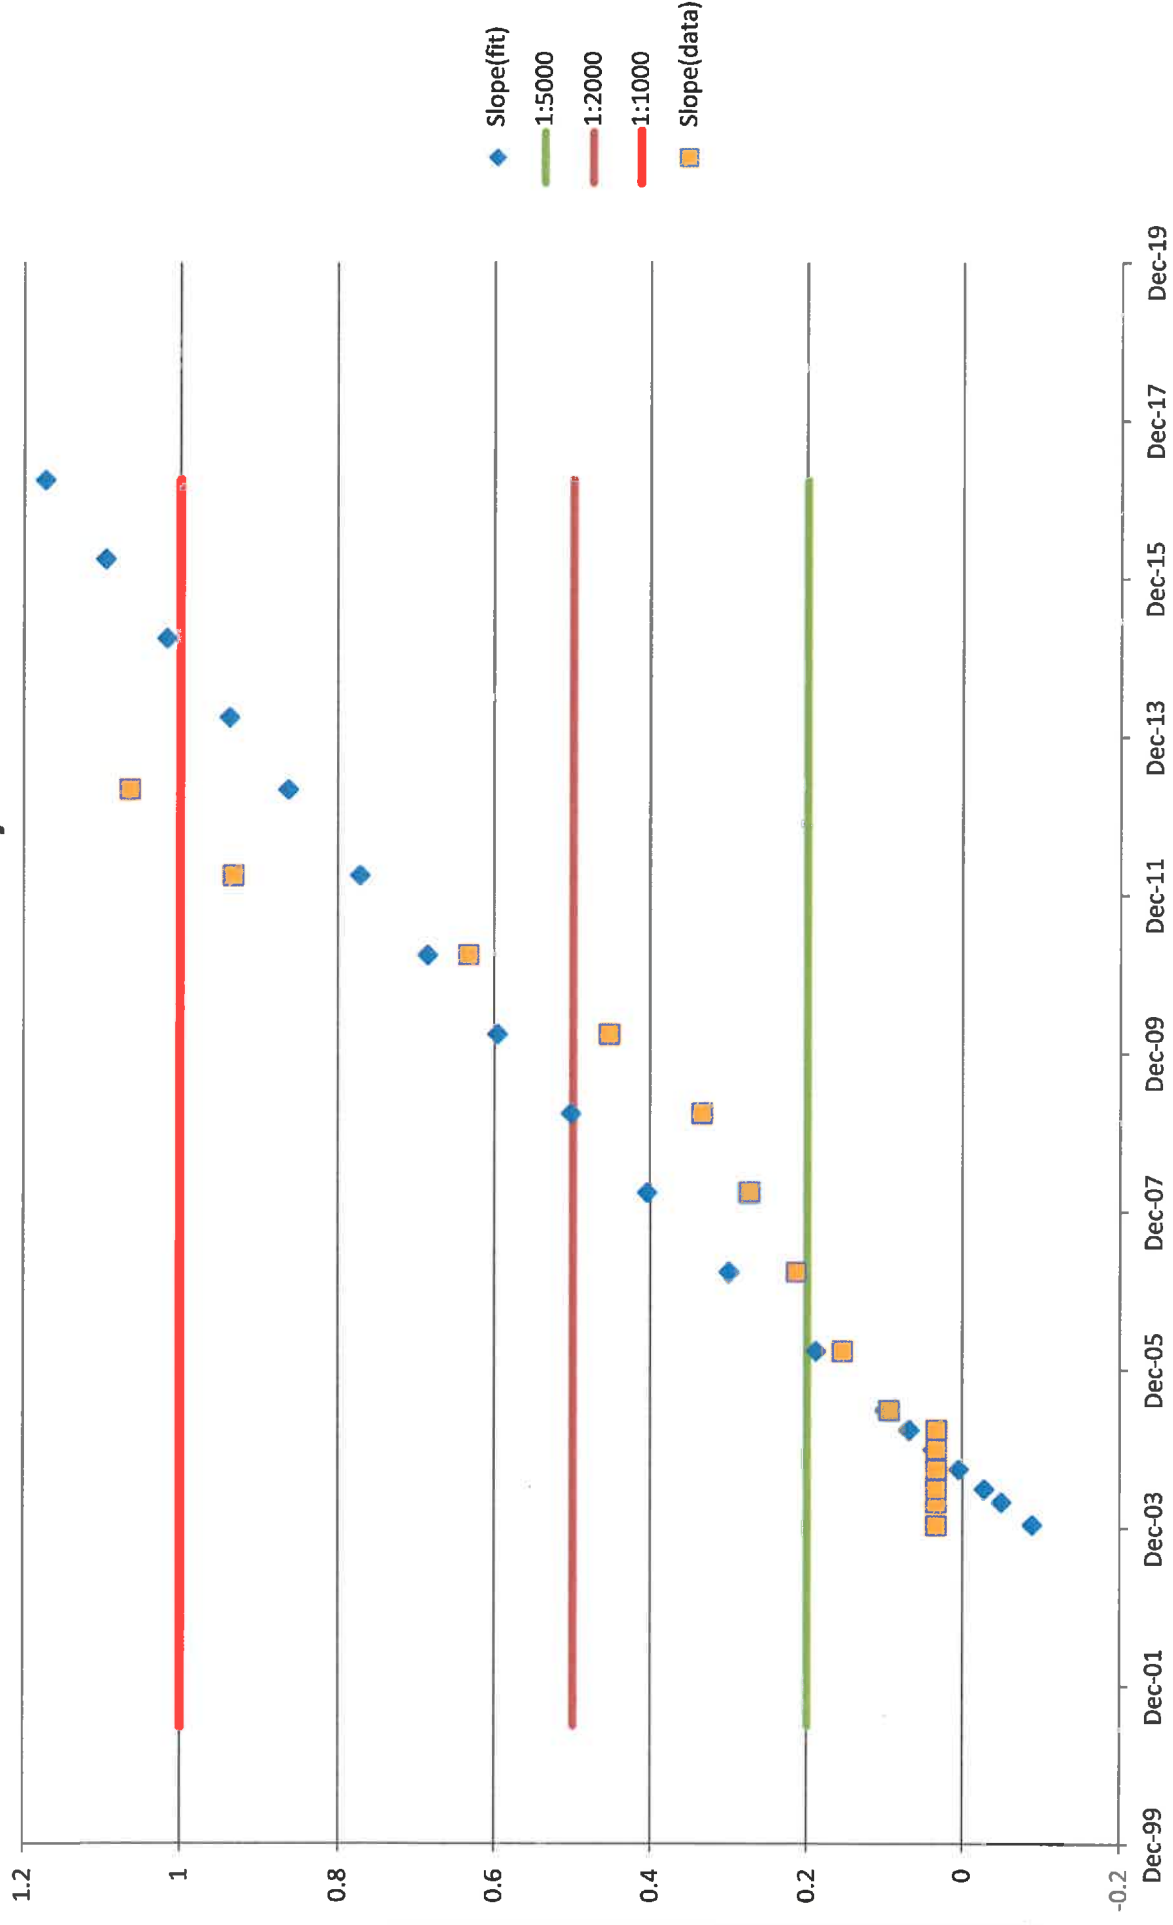
Differential Settlement Alarm Trends – Budock Road

The Differential Settlement Alarms currently being recorded between AP38, AP70 and AP117 on Budock Road are not a result of dewatering Three Kings Quarry. AP38 and AP70 have recorded settlements consistent with other marks in this area, while AP117 has recorded an 11mm rise since it was installed in 2003.

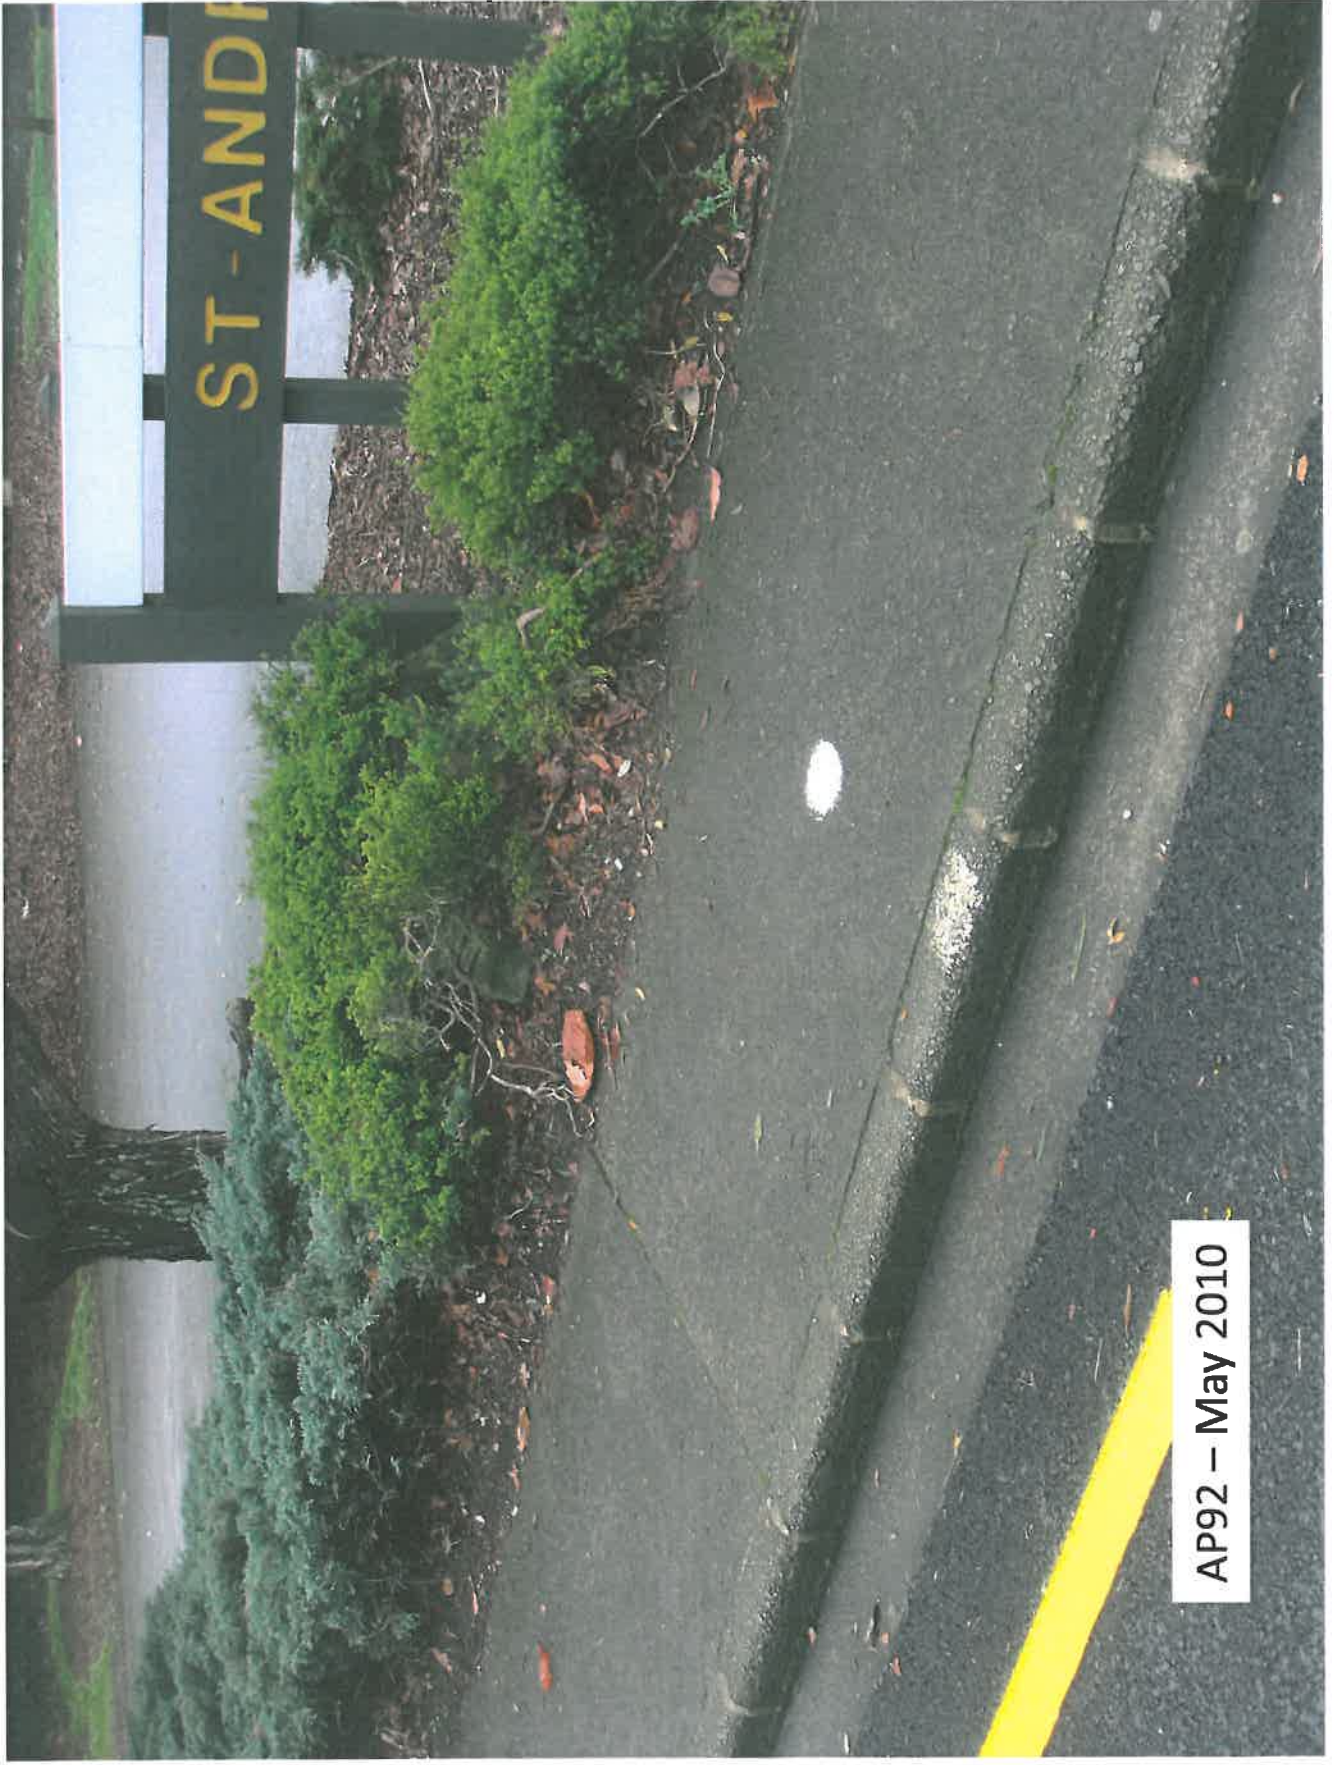
AP92 – May 2010

There are signs of deterioration or disturbance to the footpath at the location of AP92. There is a noticeable upward bowing in the concrete footpath compared with the kerb (photographs attached).

The results show that the change in level of AP92 is anomalous and not consistent with the change in levels in the surrounding precise level survey marks. Its relative rise in level is not considered to be a result of dewatering Three Kings Quarry.

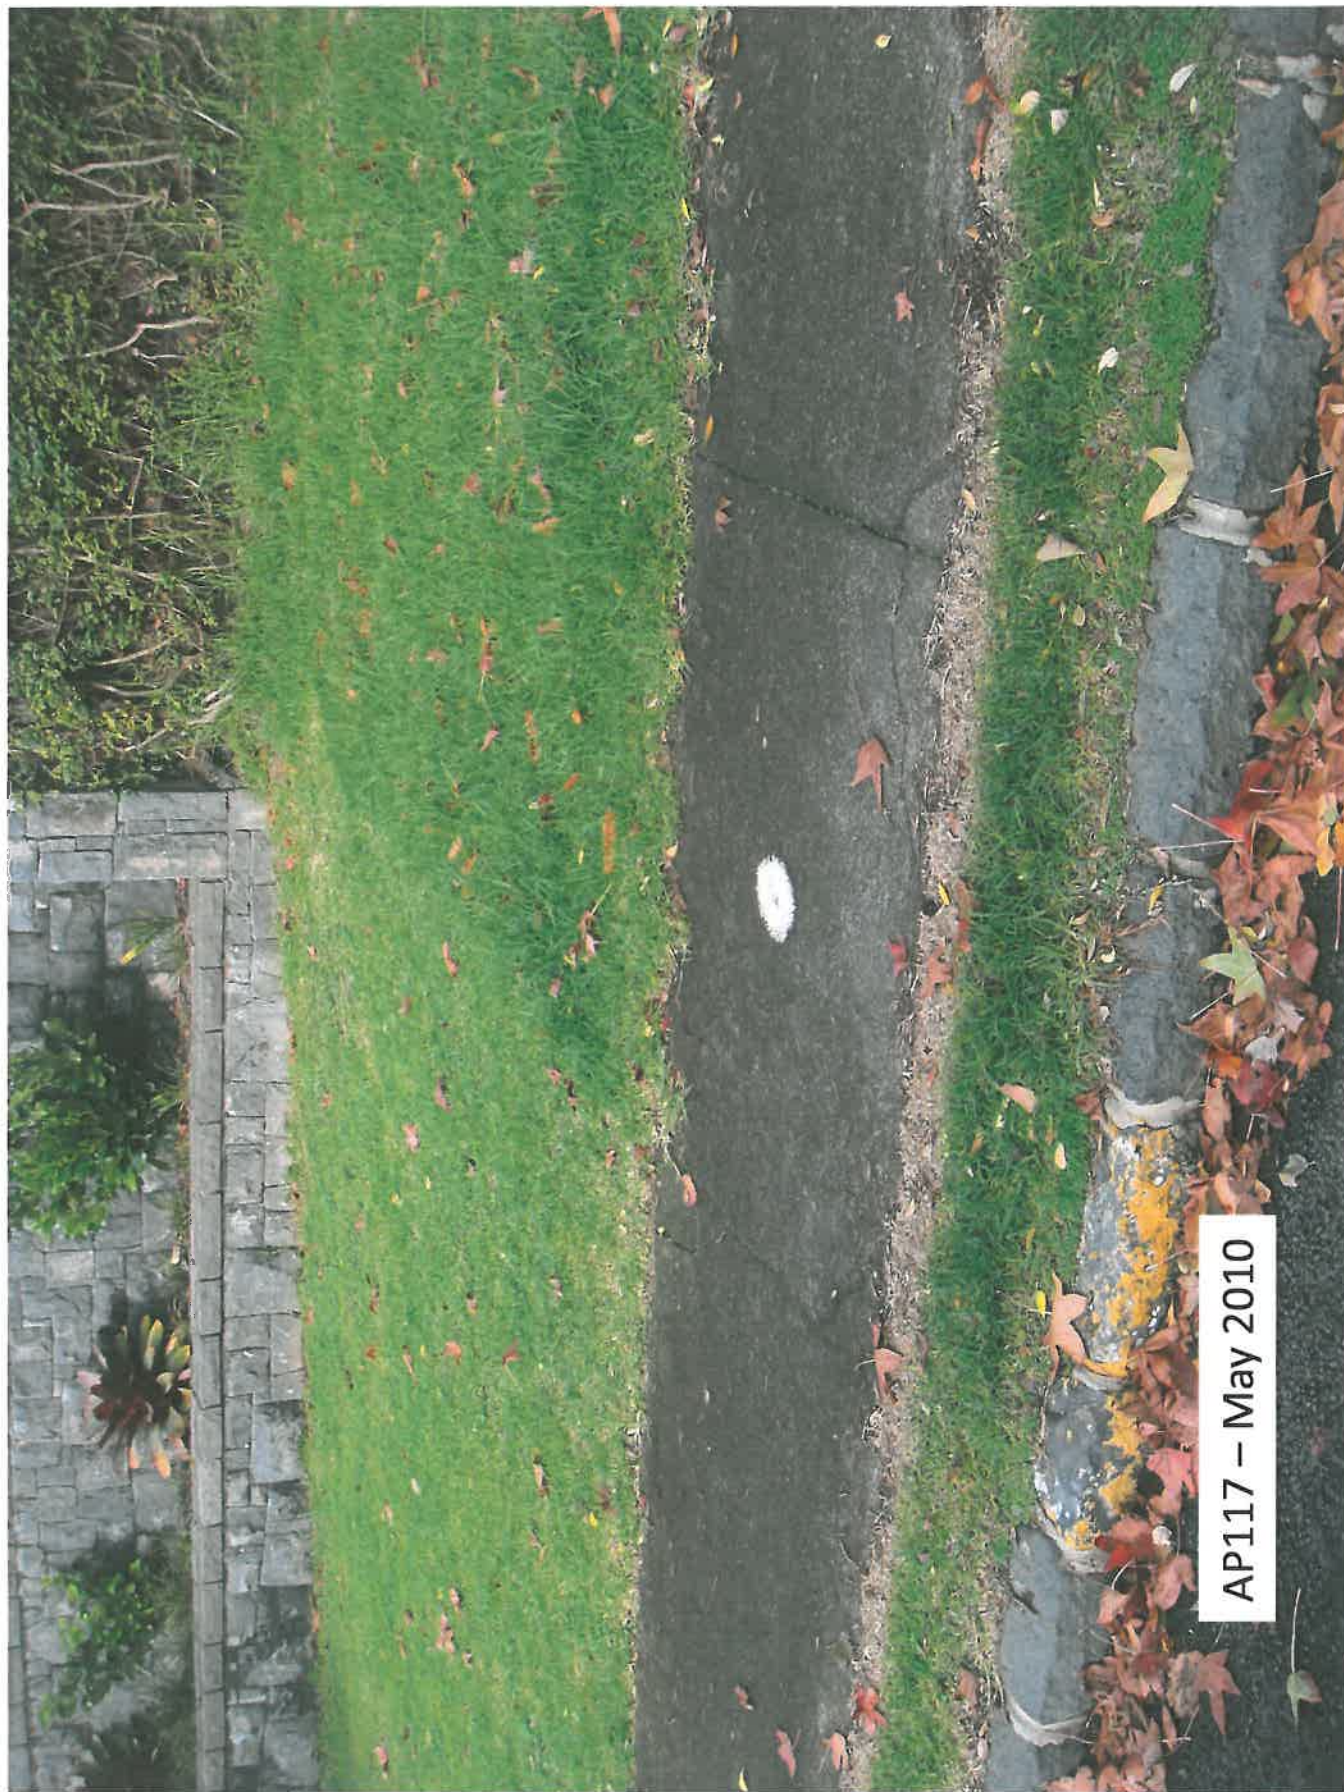
AP117 – May 2010

There are visual signs of deterioration or disturbance to the footpath along Budock Road (all marks along Budock Road are survey nails in the footpath or driveways). There is a noticeable deterioration in the footpath at the location of AP117 (photographs attached).

The results show that the change in level of AP117 (as is AP114 and to a lesser extent AP116 and AP113) is anomalous and not consistent with the settlement arising from the dewatering of Three Kings Quarry. Its relative rise in level is not considered to be a result of dewatering Three Kings Quarry.
