Three Kings Quarry

2011 Biennial - Air Report

This report has been prepared in accordance with Condition 29 of the Three Kings Quarry Air Discharge Permit (Permit Number 21875).

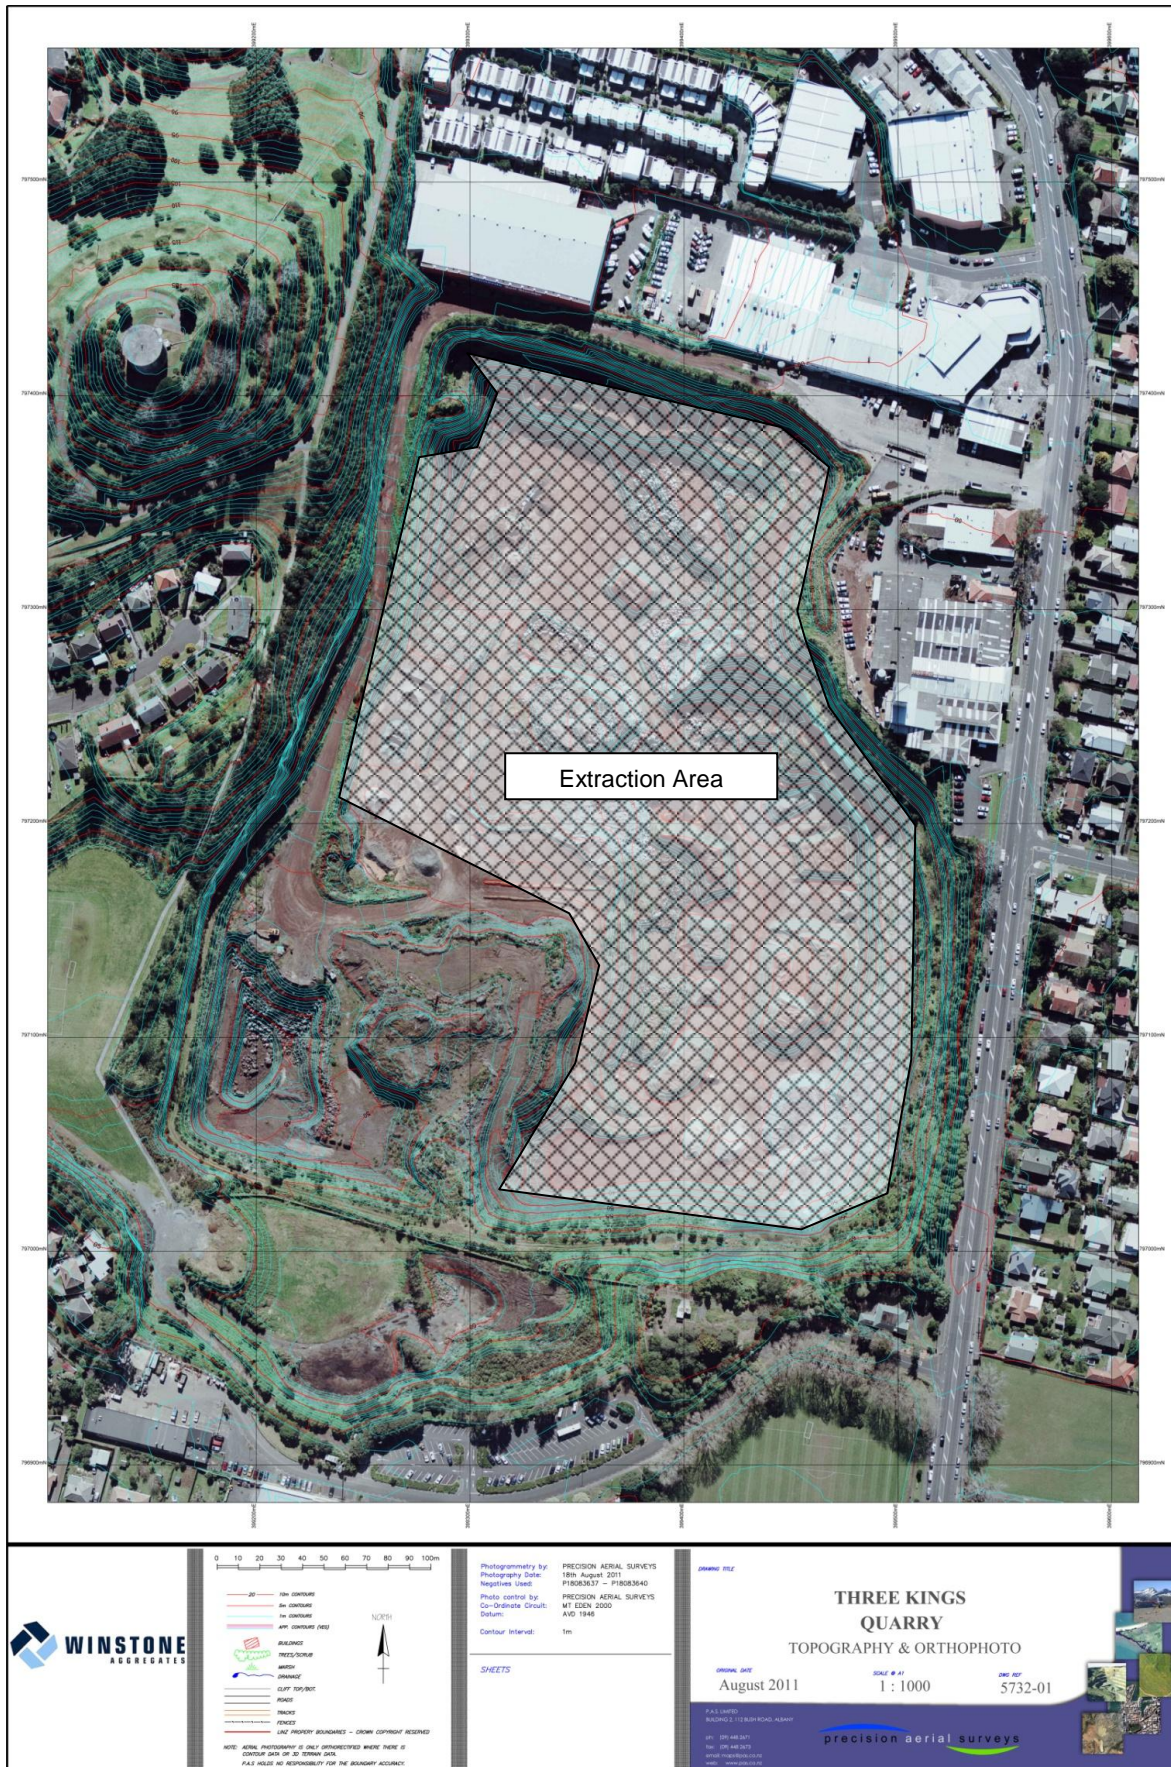
Figure 1. Area of Extraction

Figure 1 shows the areas of extraction between November 2009 and October 2011.

Approximately 133,000m³ of material was extracted and processed during this period. Of this volume the majority of material extracted was scoria with basalt in the minority.

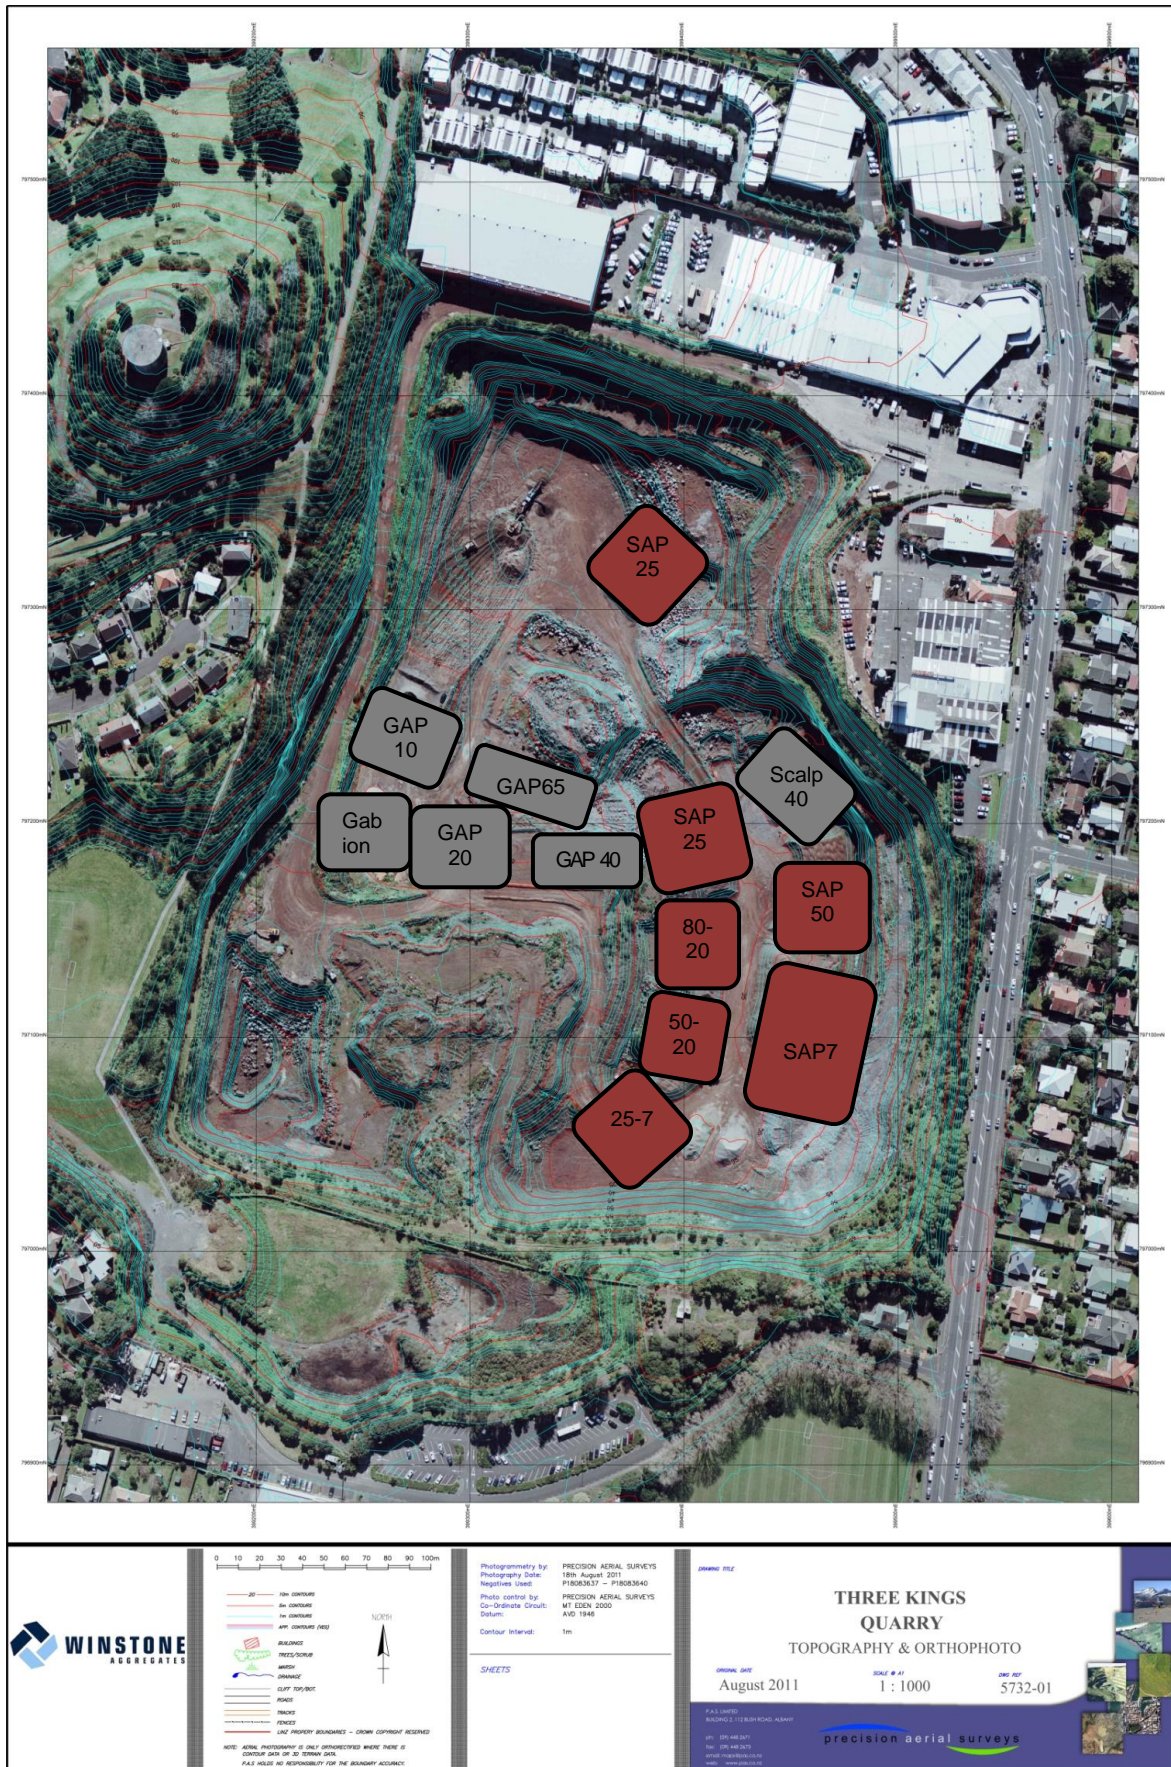
Figure 2. Stockpile Locations at October 2011.

The site currently holds stocks of scoria, basalt and greywacke aggregates. Figure 2 shows the locations of the stockpiles as of October 2011.

The approximate volumes of materials stockpiled on site as of October 2011 are as follows.

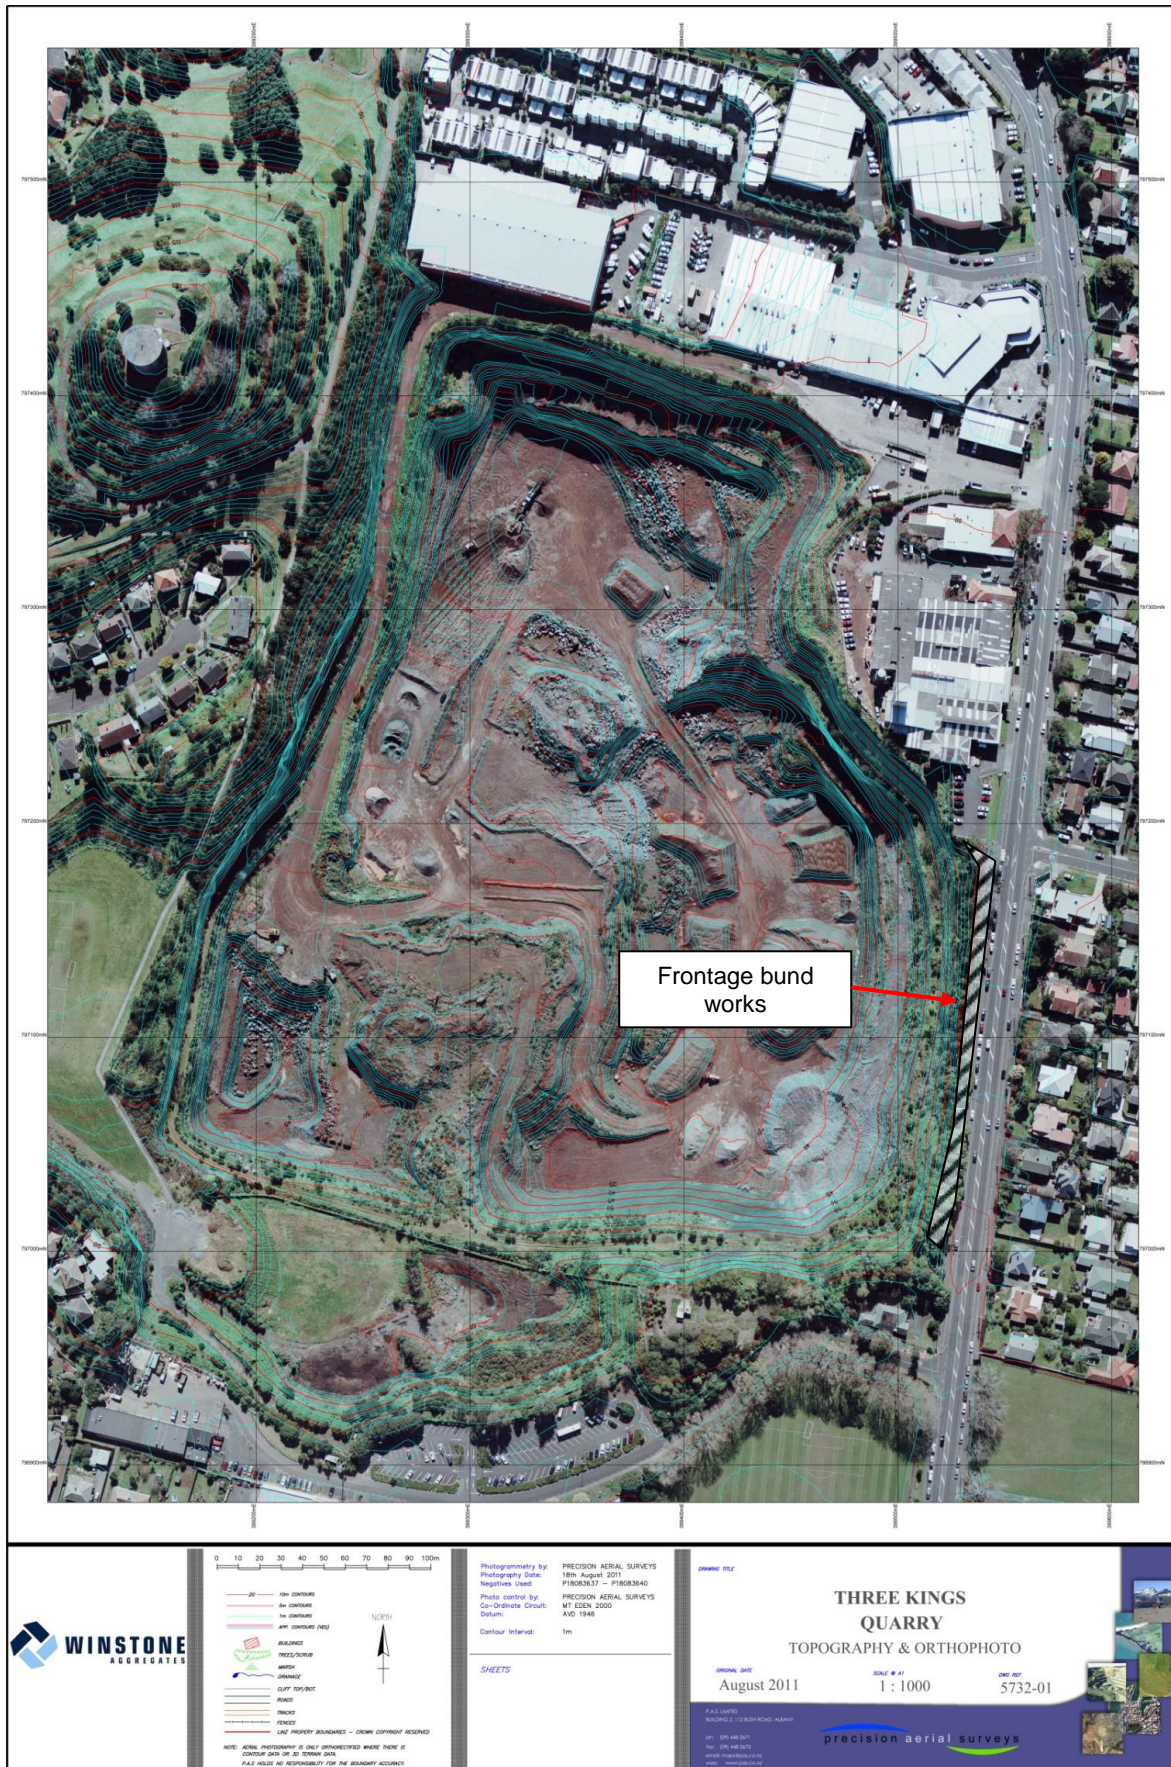
Figure 3. Rehabilitation Areas.

Figure 3 shows the area where Winstone undertook rehabilitation works on the site frontage. This work was done in 2011 which included weed removal and the planting of native species.

The quarry batters, along the Mt Eden Road frontage, around the office and weighbridge and along the main quarry haul road are areas that are currently vegetated. Ongoing maintenance to keep growth controlled and minimise weed populations is undertaken across these areas. All other open areas are currently being worked.

No specific rehabilitation is scheduled expect for ongoing maintenance. It is not expected that there will be exposed areas (other than the currently grassed batters) that will remain inactive for extended periods.

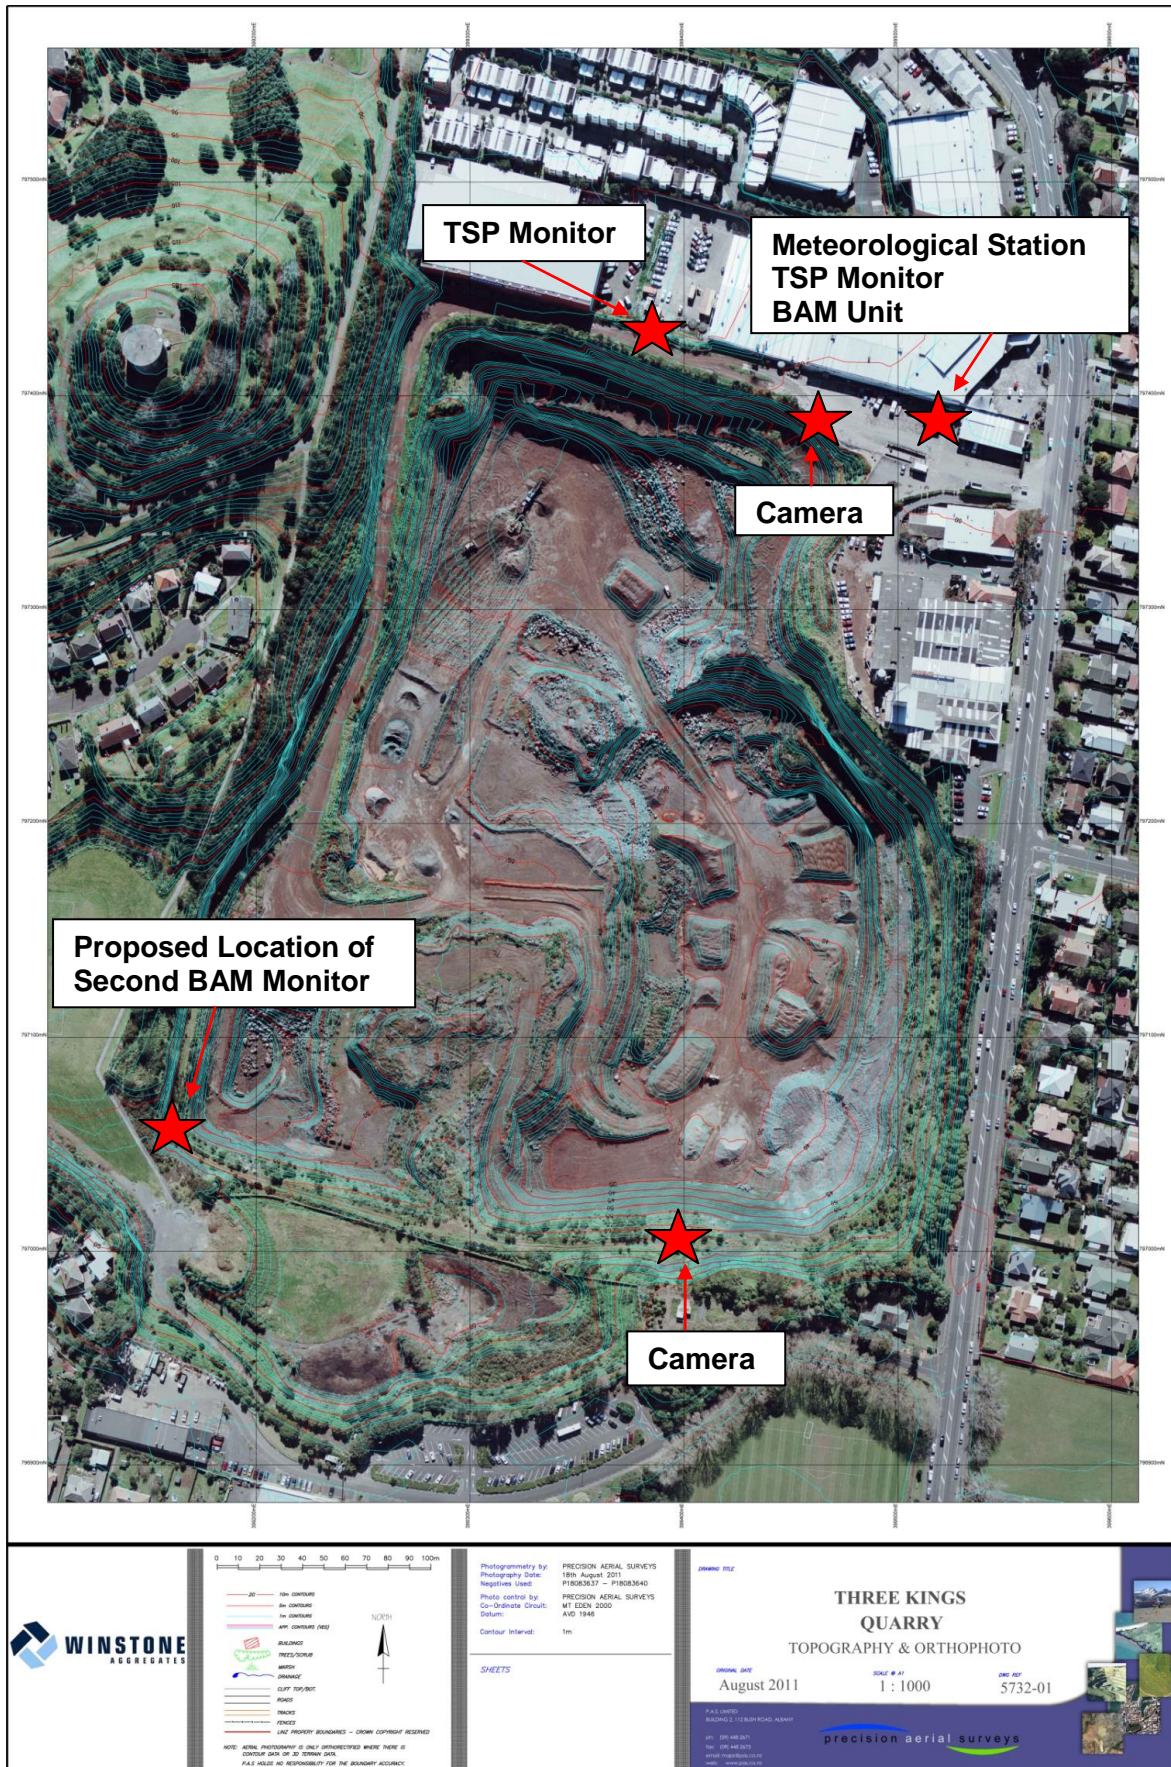
Figure 4. Monitoring Sites.

Figure 4 shows the location of the assorted monitoring units located onsite. There are currently seven monitoring units in operation.

The site continues to maintain two TSP monitoring units and one BAM monitor. An additional BAM unit is to be installed in early 2012 prior to any fill activities occurring onsite.

A new Meteorological Station was installed in 2009 as an upgrade to the previous unit.
