Differential Settlement Alarm Trend Analysis

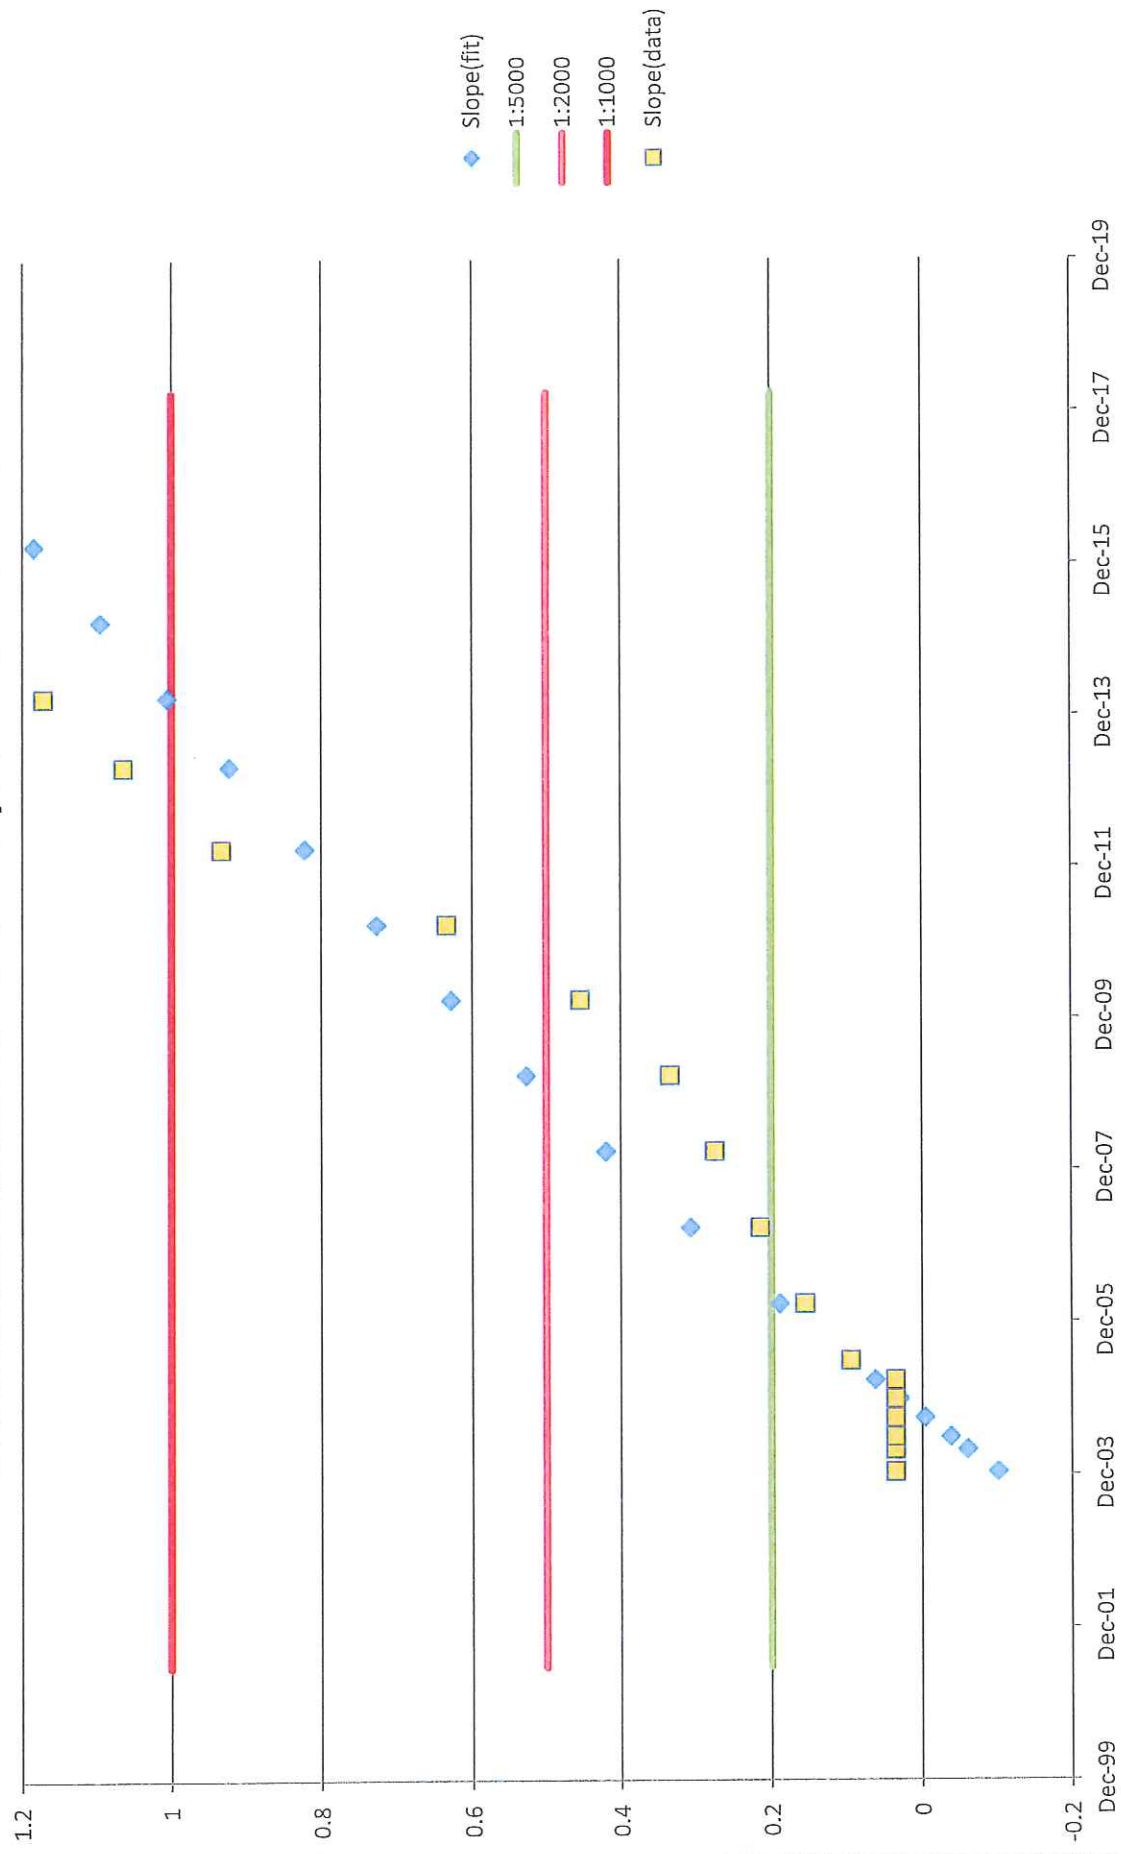
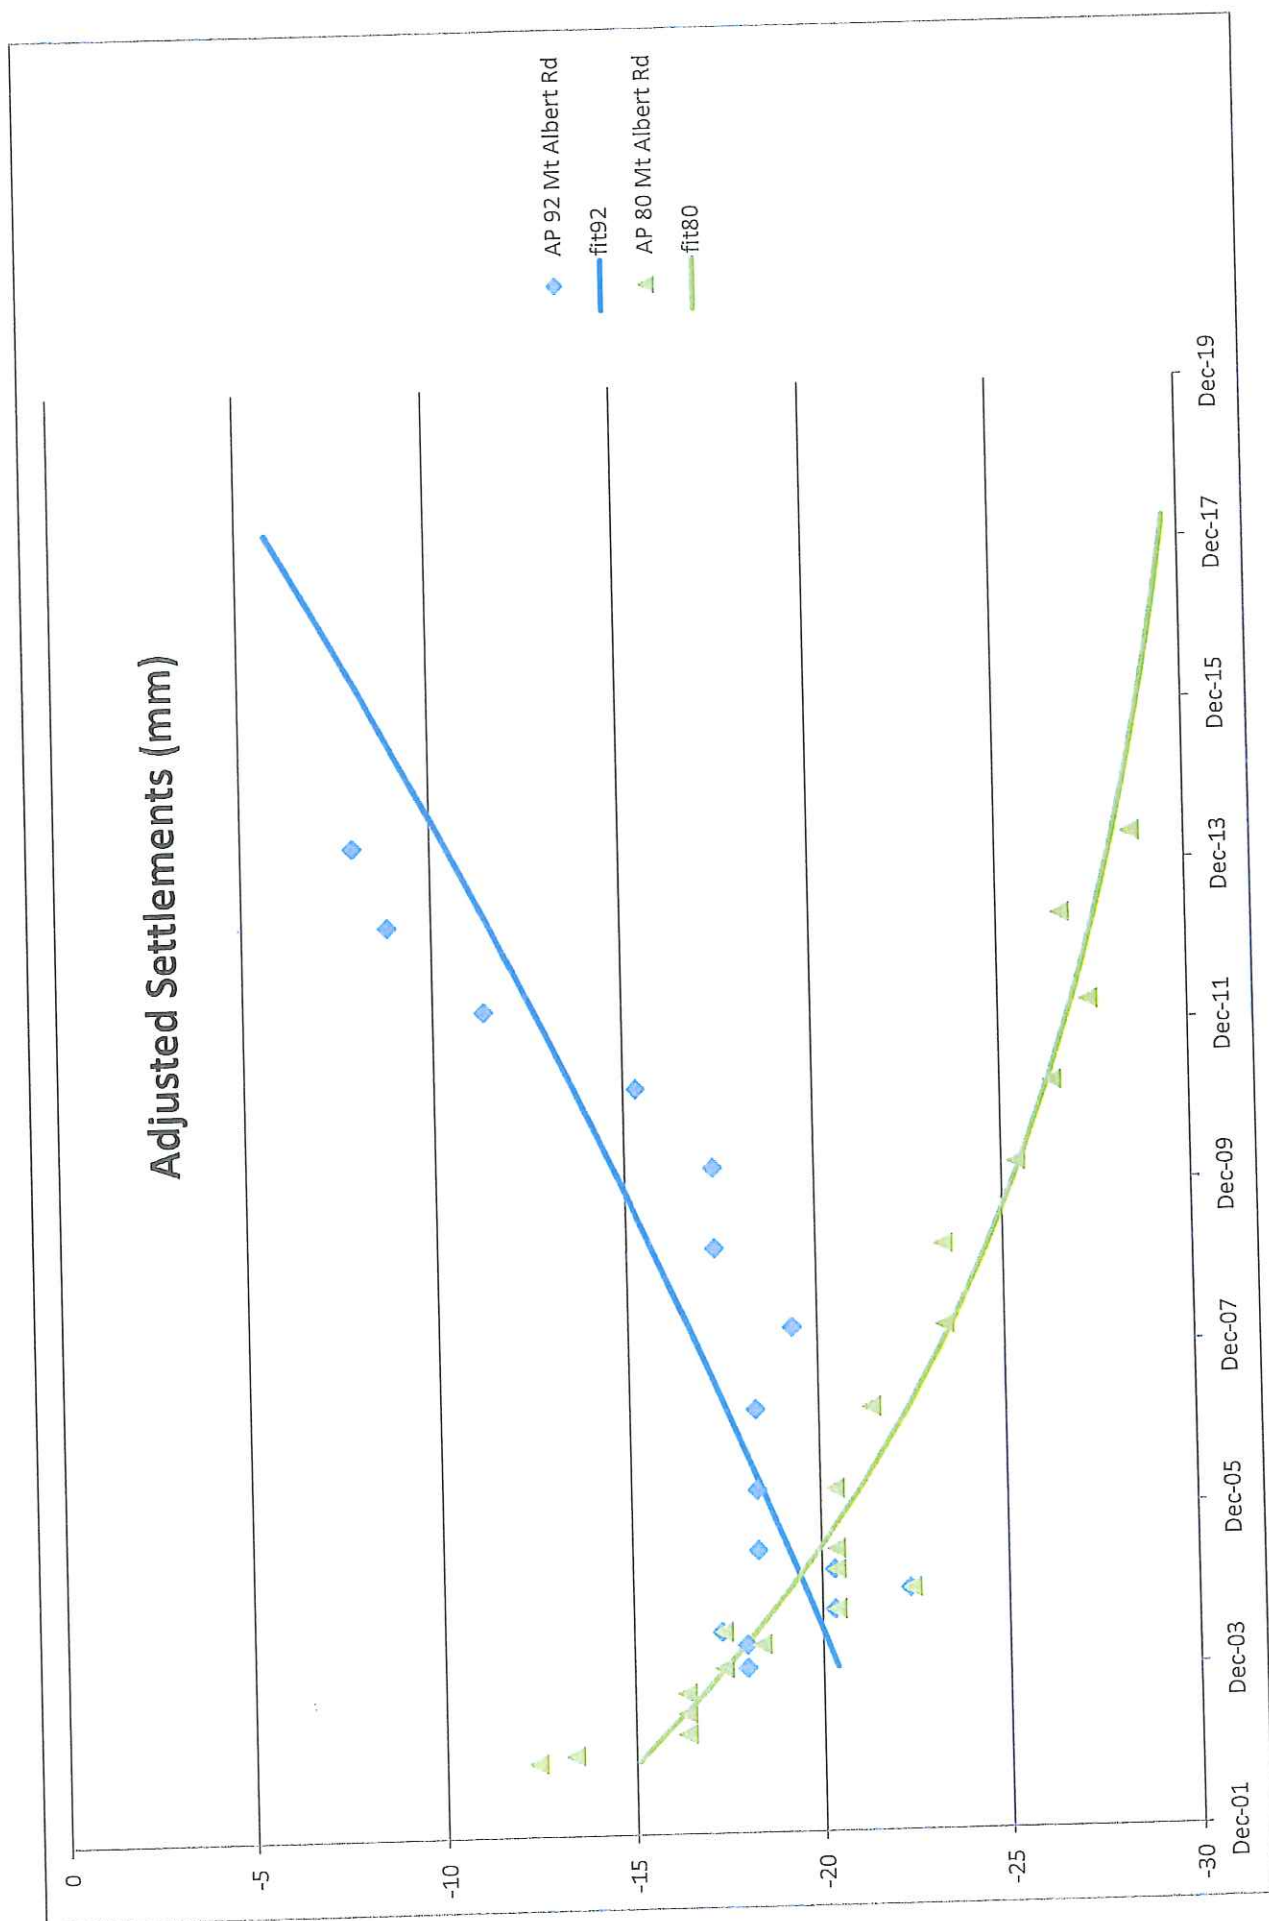
Differential Settlement Trend Analysis - AP92 vs AP93

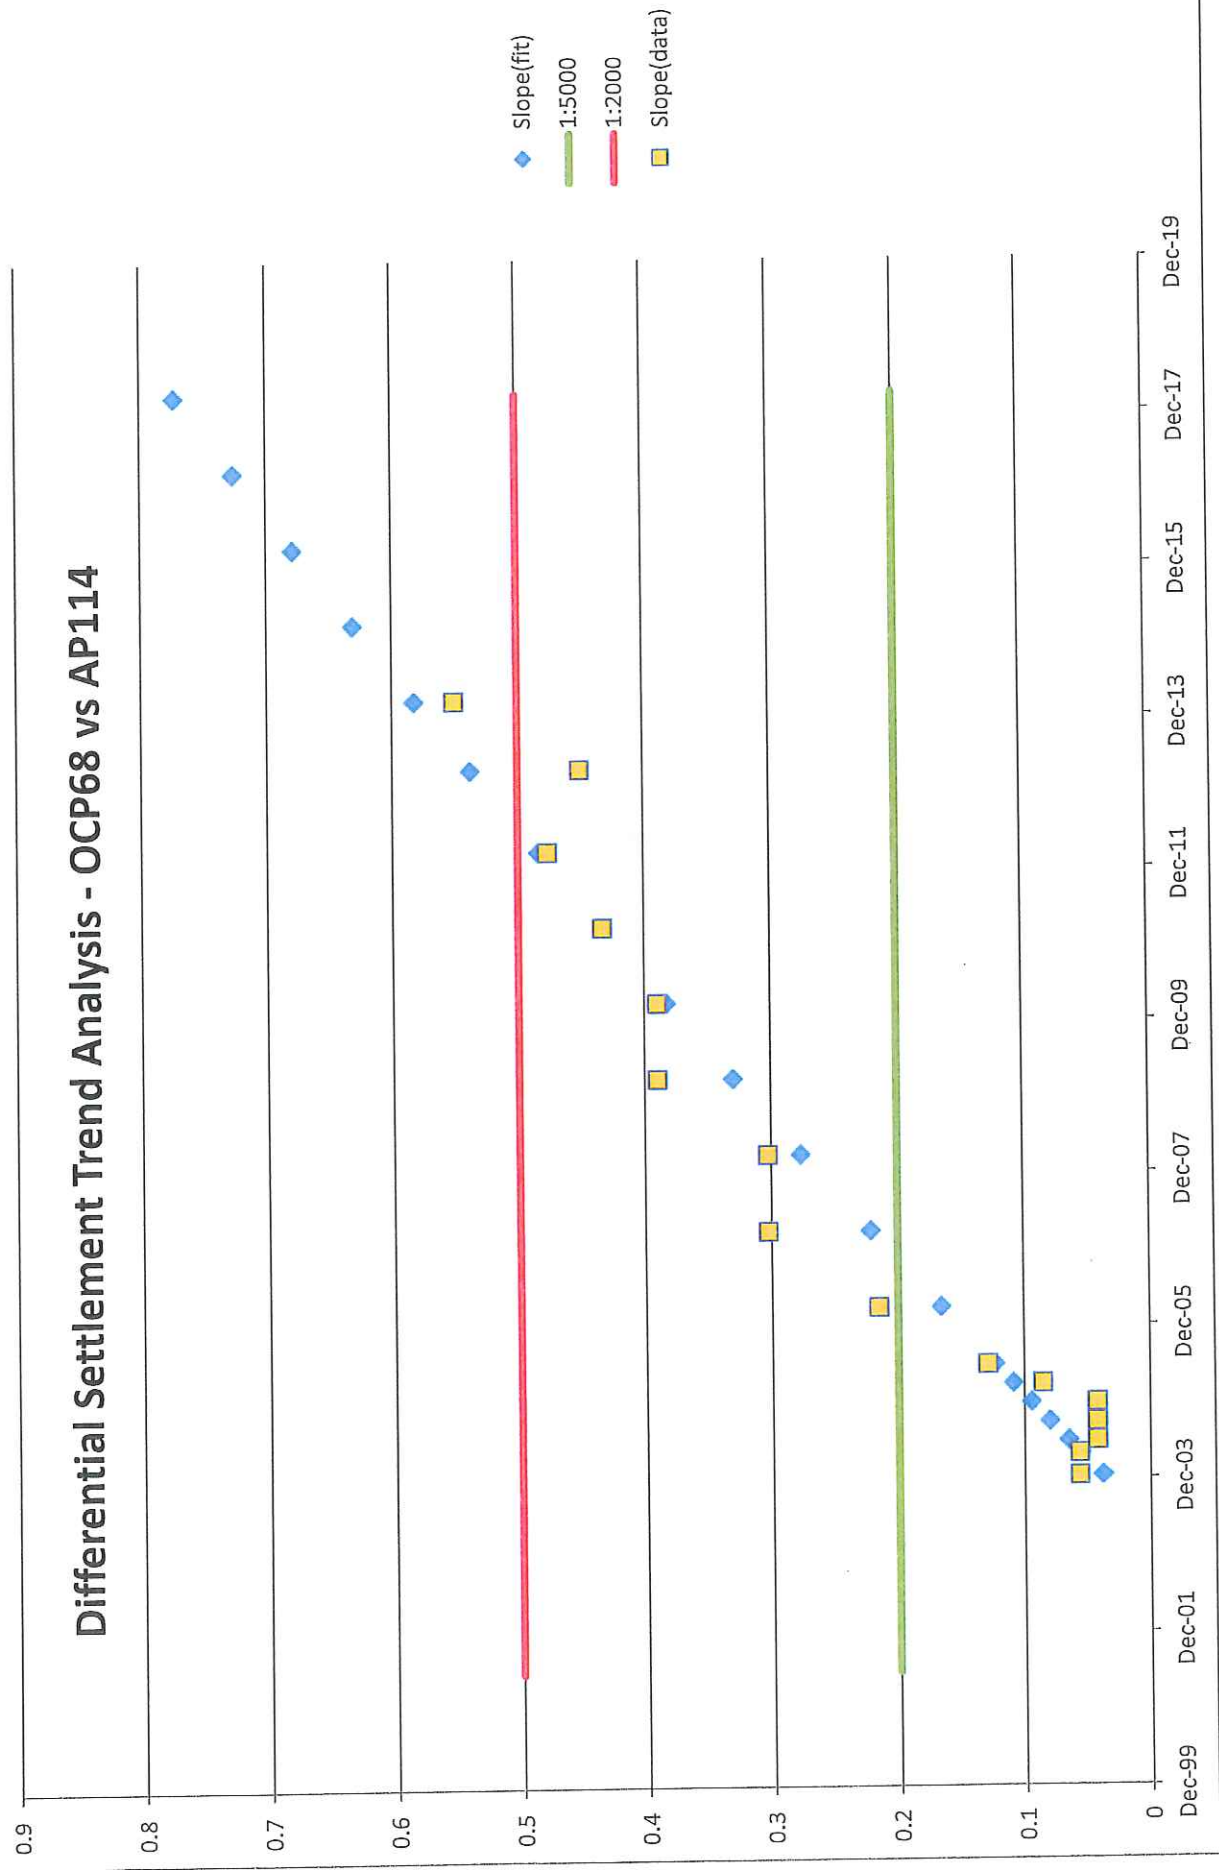
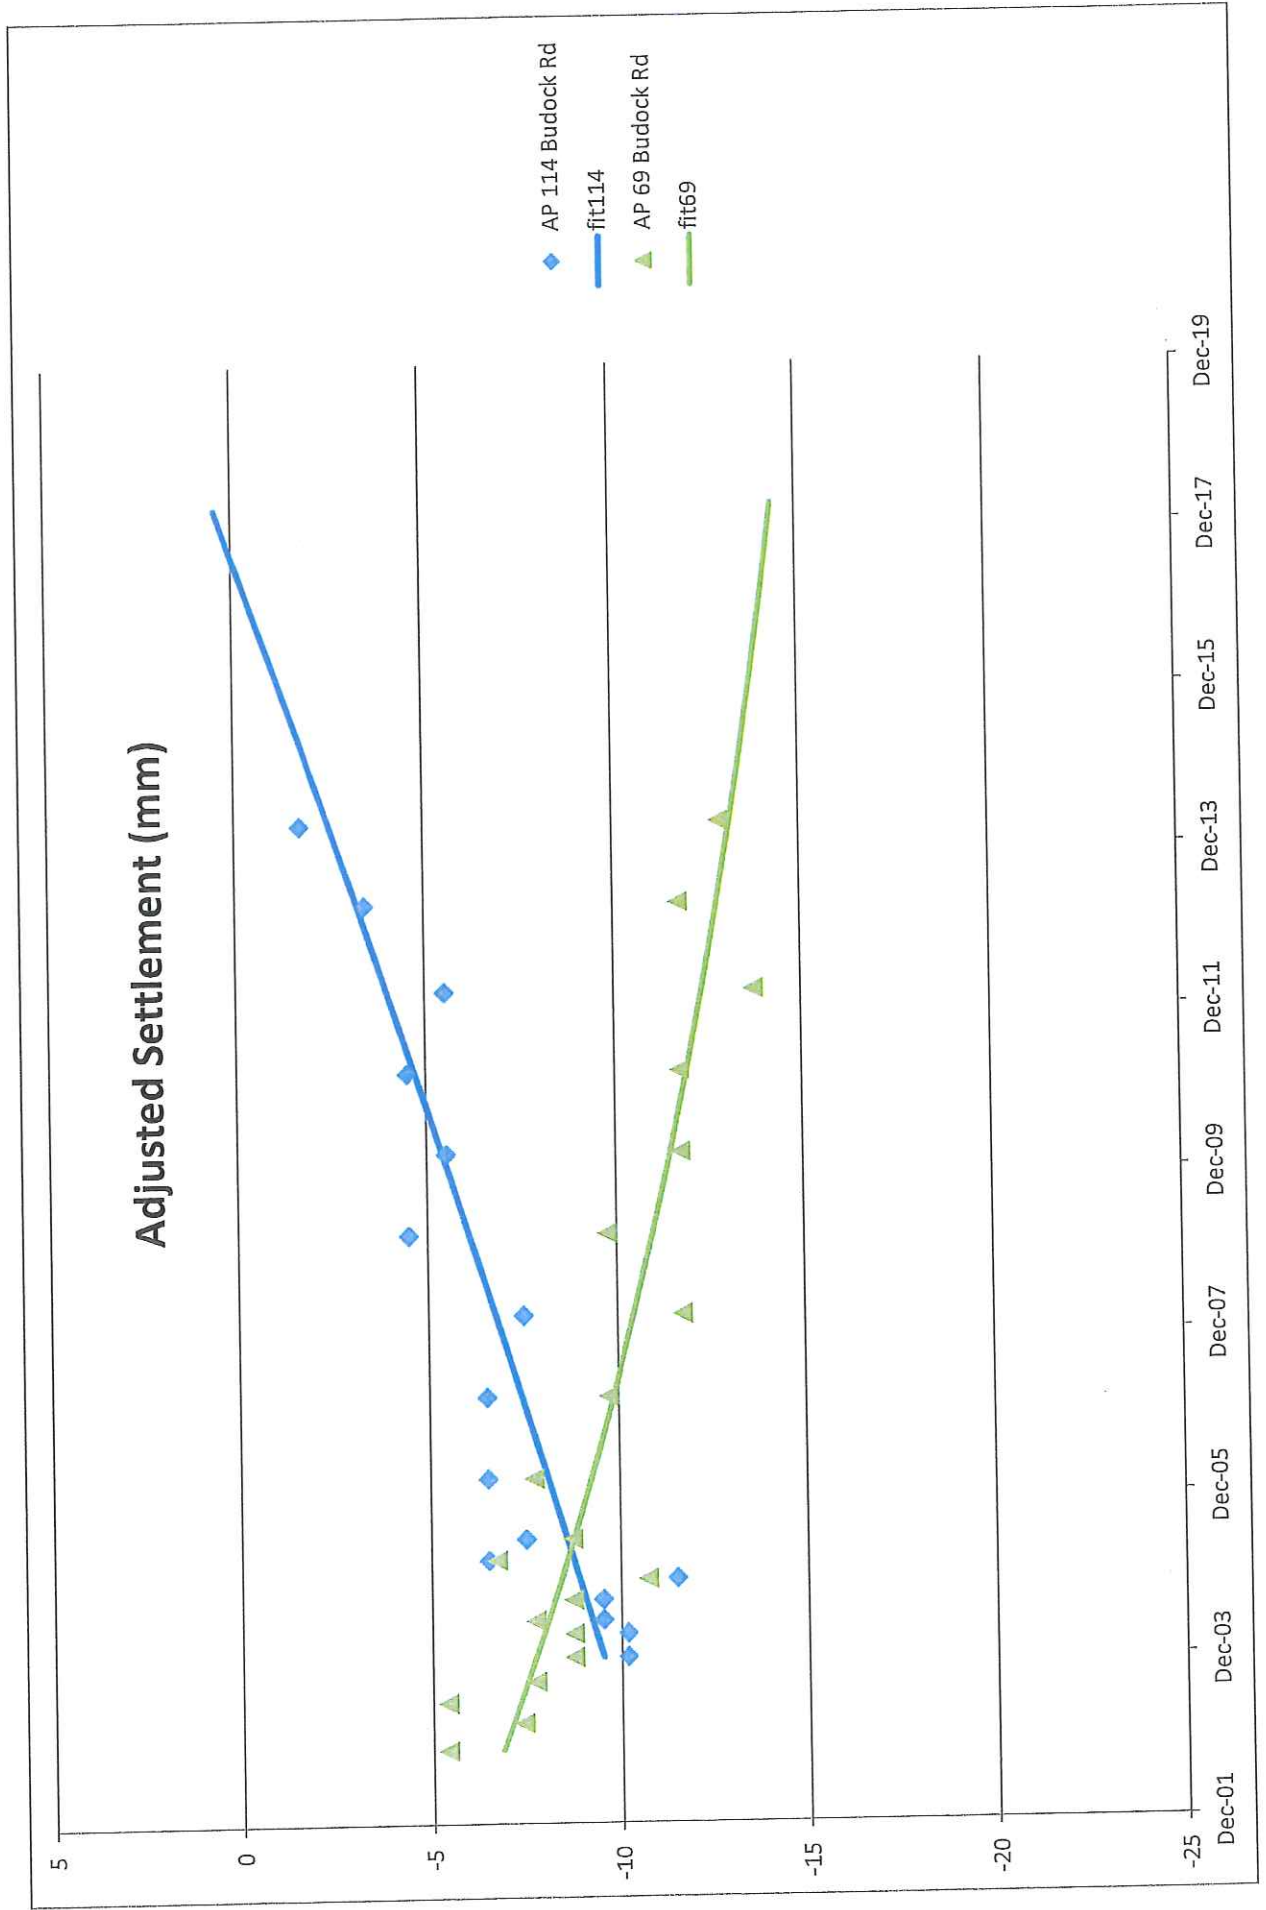
Differential Settlement Trend Analysis - OCP68 vs AP114

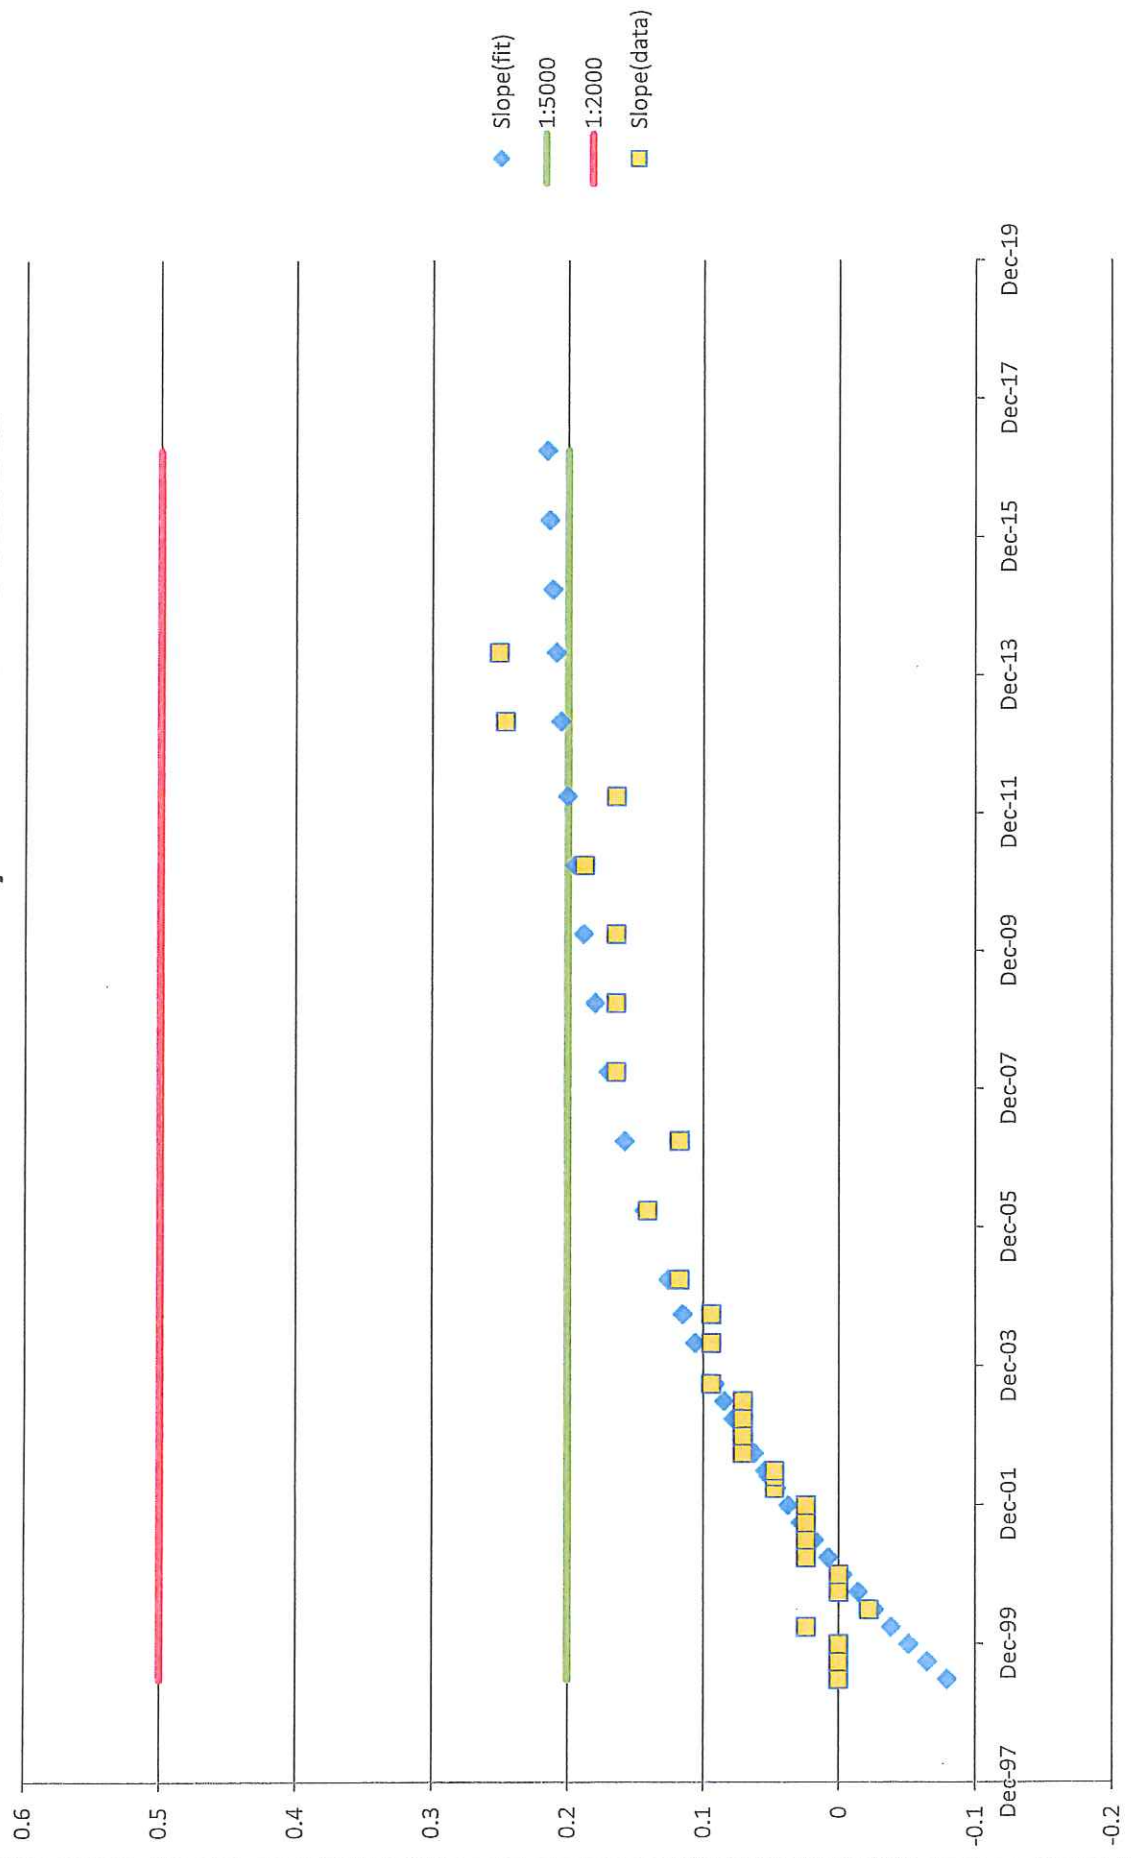
Differential Settlement Trend Analysis - OCP90B vs SM6241
