# **Three Kings Quarry**

## **28 August 2017 – Site Liaison Group Meeting**

### **Site Monitoring Report**

# August 2017 Site Monitoring Report

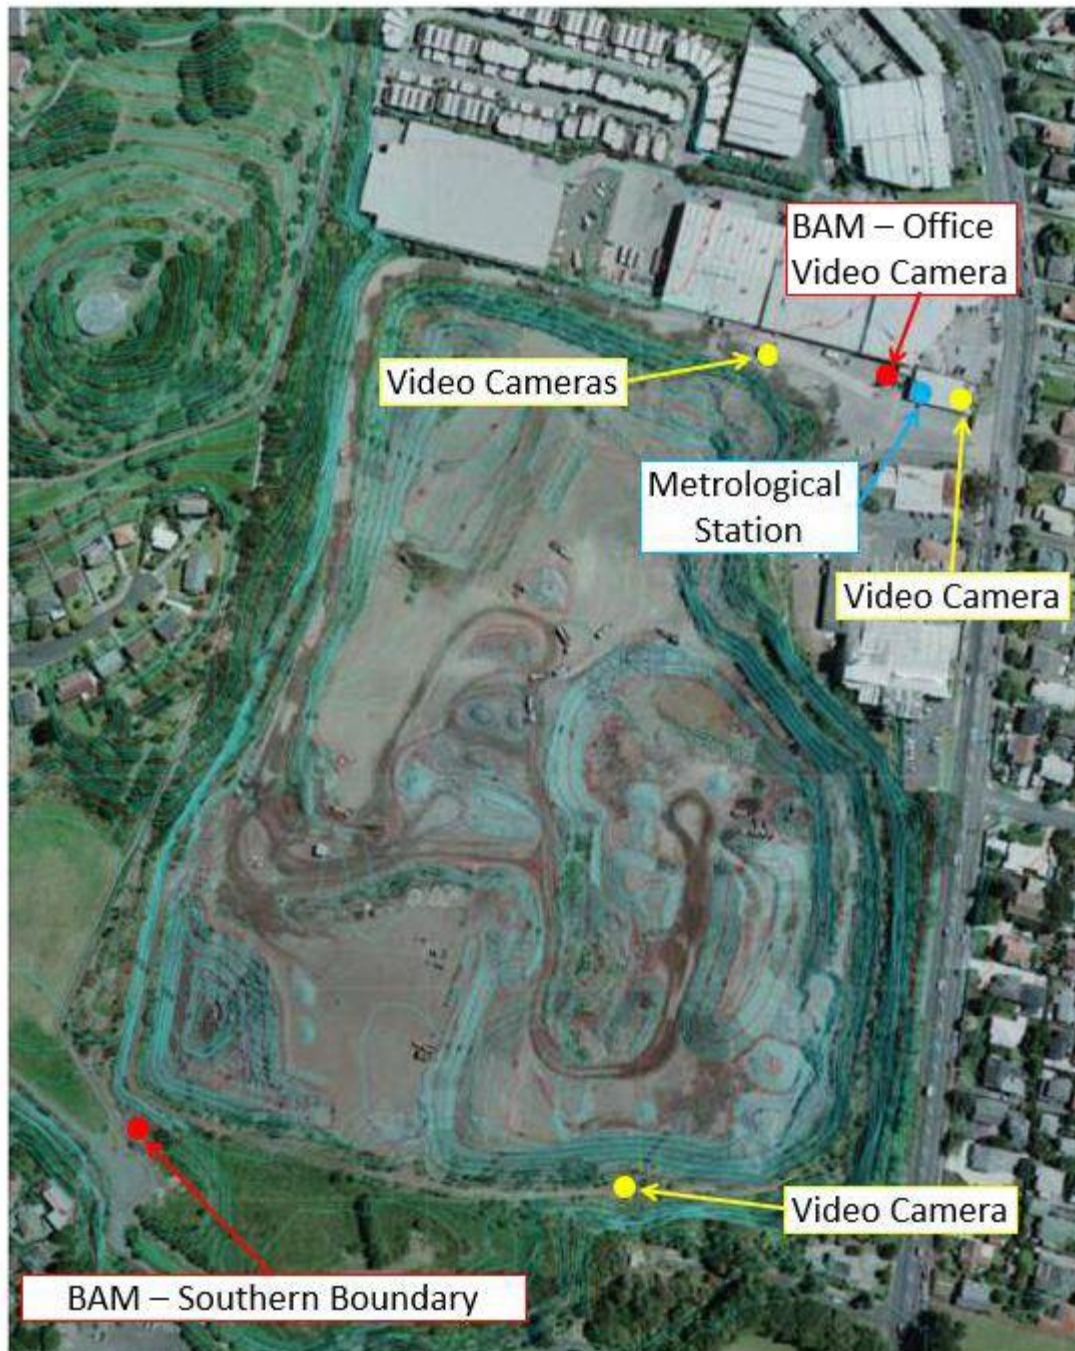
# Air Quality Monitoring Equipment

- Air Quality Monitoring equipment at Three Kings Quarry consists of two Continuous Real Time Beta Attenuation Monitors (BAM), time lapse video cameras and a metrological station
- The BAM monitor located on the roof of the site office has been operating since April 2008. A second BAM monitor was commissioned in April 2012 in the south-western corner of Three Kings Quarry
- The Air Discharge Consent for Three Kings Quarry was renewed in February 2015.
- The air quality trigger was changed from 80 micrograms per cubic metre as a 24hour average (all results) to 60 micrograms per cubic metre as a 24hour average as measured by the BAM units.

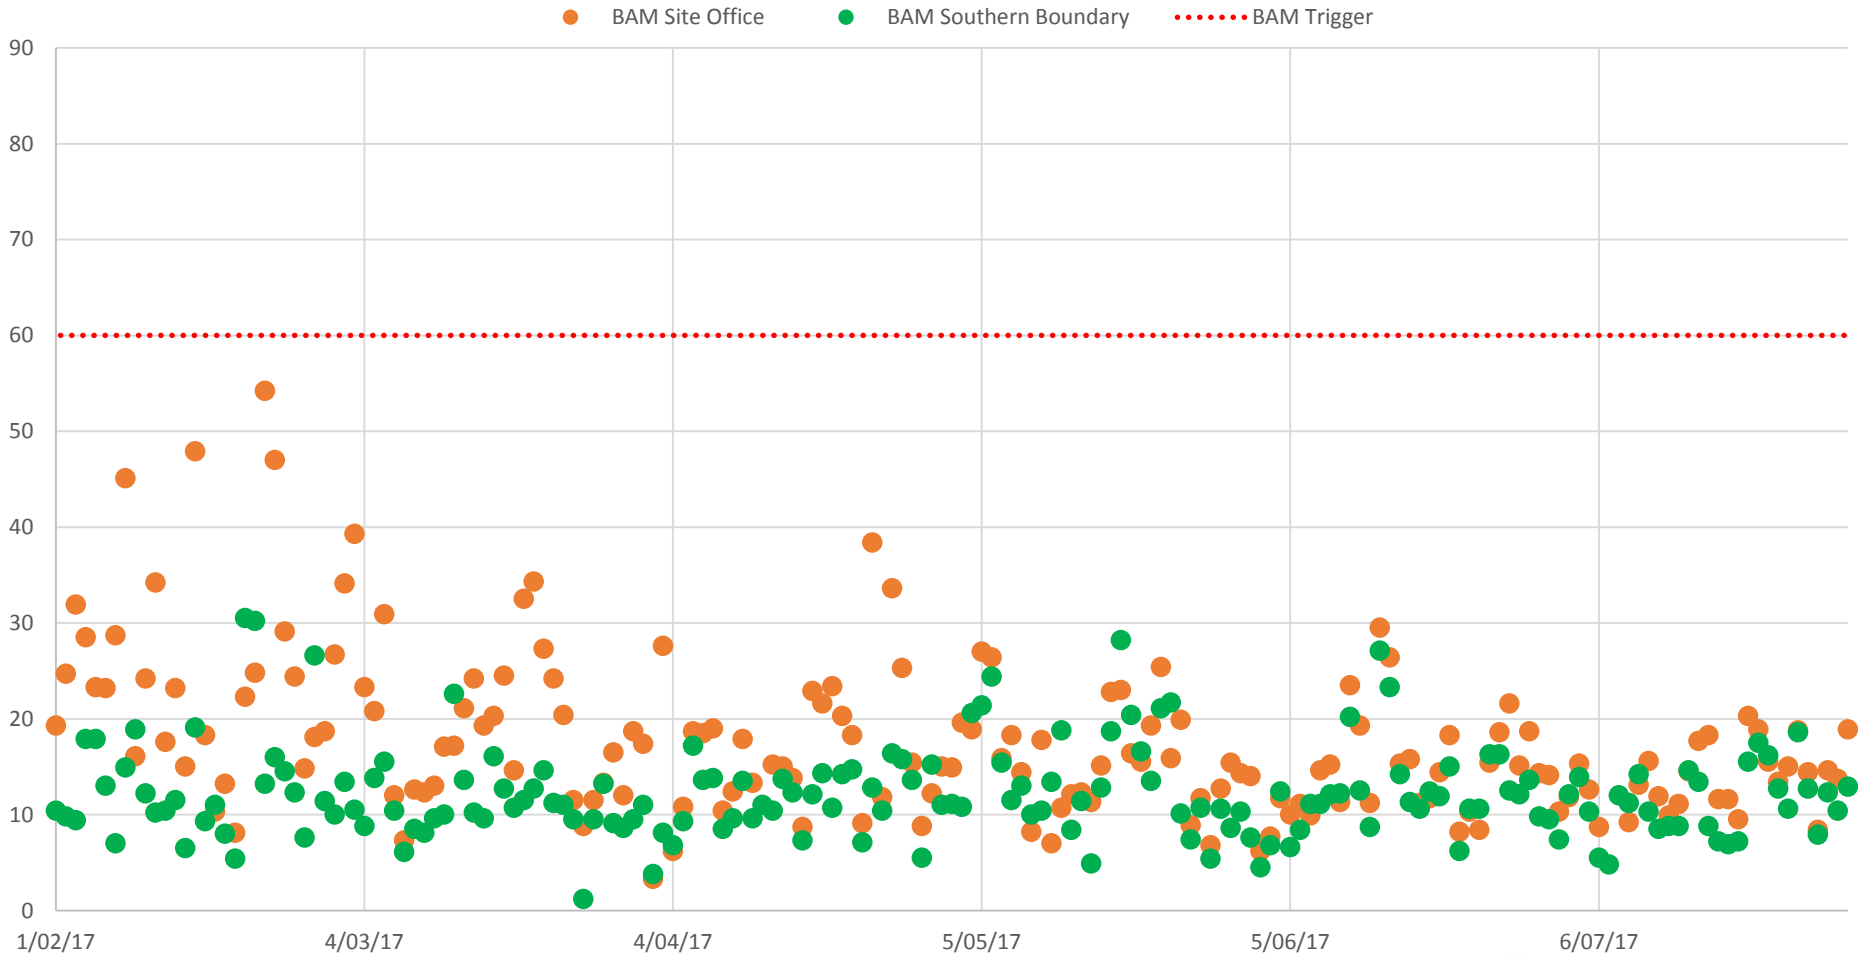
The following figure shows air monitoring results from 1<sup>st</sup> February to 31<sup>st</sup> July 2017.

- Continuous air quality monitoring results recorded since the last SLG meeting have been less than 30 micrograms per cubic meter as a 24 hour average
- No air quality triggers have been recorded since the last SLG meeting.

All results are in  $\mu\text{g}/\text{m}^3$ .

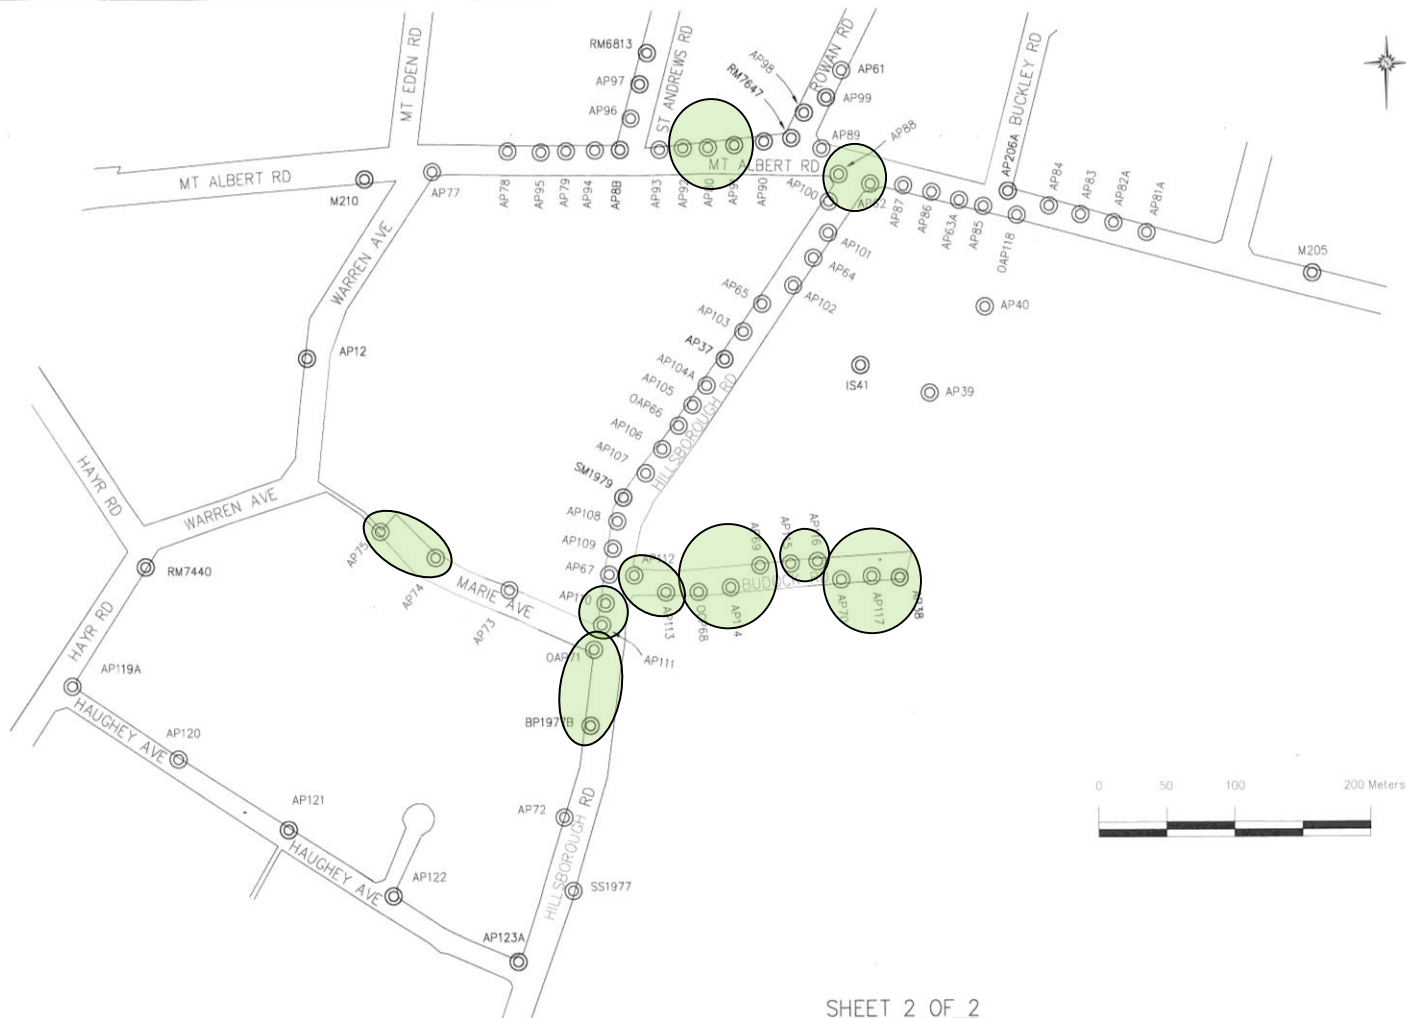
# Mt Albert Road – AP80, AP92 and AP93

- Differential Settlement Alarms continue to be recorded as follows:
  - AP92 and AP93, and AP92 and AP80 on Mt Albert Road,
  - AP62A and AP88A at the intersection of Mt Albert Road and Hillsborough Road,

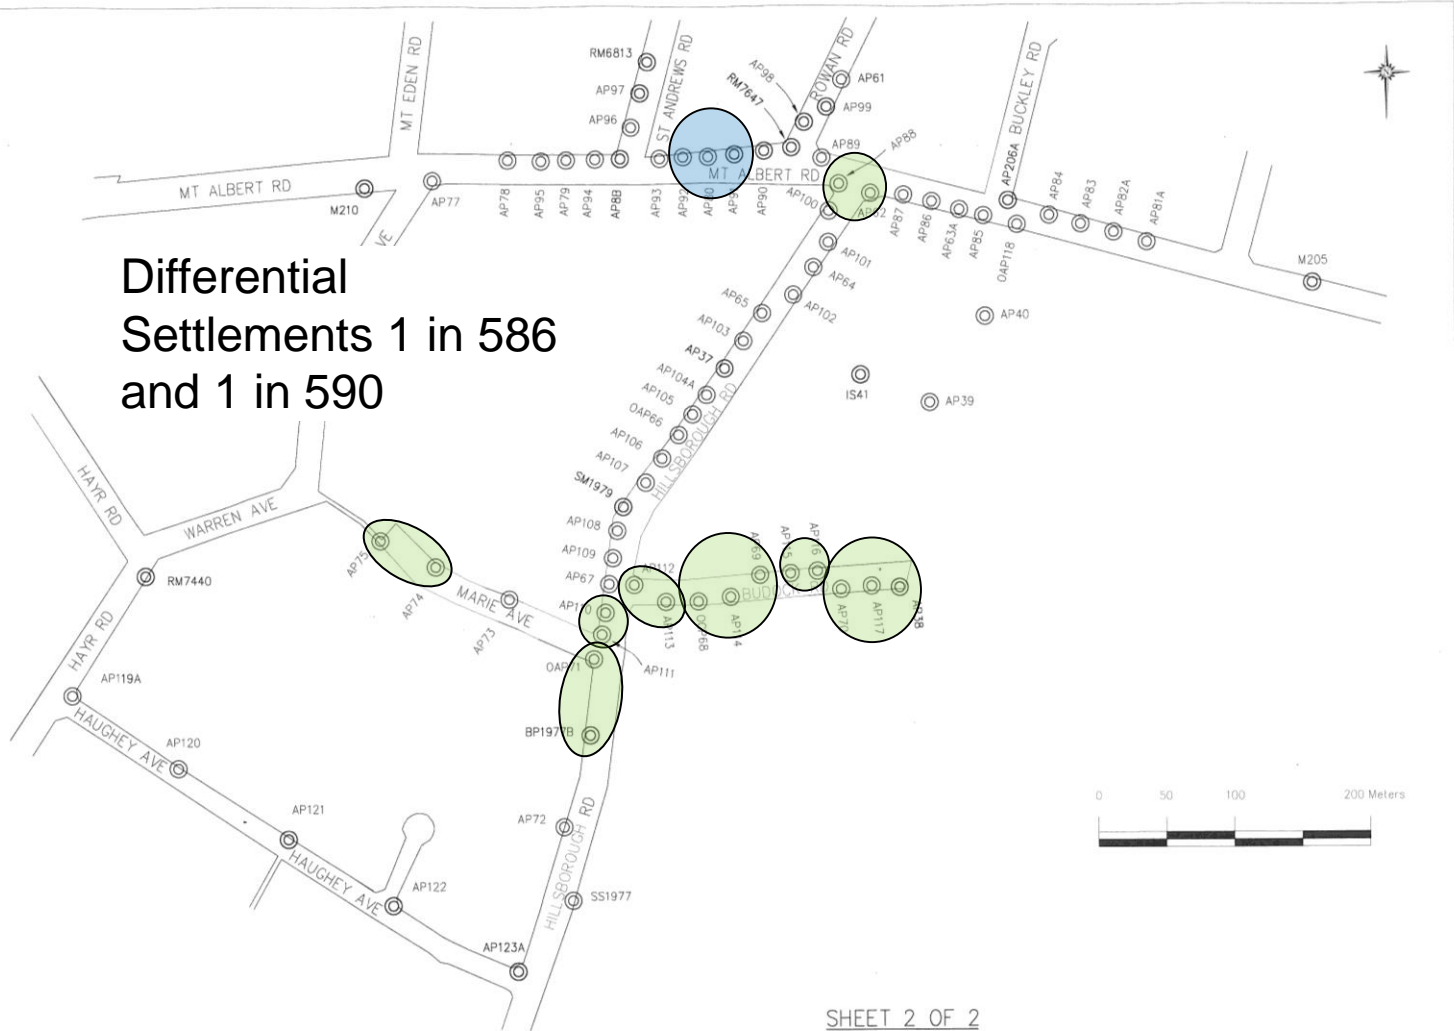
- The Differential Settlement Alarms between AP80, AP92 and AP93 on Mt Albert Road adjacent to the St Andrews Reserve are not a result of dewatering Three Kings Quarry.
- AP80 and AP93 have recorded settlements consistent with other marks in this area, AP92 has risen since it was first surveyed;
- The results of the precise level survey show that the change in level of AP92 is anomalous and not consistent with the change in levels in the surrounding precise level survey marks.
- The relative rise in level of AP92 is not a result of dewatering Three Kings Quarry.

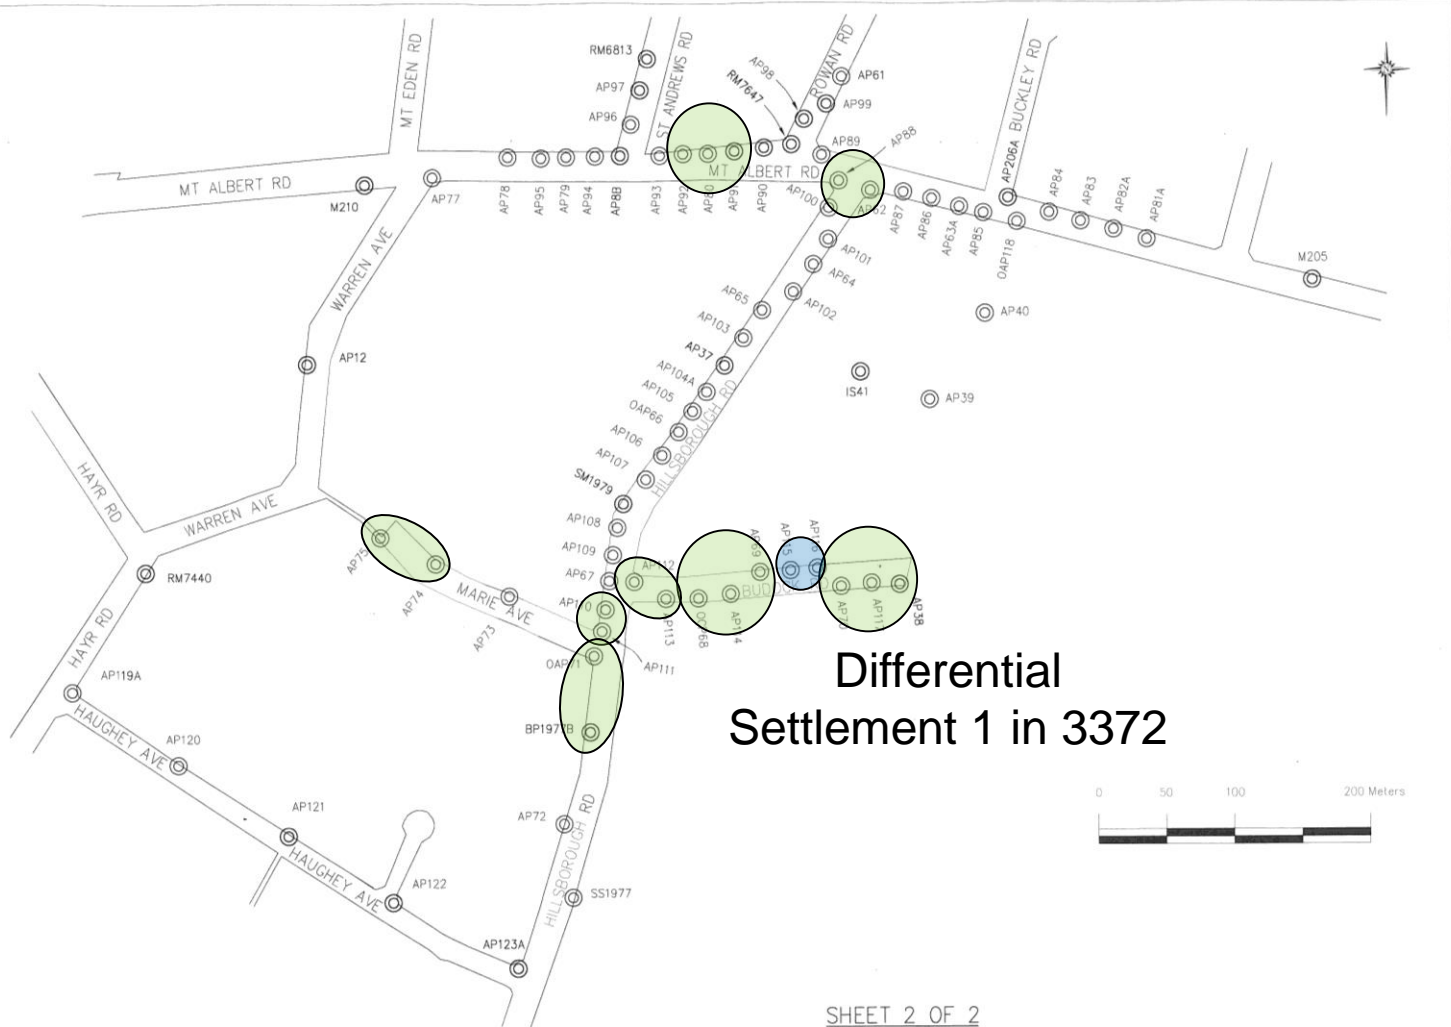
## Budock Road – AP115 and AP116

<i>Precise Level Mark</i>	<i>Change in Level since First Survey (mm)</i>	<i>Adjusted Change in Level (mm)</i>	<i>Precise Level Marks</i>	<i>Differential Settlement</i>	
				Spacing (metres)	Differential Settlement
AP 38	-7.00	-7.00			
AP 117	+13.03	+8.69	AP38-AP117	22.9	1 in 1457
AP 70	-3.97	-6.43	AP117-AP70	21.5	1 in 1420
AP 116	-1.87	-8.05	AP70-AP116	18.7	1 in 11569
AP 115	-6.63	-14.04	AP116-AP115	20.2	1 in 3372
AP 69	-7.03	-13.45	AP115-AP69	22.0	1 in 37285
AP 114	+10.87	+0.68	AP69-AP114	26.4	1 in 1865
OCP 68	-5.10	-14.57	AP114-OCP68	23.0	1 in 1507
AP 113	-1.23	-14.02	OCP68-AP113	22.1	1 in 40379
AP 112	-5.90	-20.63	AP113-AP112	25.7	1 in 3886
AP 67	-9.00	-22.71	AP112-AP67	17.6	1 in 8463

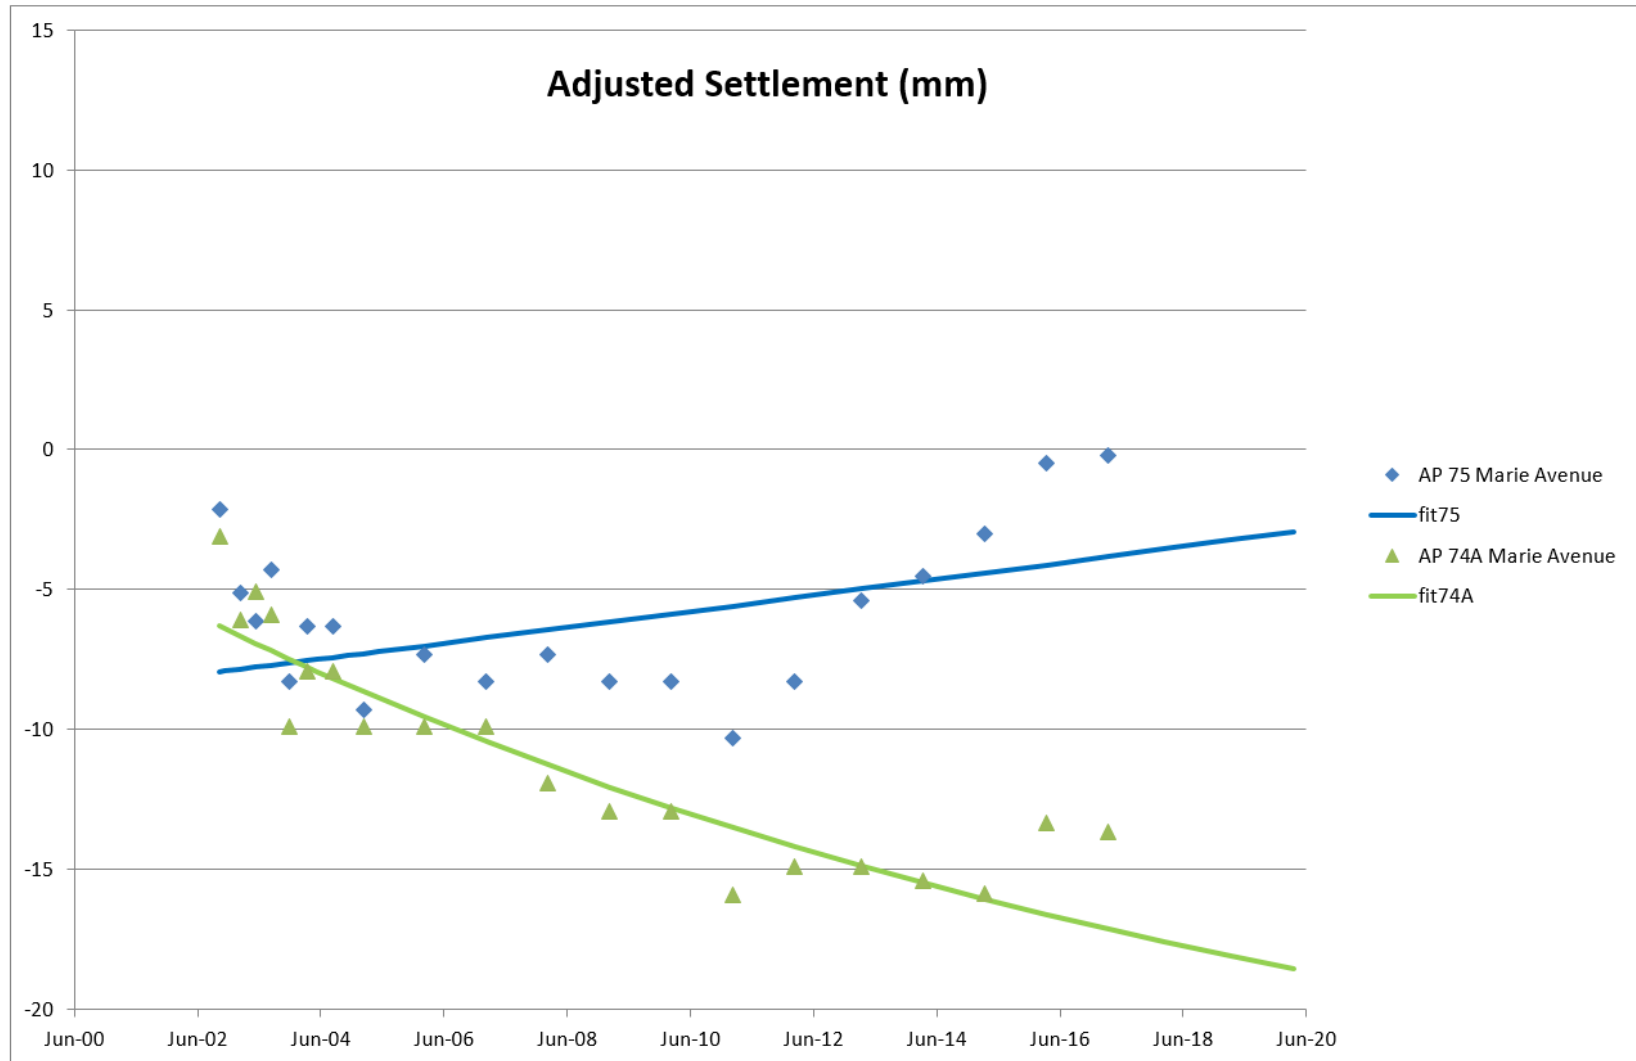
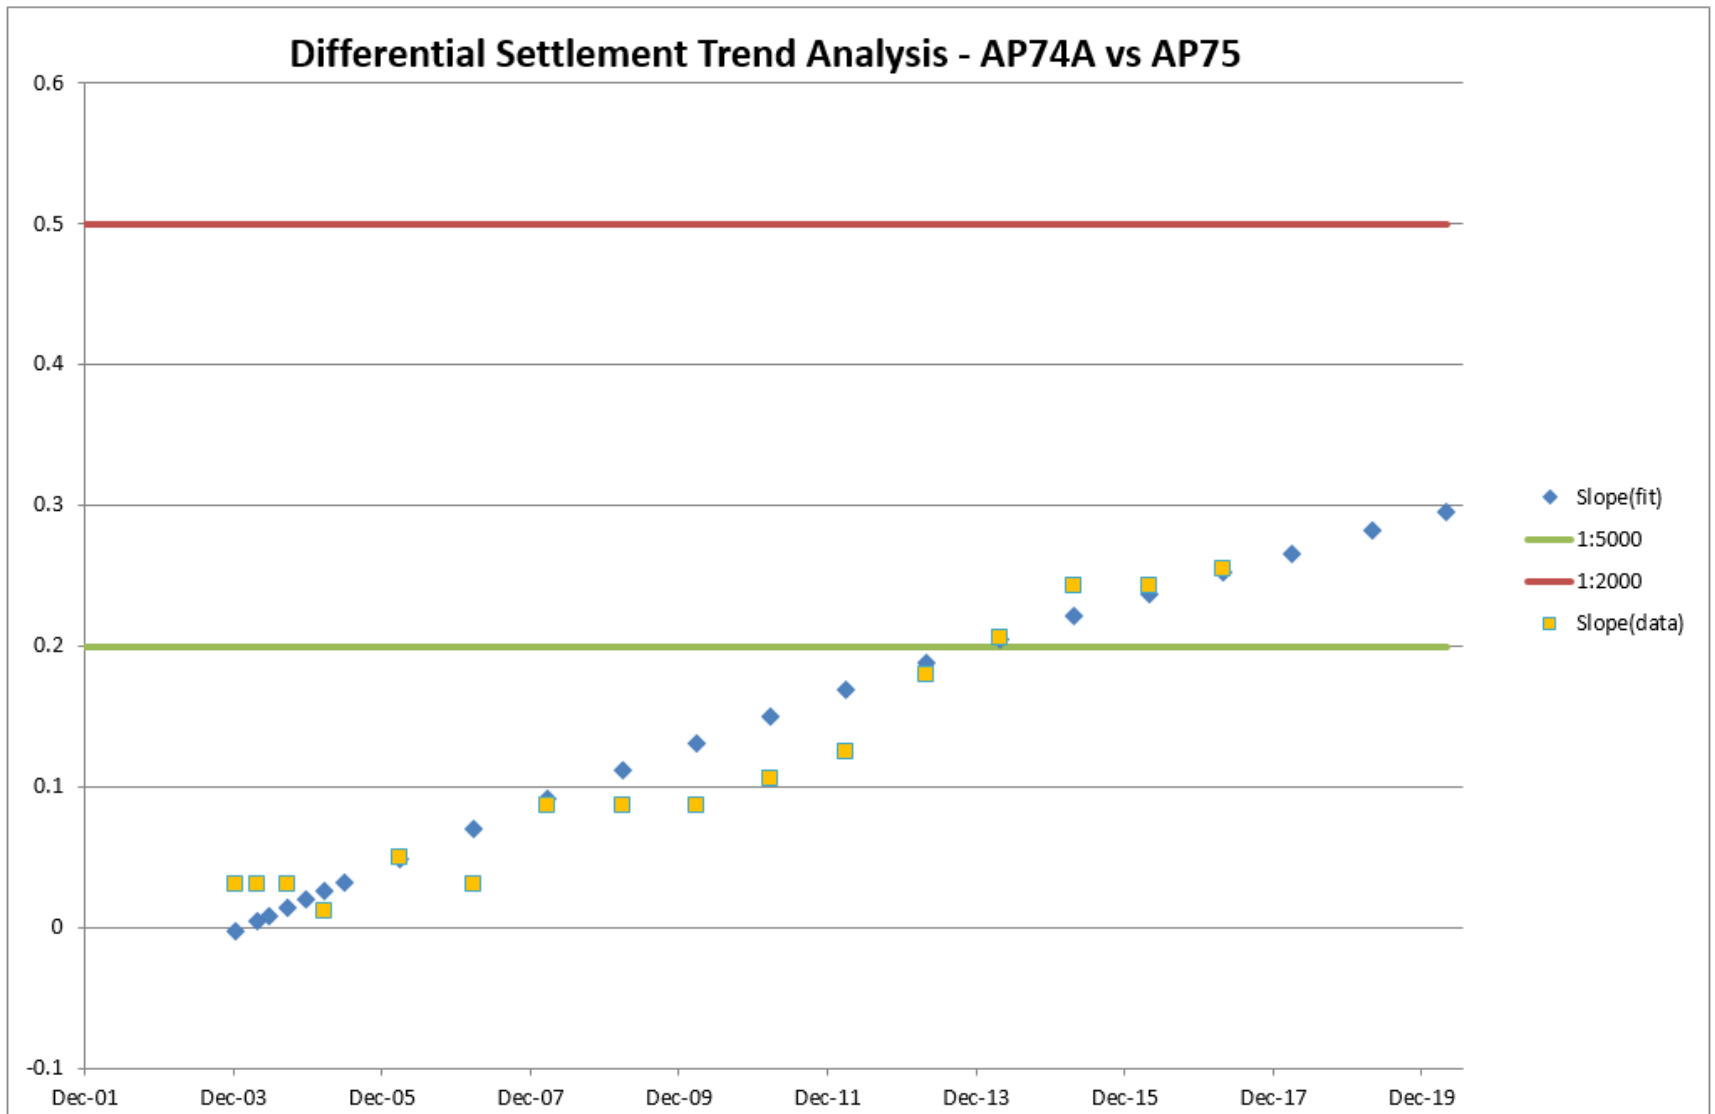
## Settlement Trends – AP74A and AP75

Differential  
Settlement 1 in 3930

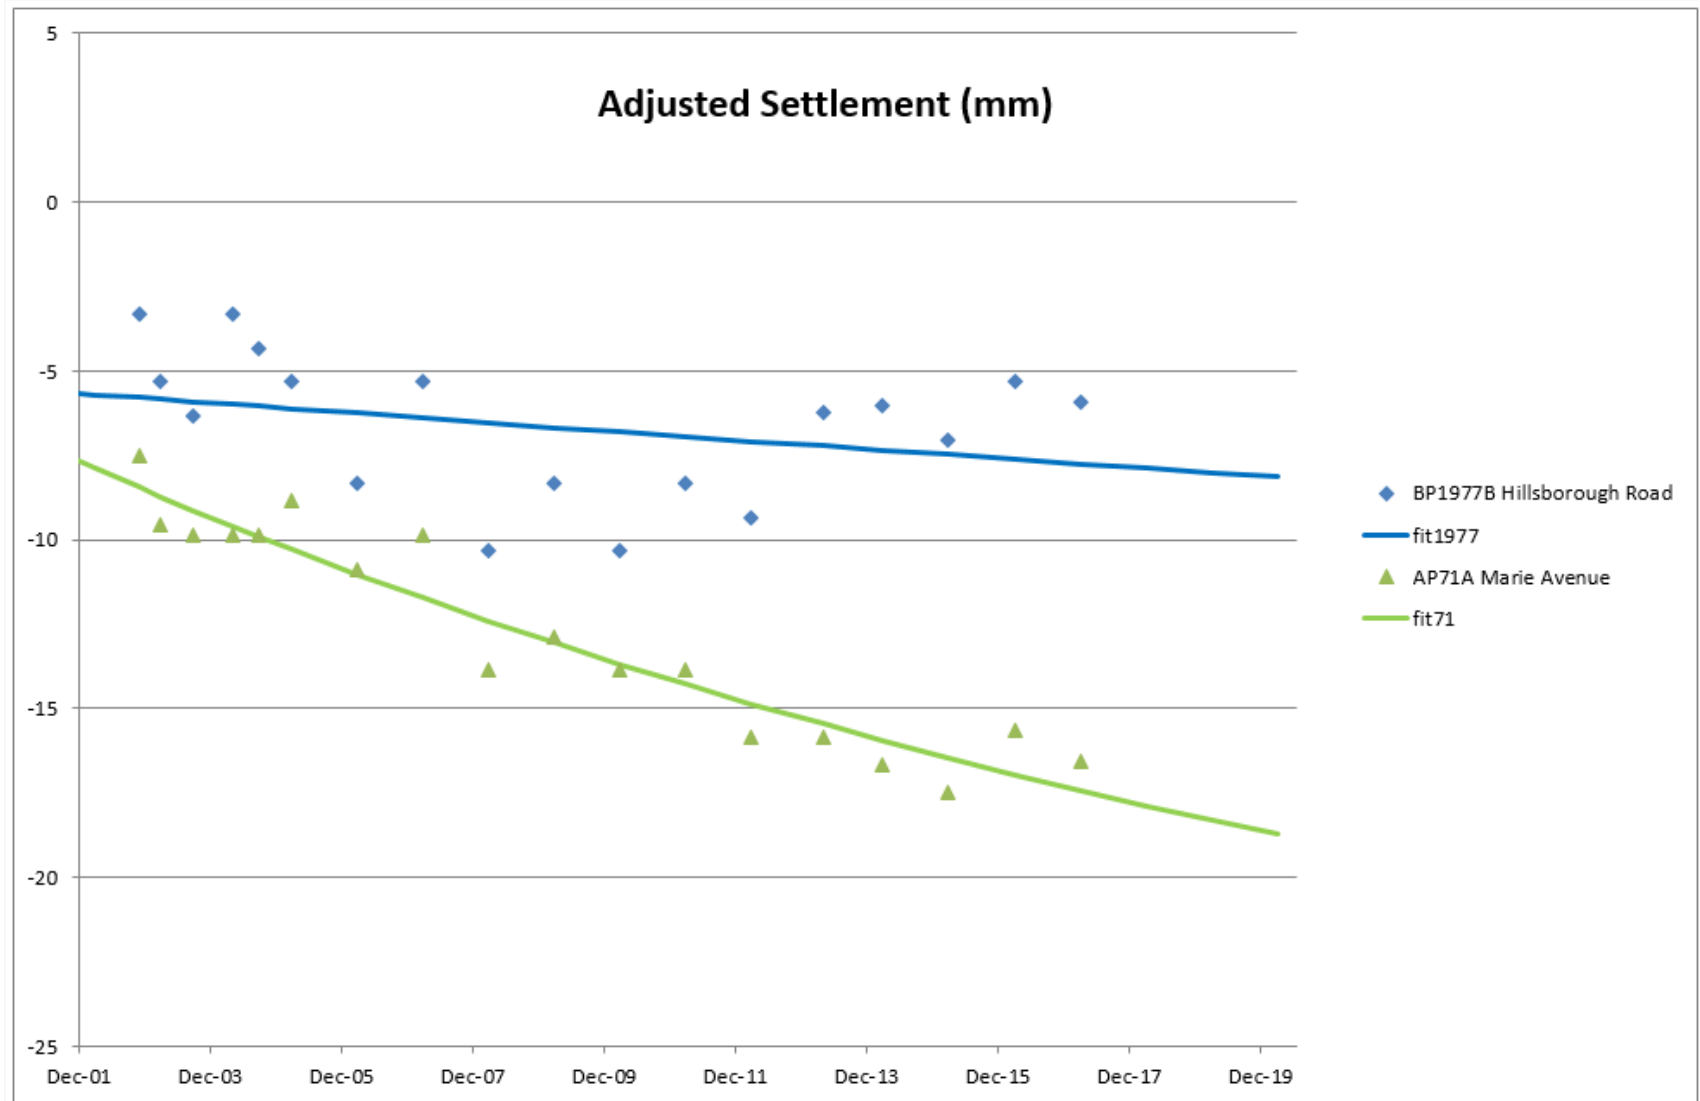
## Settlement Trends – BP1977B and AP71A

- Differential Settlement Alarms were also recorded between:
  - AP71A and BP1977B on Hillsborough Road (previously recorded in 2014), and
  - RM3901 and RM7457 on McCullough Avenue.
