Three Kings Quarry

29 May 2017 – Site Liaison Group Meeting

Site Monitoring Report

May 2017 Site Monitoring Report

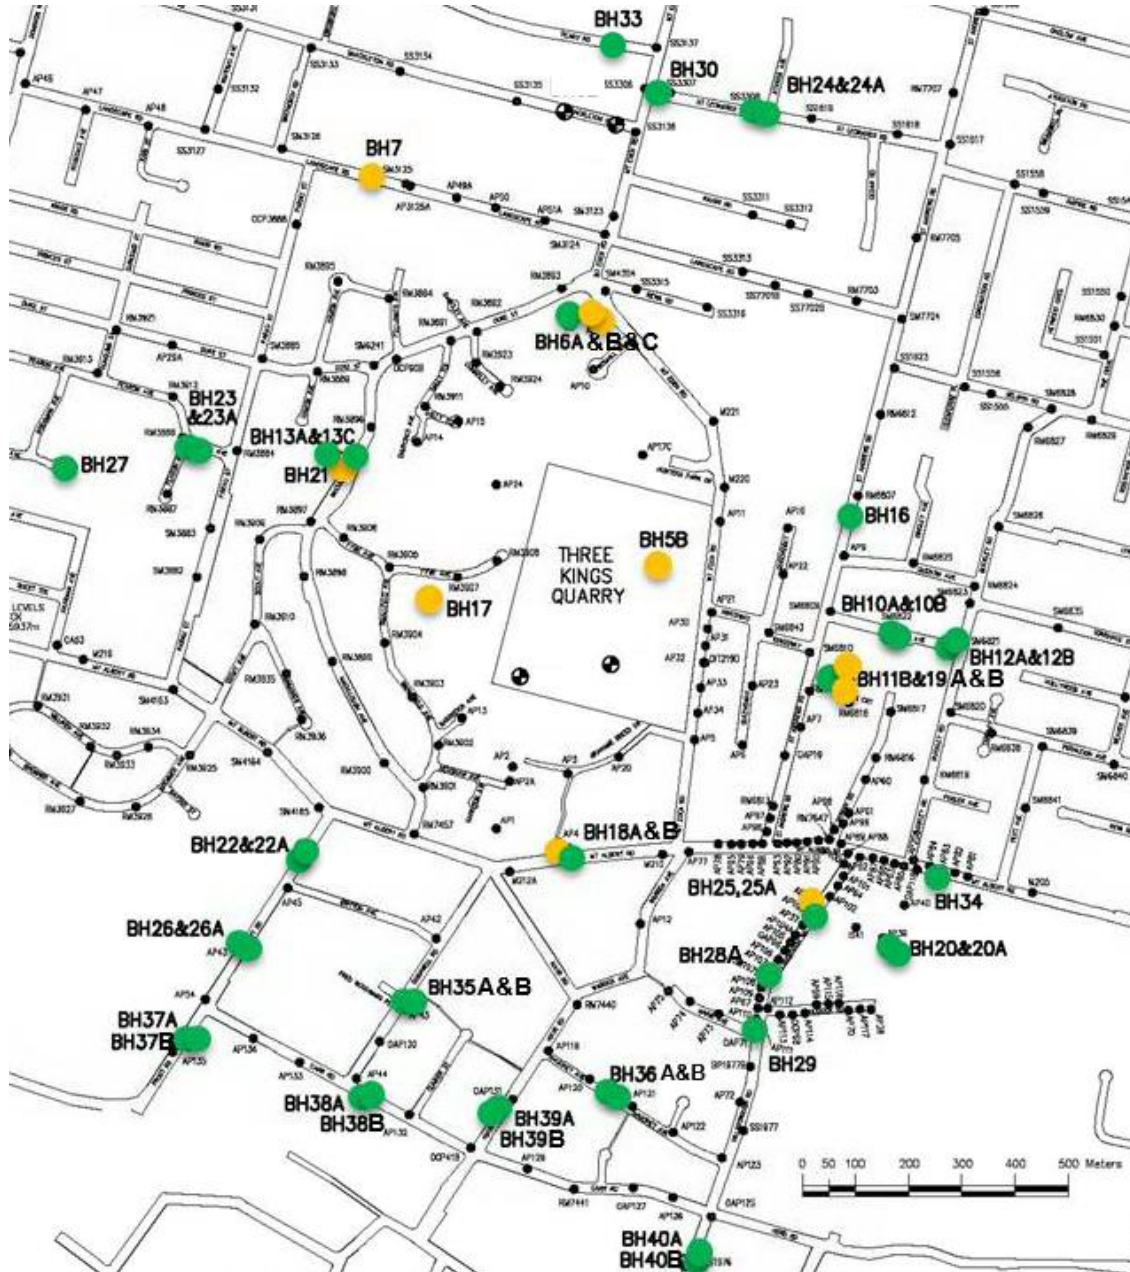
Borehole Location Plan with April 2017 Groundwater Levels Included

- Dewatering of Three Kings Quarry commenced in March 1999
- Groundwater levels within Three Kings Quarry have been held above RL34m since October 2002
- Groundwater levels are currently being measured monthly in 51 boreholes and piezometers located in and around Three Kings Quarry
- Groundwater levels are generally following seasonal trends

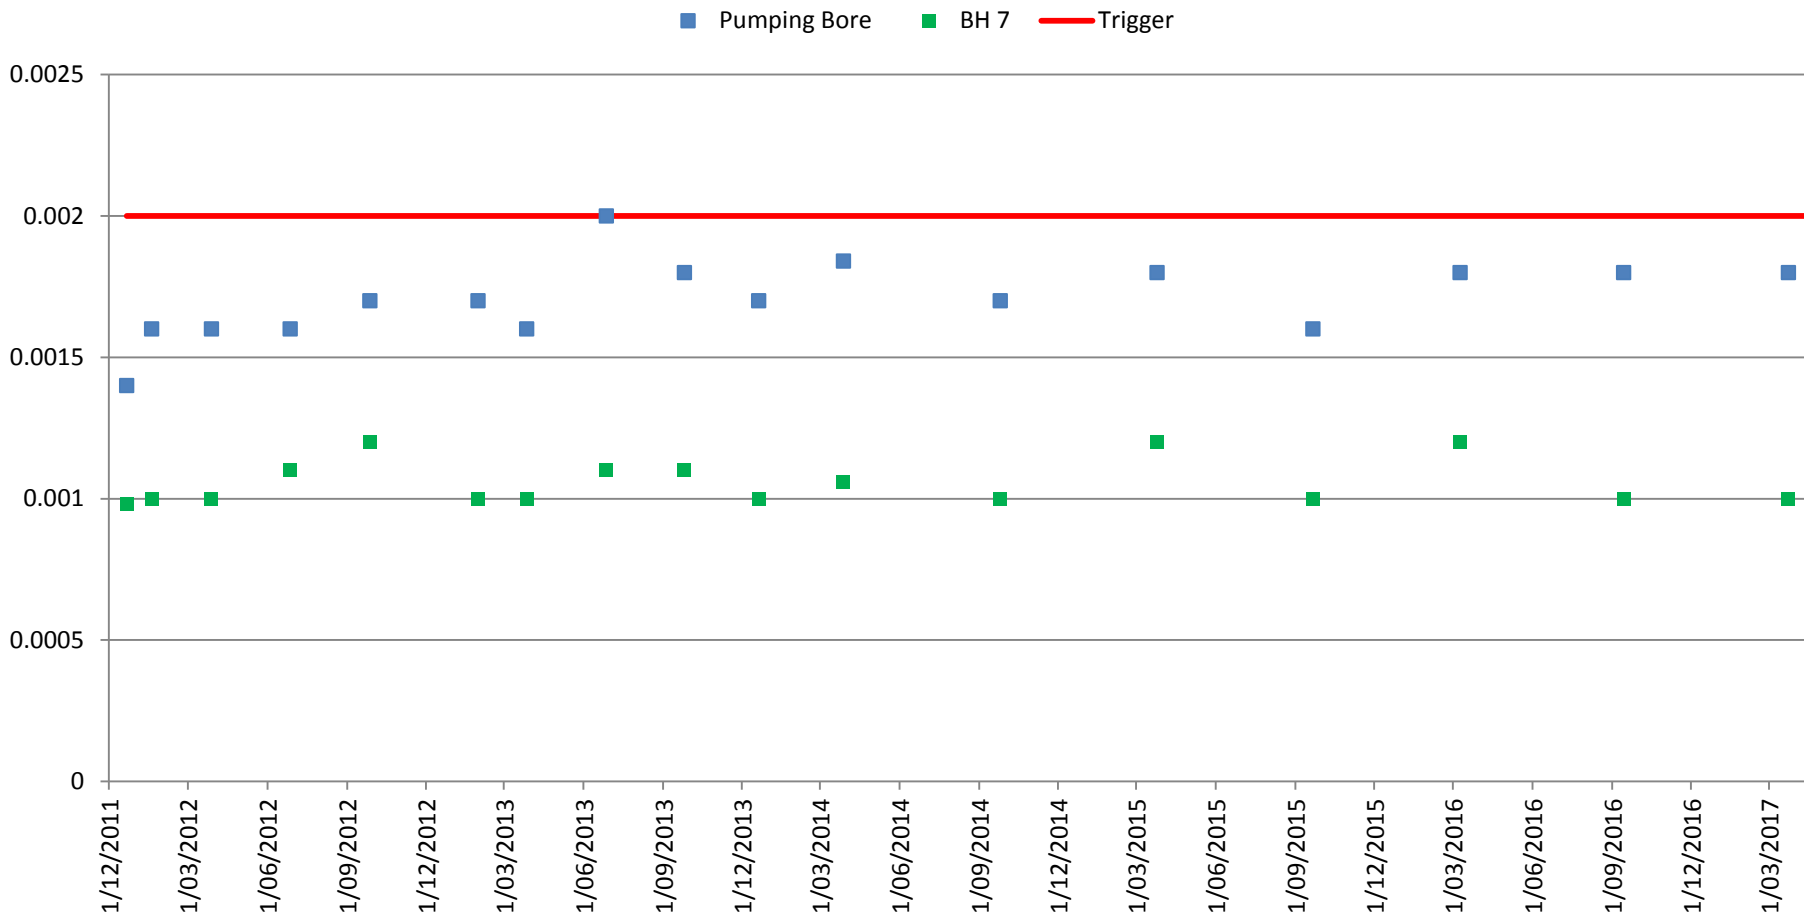
The following figure show all the results for Arsenic since the commencement of sampling.

All results are in g/m³ unless otherwise stated.

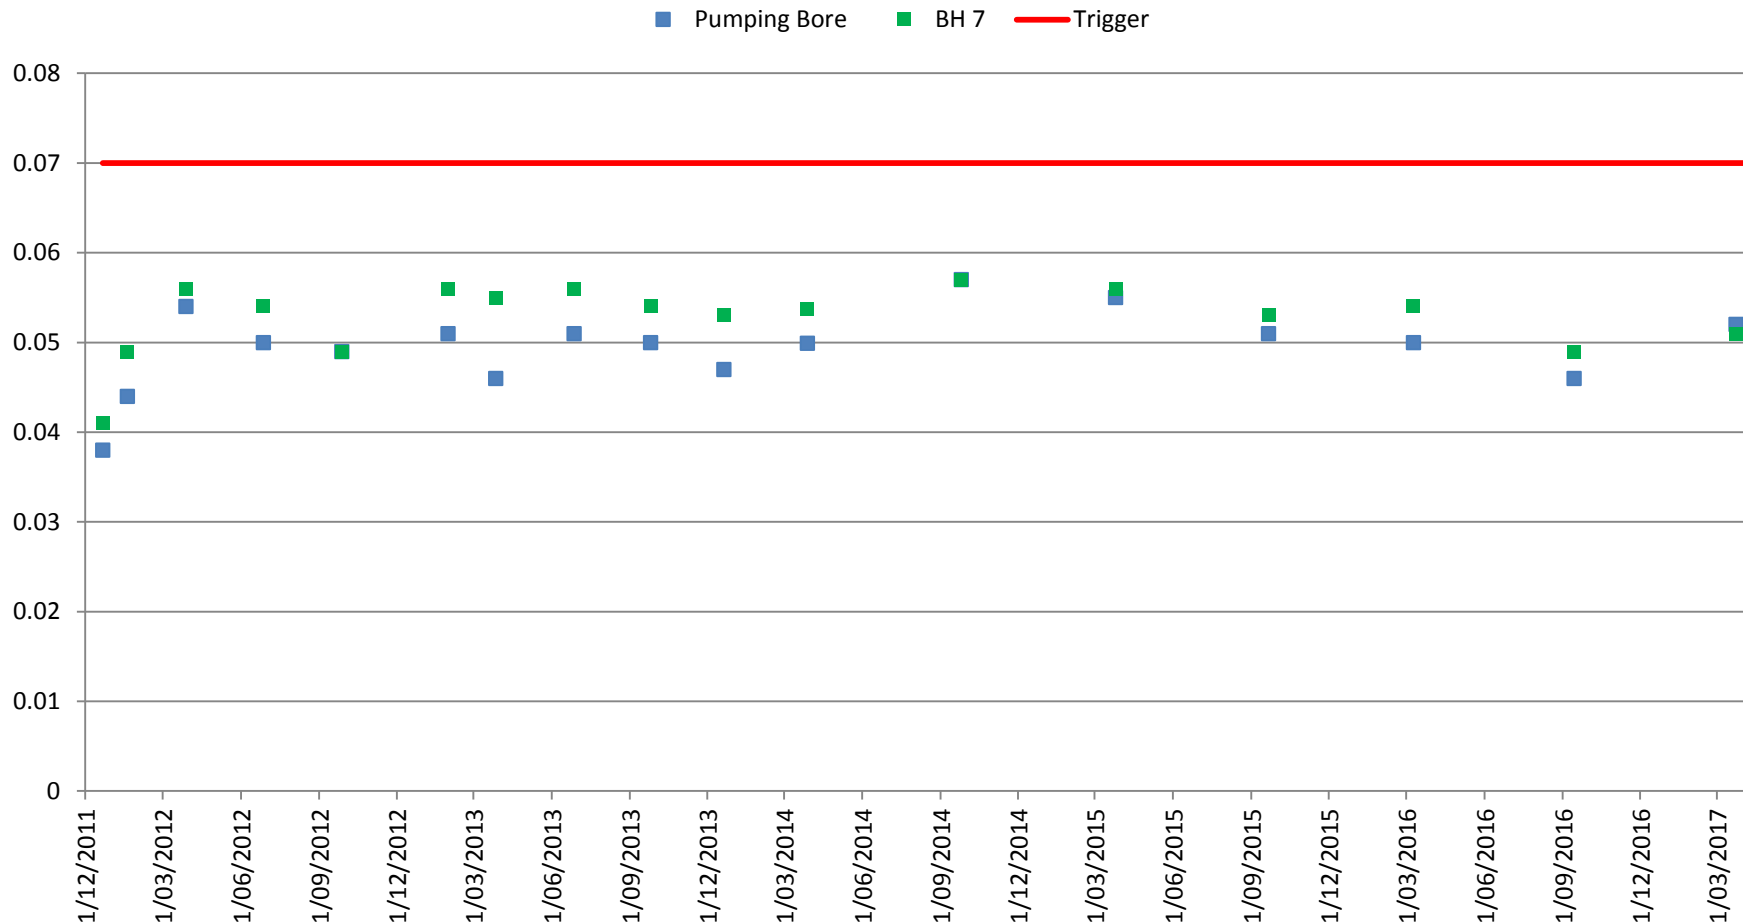
The following figure show all the results for the Boron since the commencement of sampling.

All results are in g/m³ unless otherwise stated.

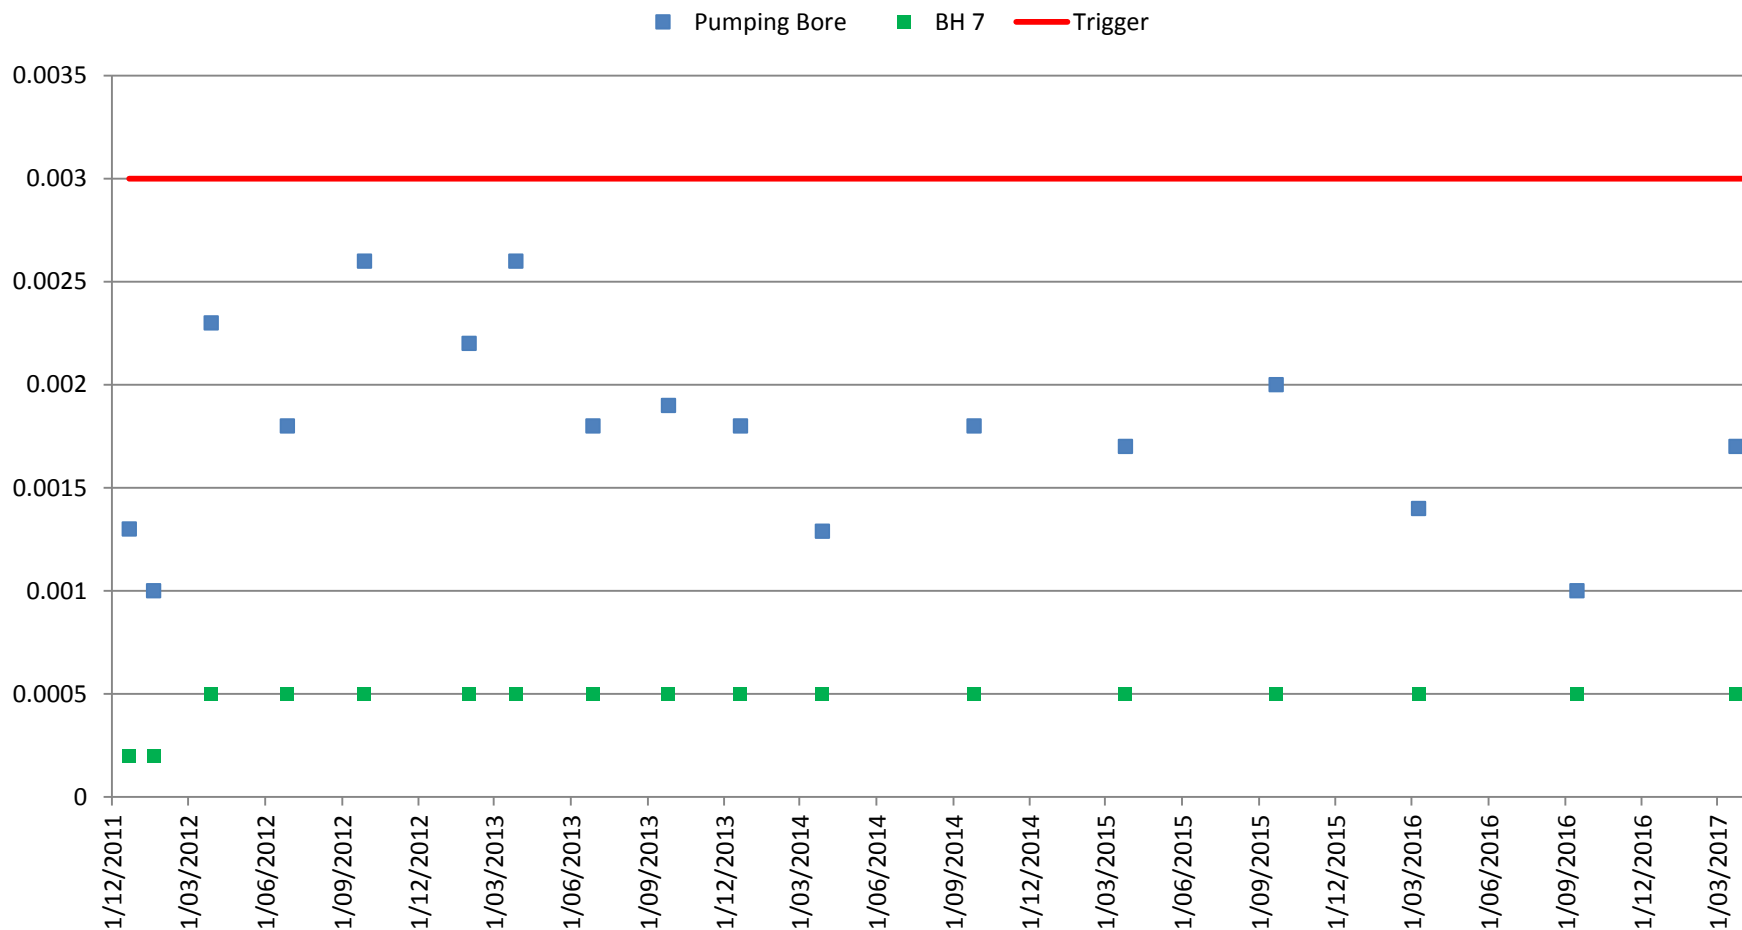
The following figure show all the results for the Copper since the commencement of sampling.

All results are in g/m³ unless otherwise stated.

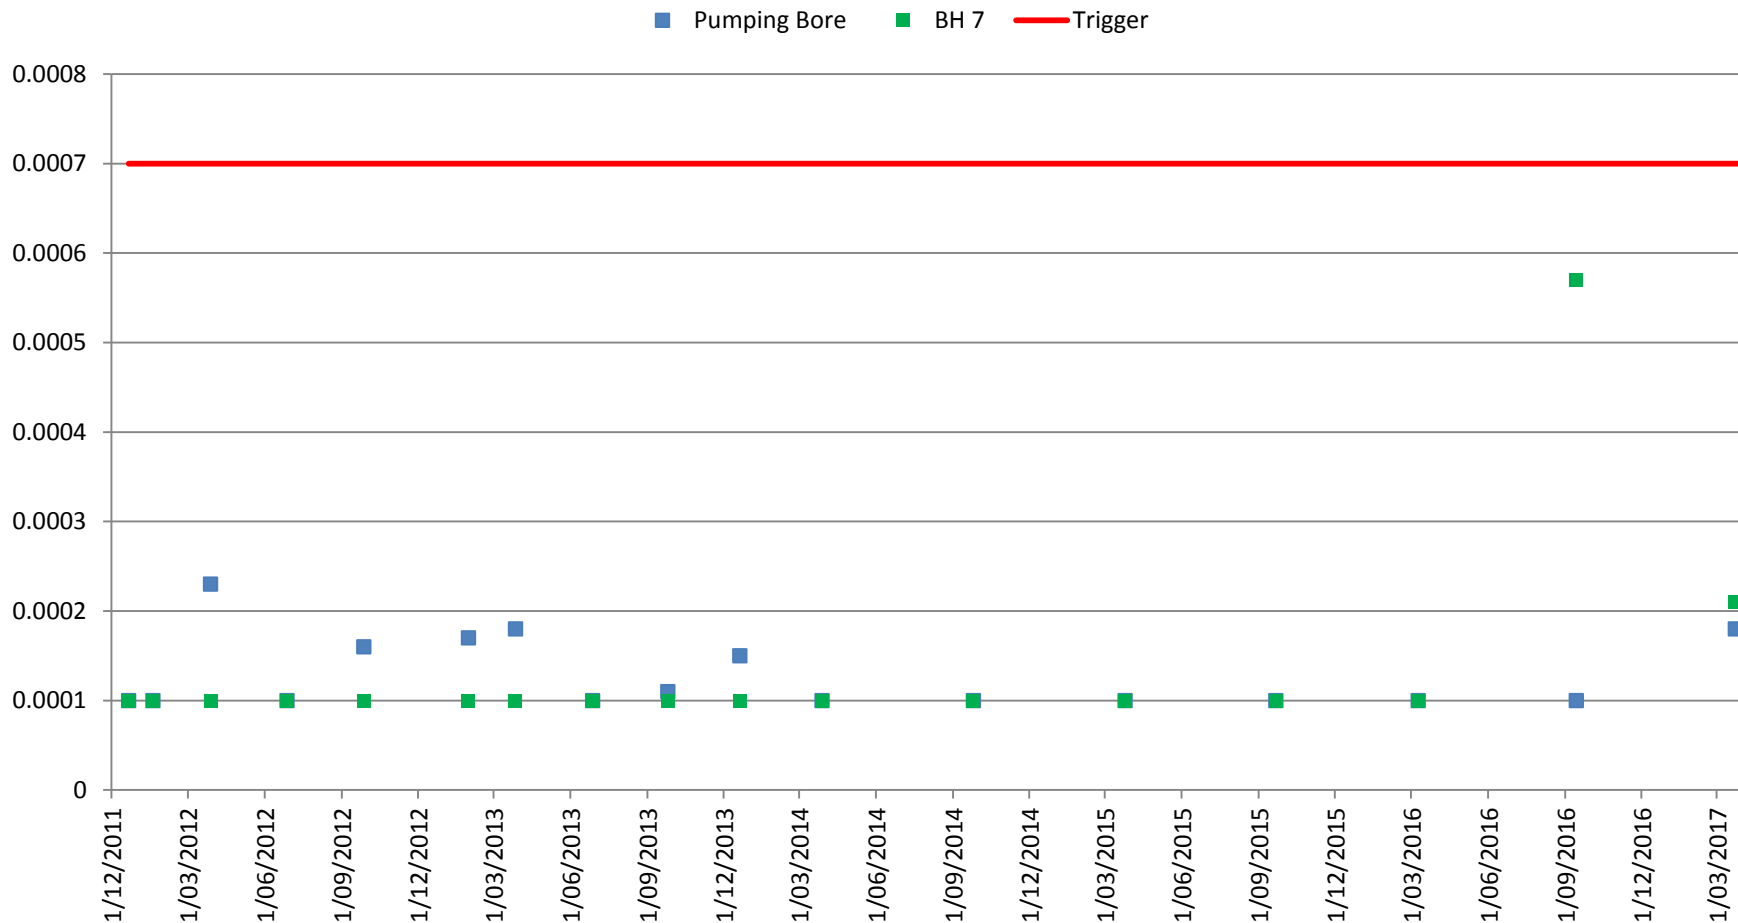
The following figure show all the results for the Lead since the commencement of sampling.

All results are in g/m³ unless otherwise stated.

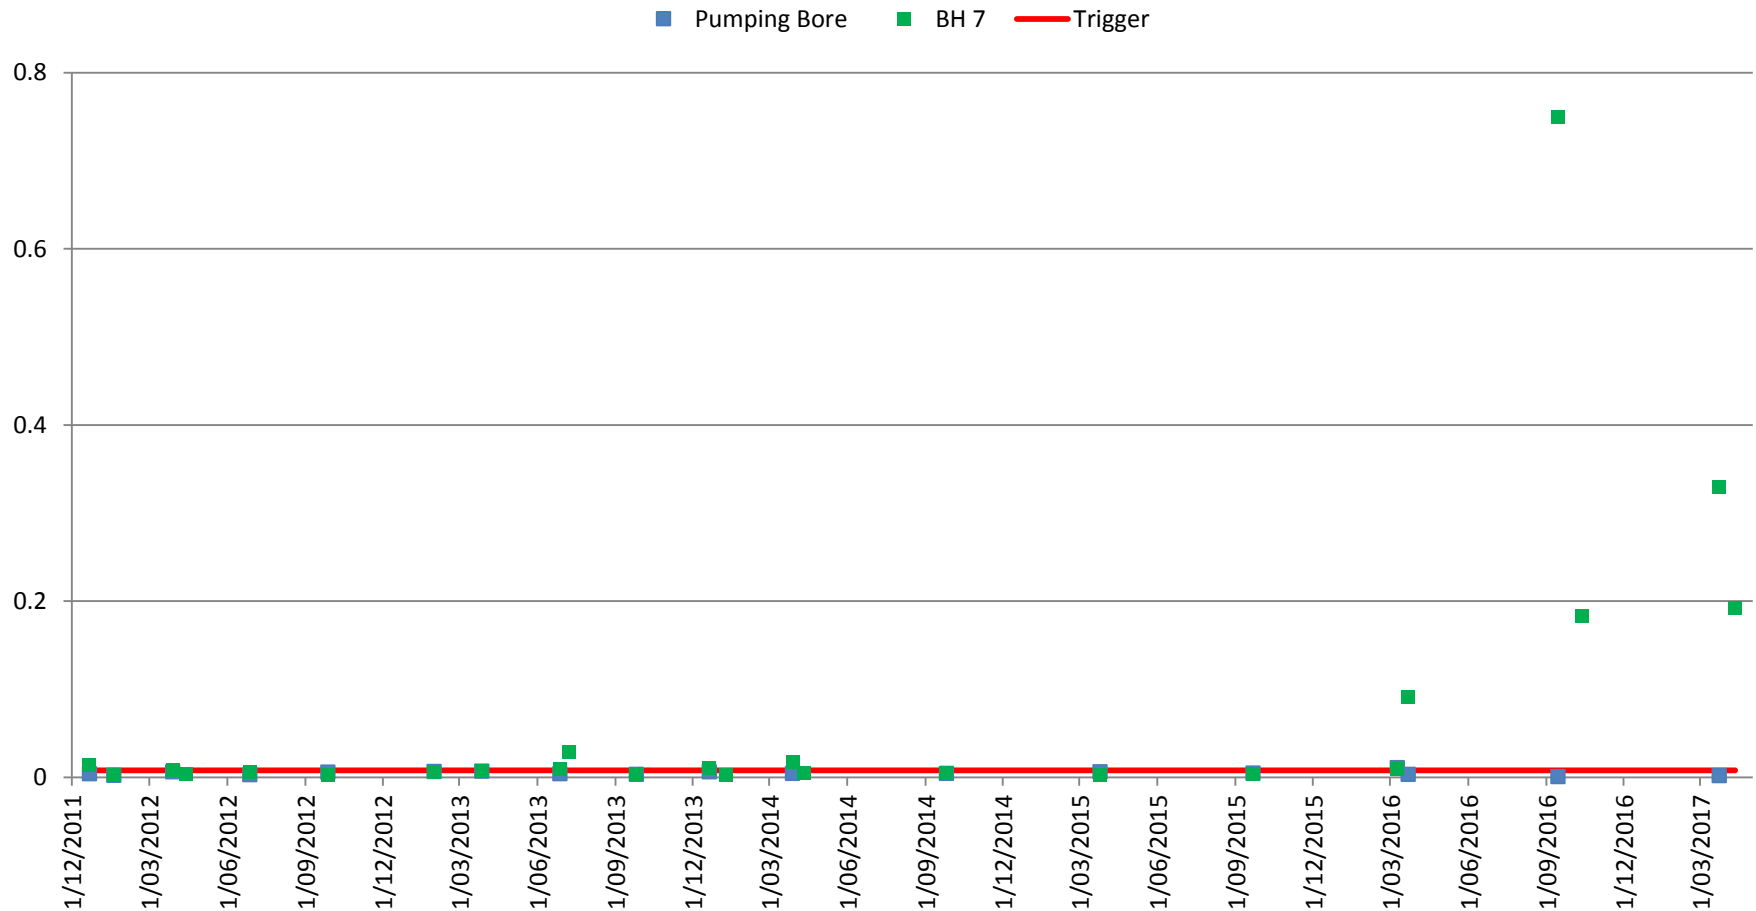
The following figure show all the results for the Zinc since the commencement of sampling.

All results are in g/m³ unless otherwise stated.

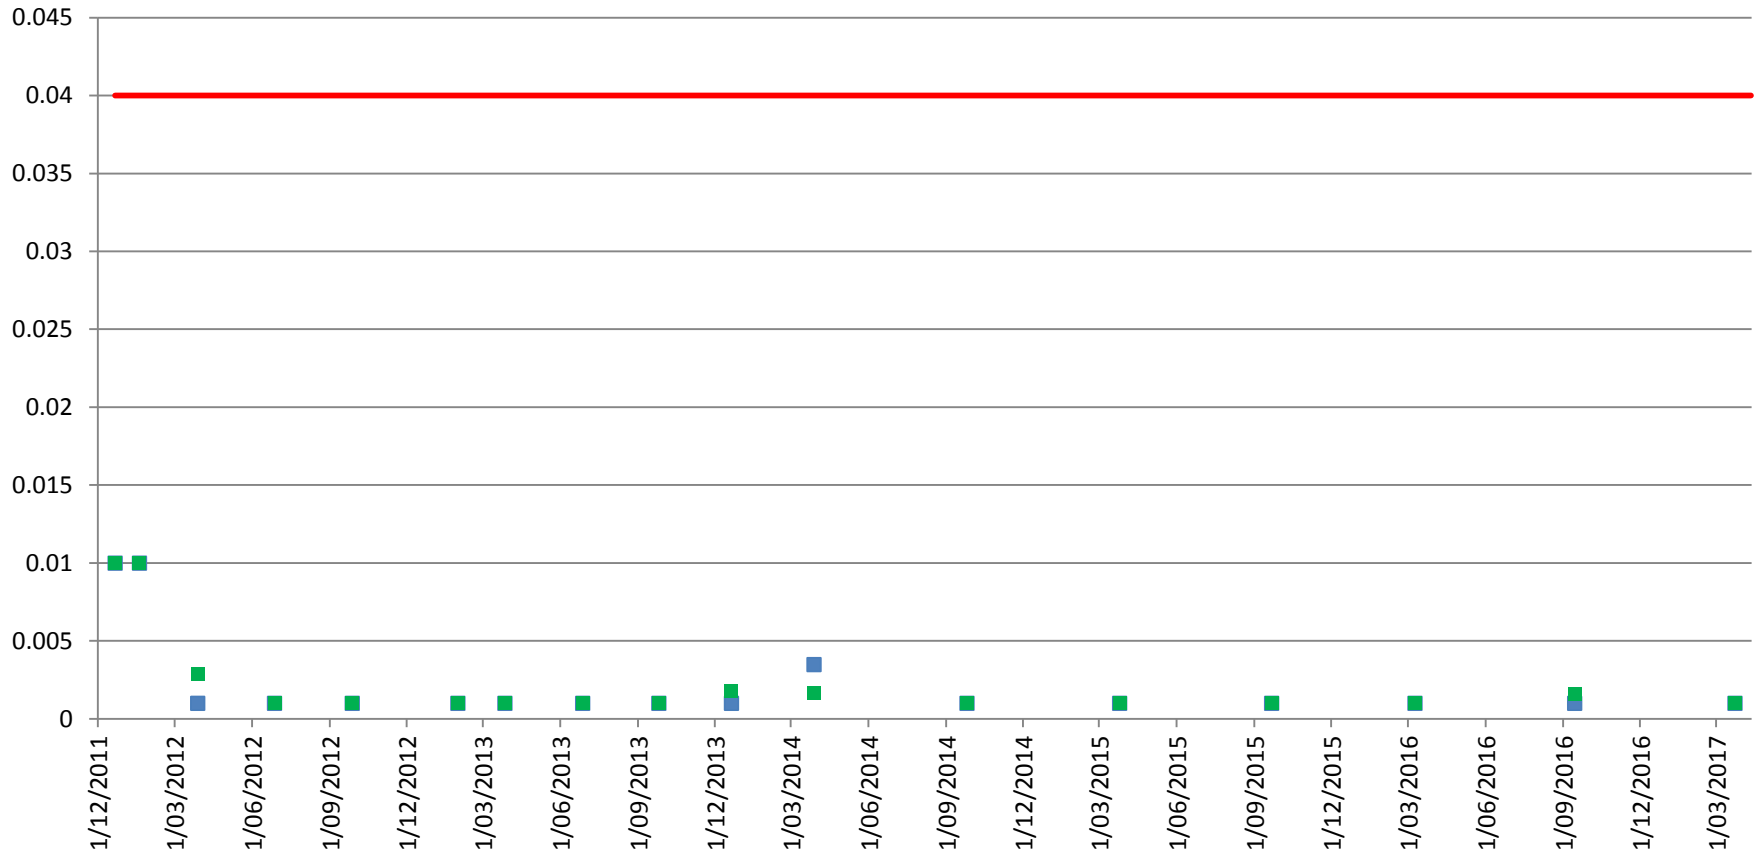
- Monitoring of Groundwater Chemistry commenced in December 2011 following the granting of Resource Consents to fill Three Kings Quarry.
- Samples were taken at three monthly intervals from the Pumping Bore within Three Kings Quarry and from BH 7 on Landscape Road for analysis of a suite of chemical parameters for the first 2 years of monitoring.
- Following 2 years of monitoring, samples for chemical analysis are required to be taken at 6 monthly intervals from the Pumping Bore within Three Kings Quarry and from BH 7 on Landscape Road (March and September).
- Results from the March 2017 monitoring round have been received since the last SLG meeting. All parameters were less than the trigger limits with the exception of Zinc in BH7. BH7 currently has no direct groundwater link to Three Kings Quarry. Auckland Council and Watercare were notified of the trigger exceedance.

The following figure show all the results for the Cyanide since the commencement of sampling.

All results are in g/m³ unless otherwise stated.

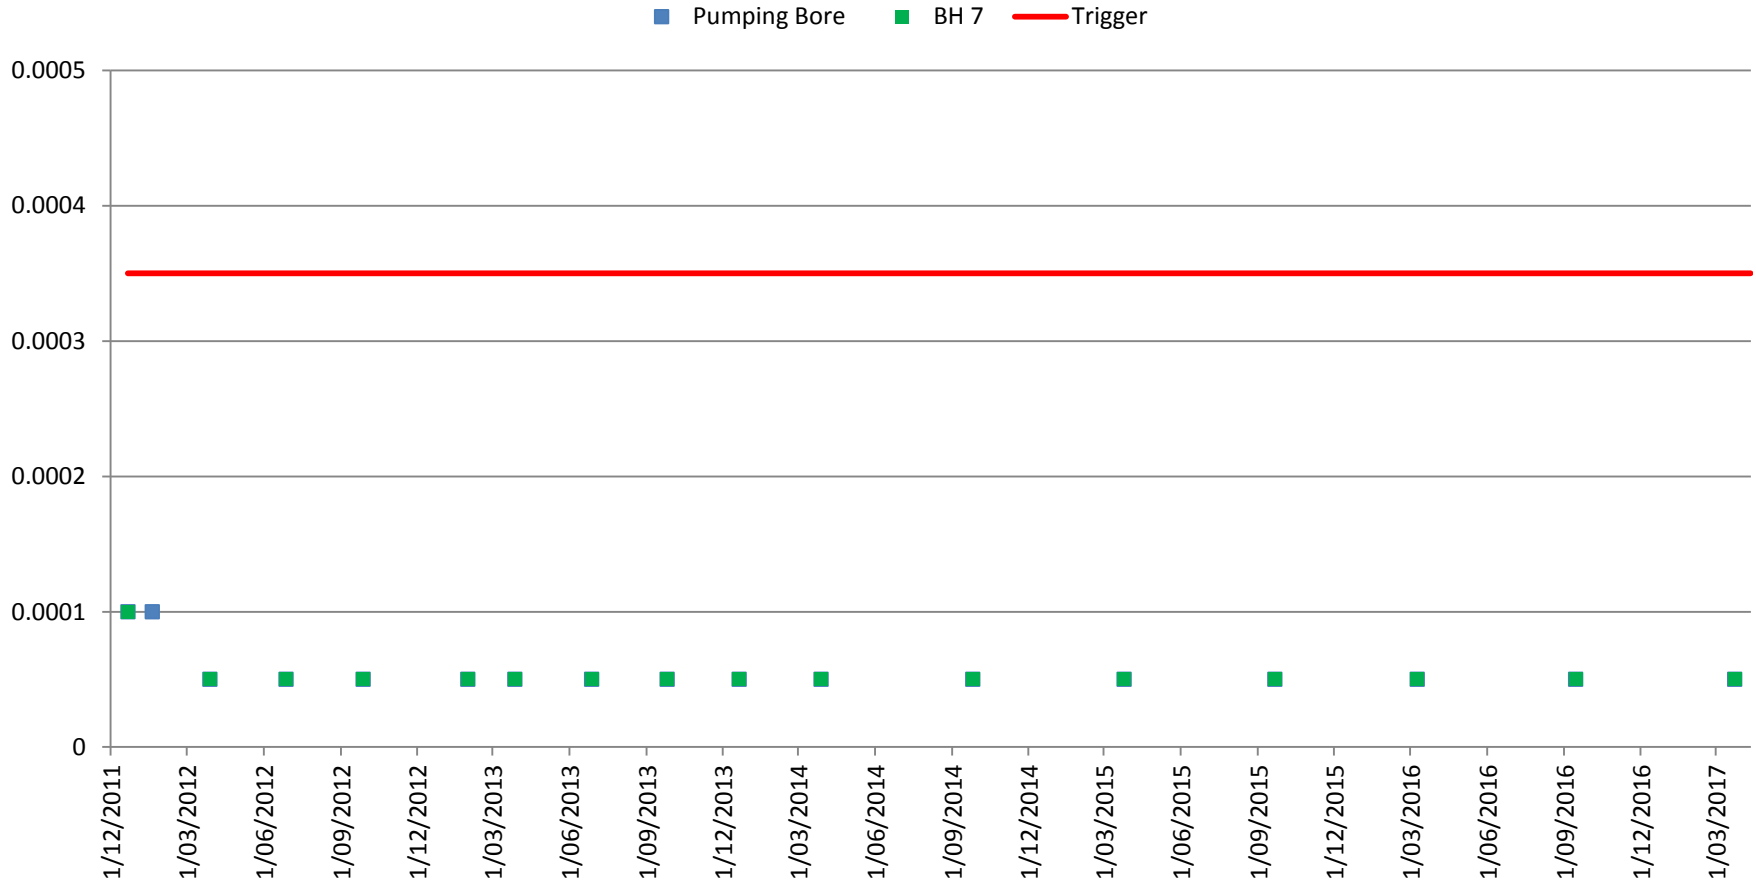
BaP (eq)

The following figure show all the results for BaP(eq) since the commencement of sampling.

All results are in g/m³.

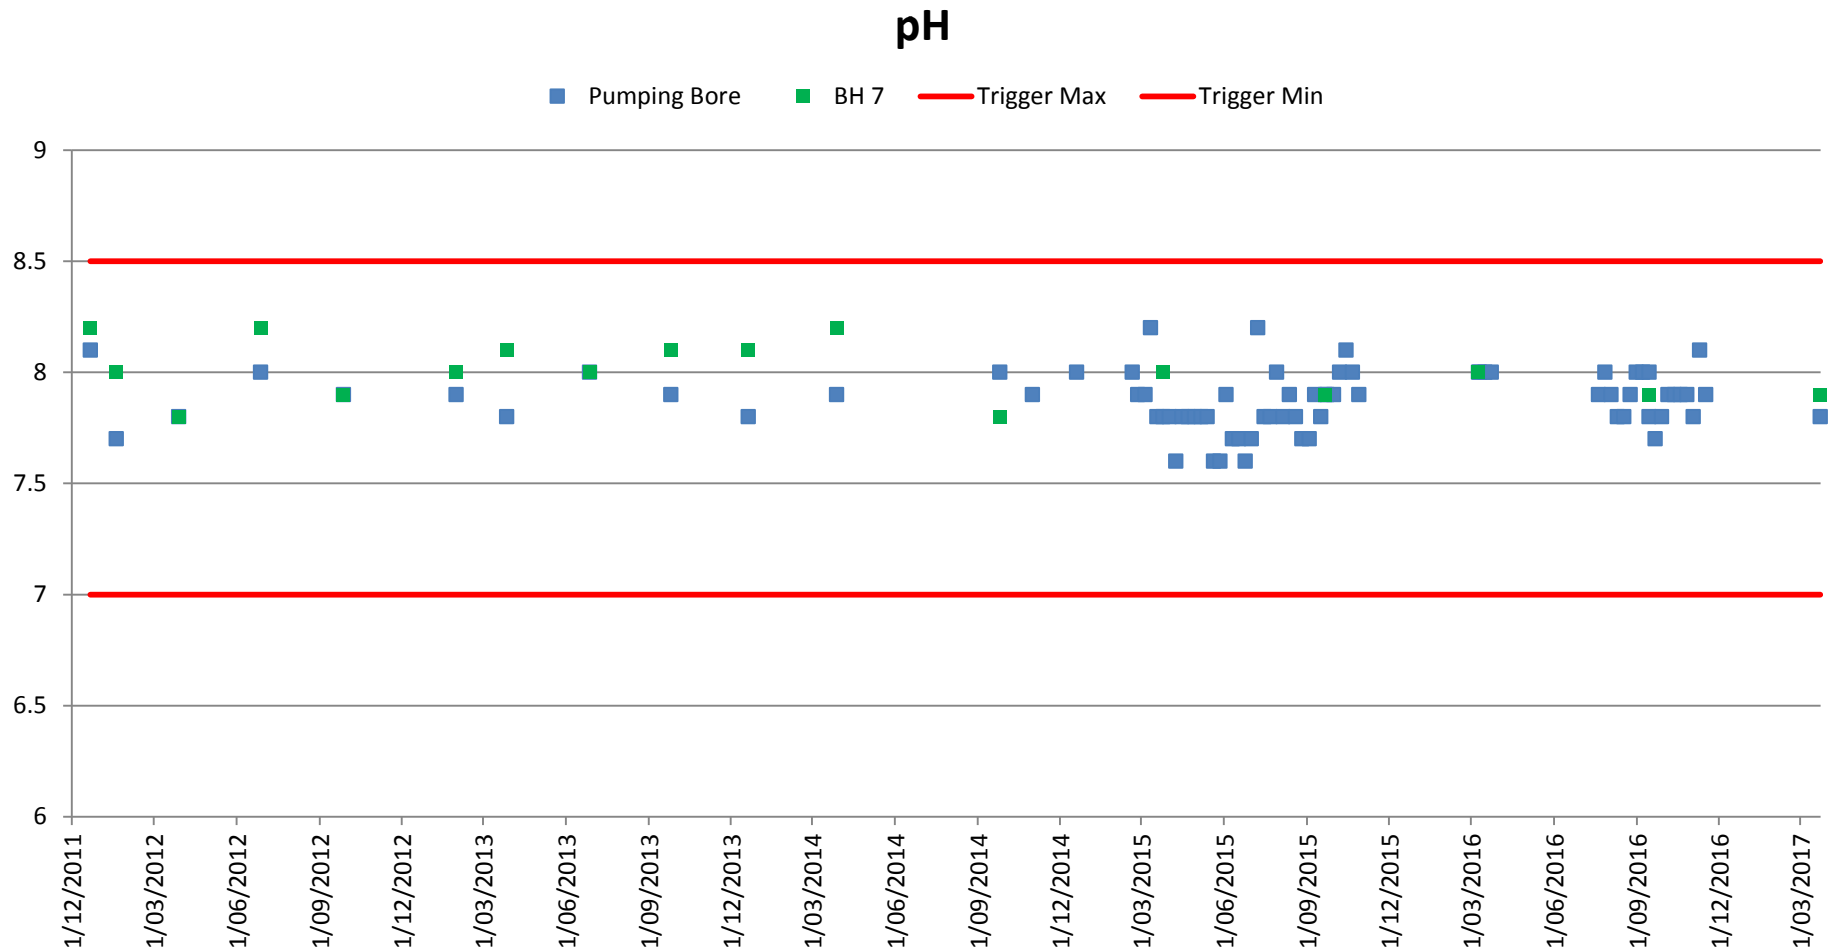
The following figure show all the results for pH since the commencement of sampling.

All results are in pH Units

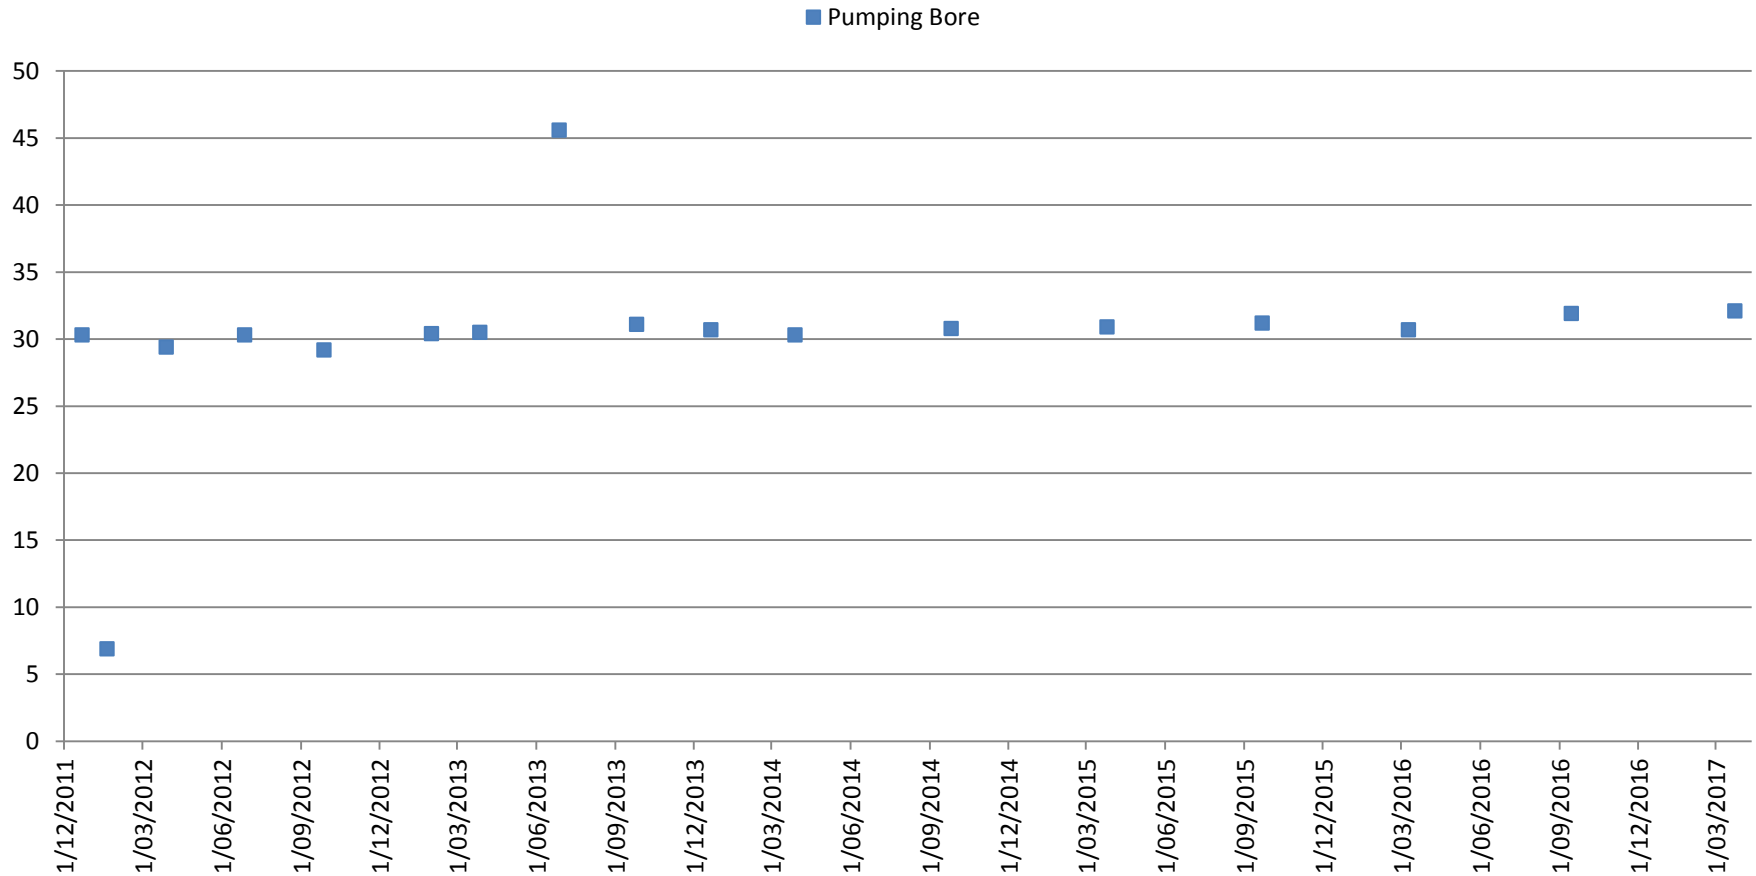
Electrical Conductivity

The following figure show all the results for EC since the commencement of sampling.

All results are in mS/m.

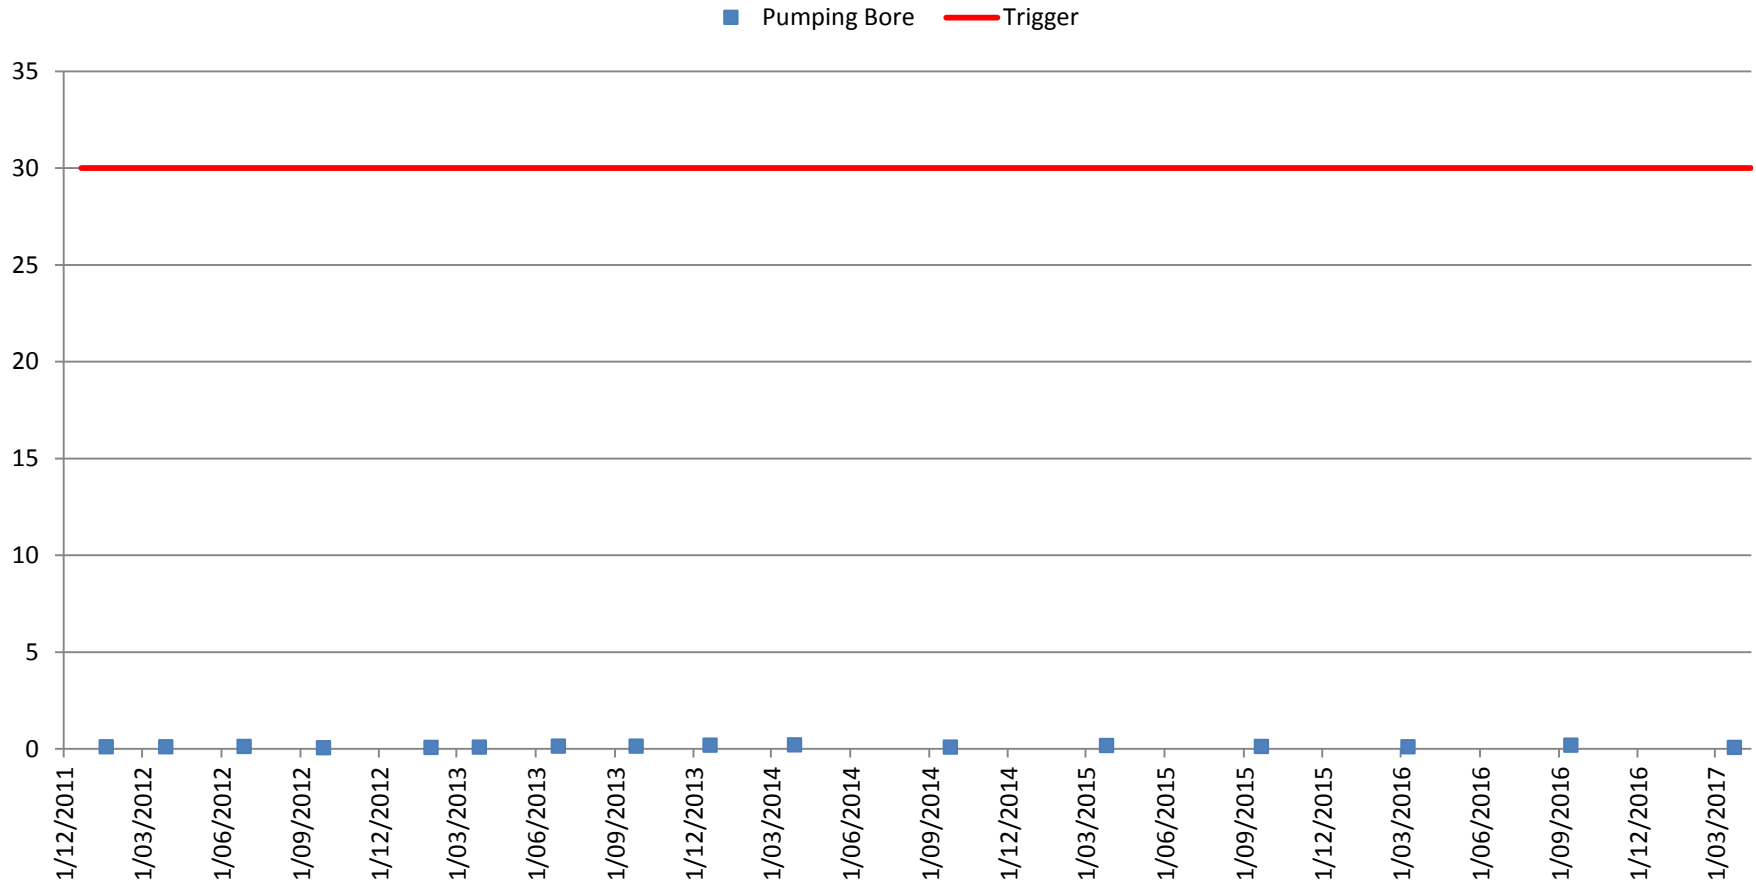
The following figure show all the results for Turbidity since the commencement of sampling.

All results are in NTU.

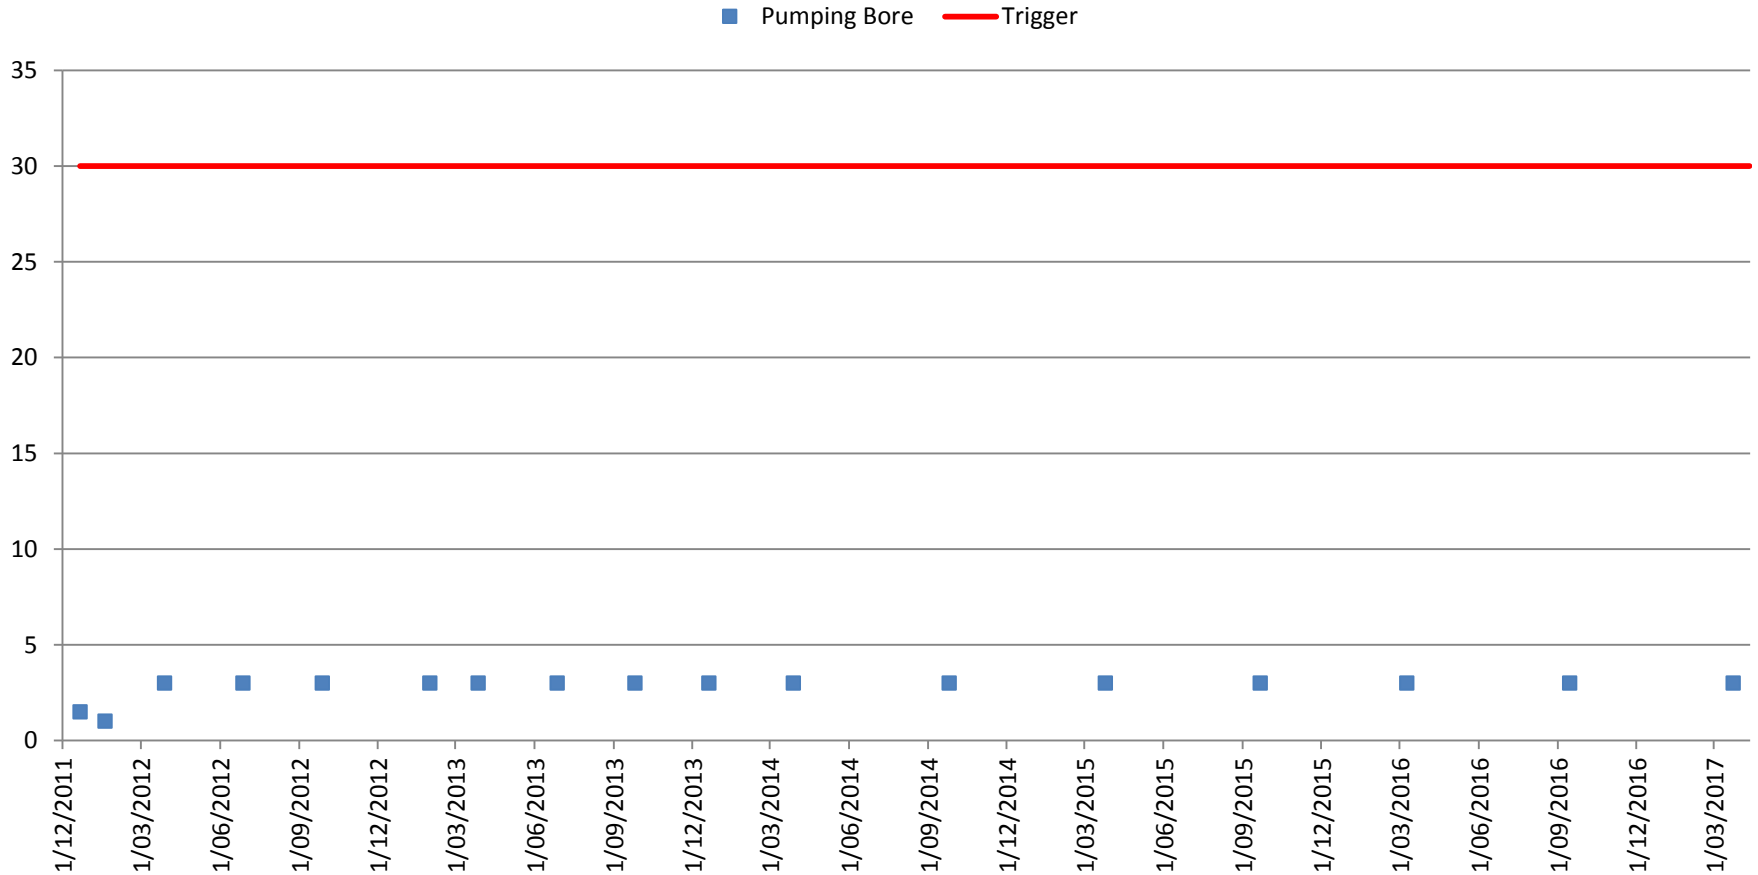
Total Suspended Solids

The following figure show all the results for TSS since the commencement of sampling.

All results are in g/m³.

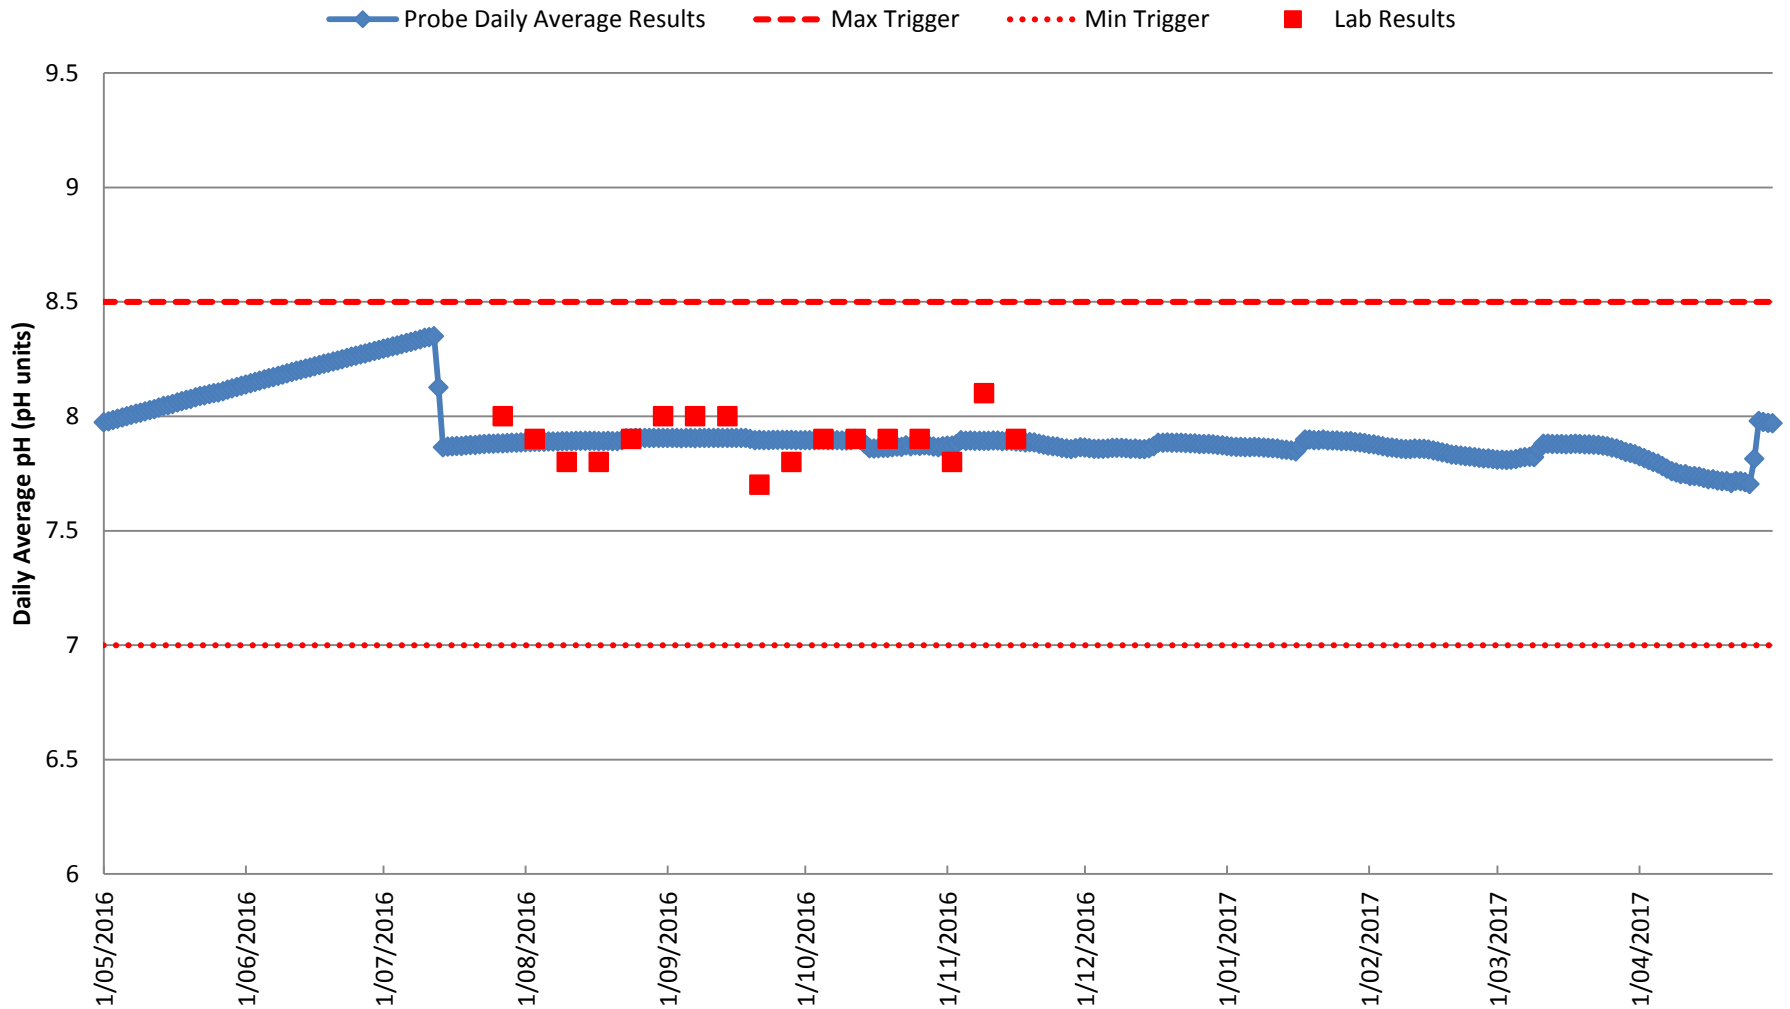
Average Daily pH Graph

- Continuous monitoring of electrical conductivity and pH is required to be undertaken in the Three Kings Quarry pumping bore.
- Historically, the pH probe in particular showed an undesirable downward trend following calibration, therefore a weekly water sample was taken and sent to Hill Laboratories Ltd for analysis of pH & EC
- New pH & EC probes were installed at the Three Kings Quarry pumping bore in August 2015.
- An upward drift in pH was recorded from January 2016 to July 2016. The electrode was replaced in July 2016 and is showing much more consistent results.
- The downward spike in the EC recorded in October 2016 was investigated and found to be a result of too high a flow in the sampling vessel.
