Three Kings Quarry

29 May 2017 – Site Liaison Group Meeting

Site Monitoring Report

May 2017 Site Monitoring Report

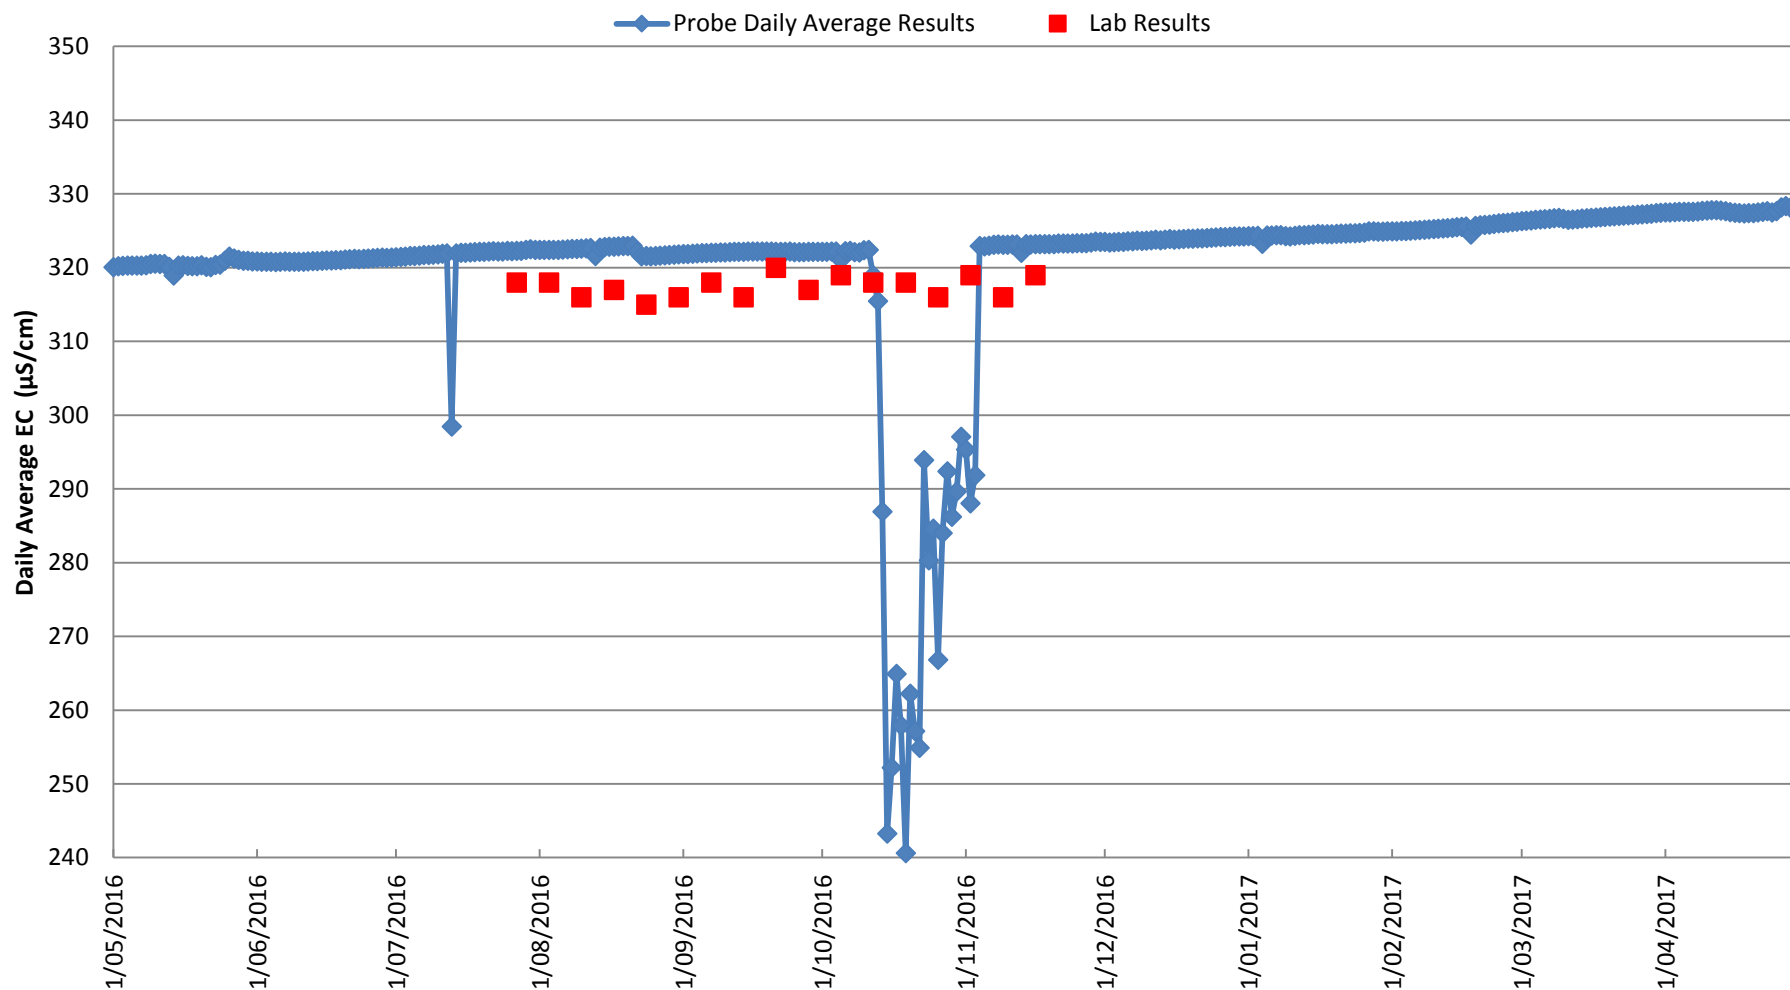
Average Daily EC Graph

- Continuous monitoring of electrical conductivity and pH is required to be undertaken in the Three Kings Quarry pumping bore.
- Historically, the pH probe in particular showed an undesirable downward trend following calibration, therefore a weekly water sample was taken and sent to Hill Laboratories Ltd for analysis of pH & EC
- New pH & EC probes were installed at the Three Kings Quarry pumping bore in August 2015.
- An upward drift in pH was recorded from January 2016 to July 2016. The electrode was replaced in July 2016 and is showing much more consistent results.
- The downward spike in the EC recorded in October 2016 was investigated and found to be a result of too high a flow in the sampling vessel.

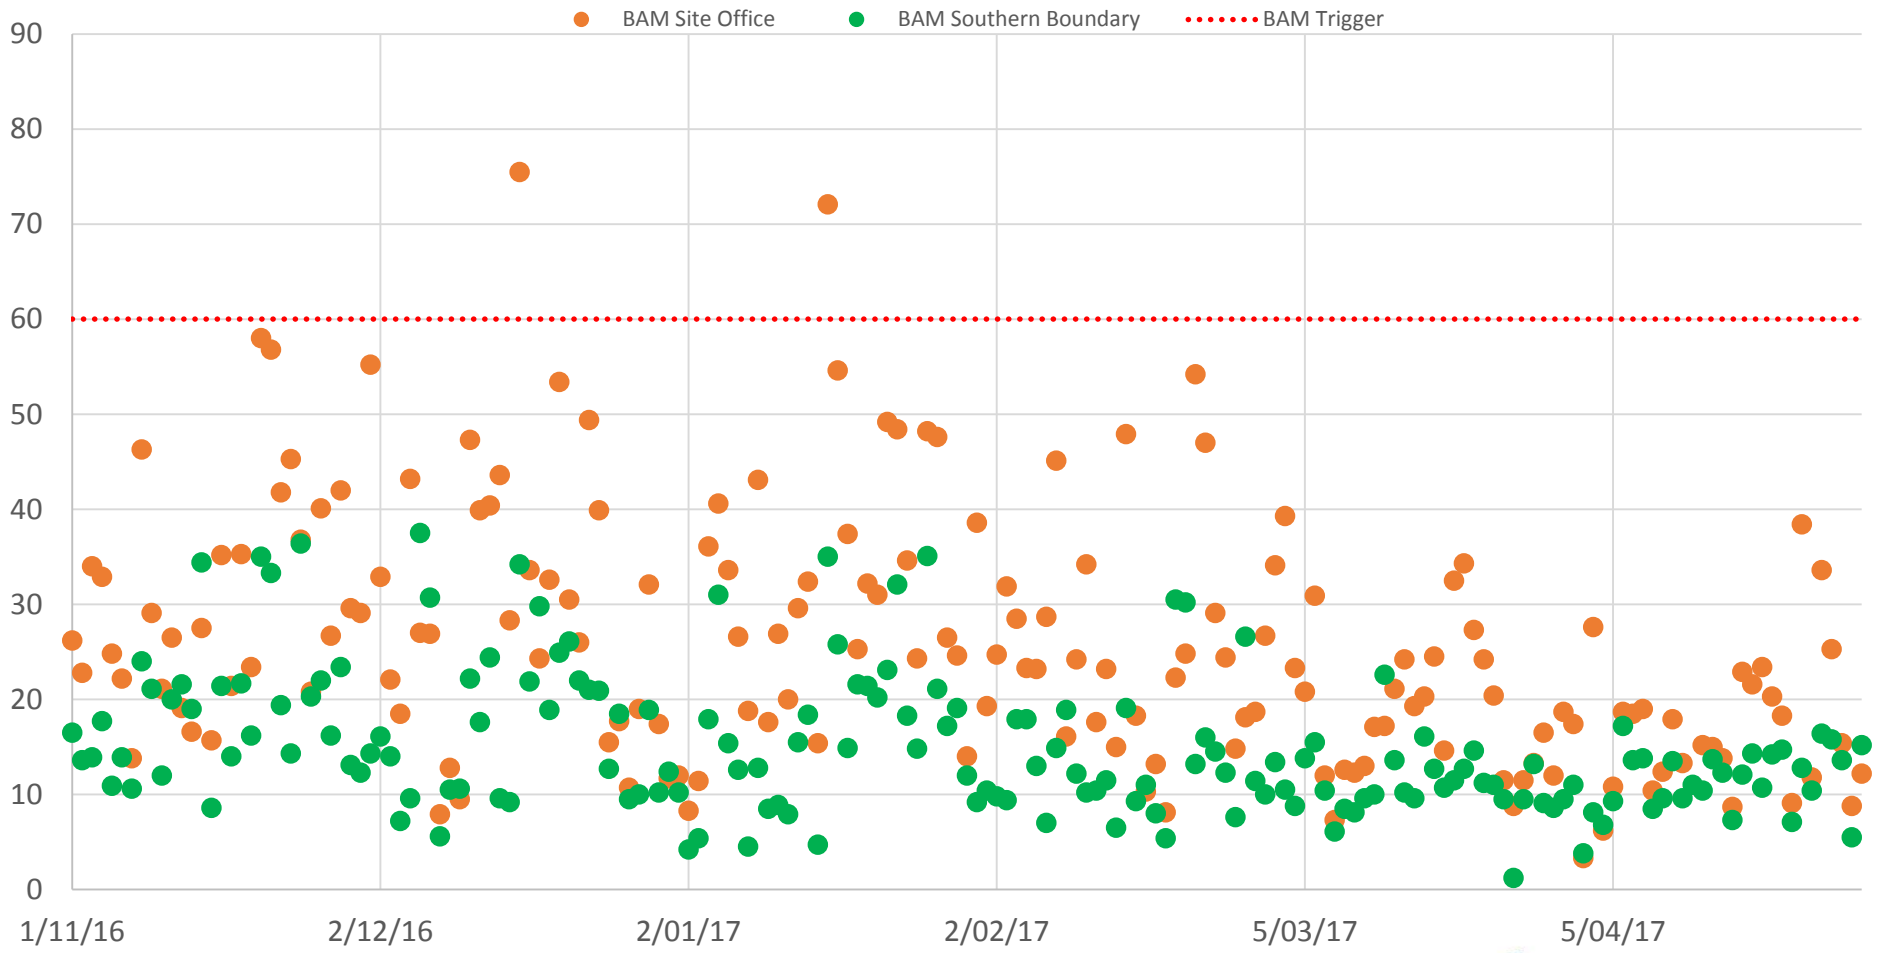
- Continuous air quality monitoring results recorded since the last SLG meeting have been less than 40 micrograms per cubic meter as a 24 hour average
- No air quality triggers have been recorded since the last SLG meeting.

The following figure shows air monitoring results from 1st November 2016 to 30th April 2017.

All results are in $\mu\text{g}/\text{m}^3$.

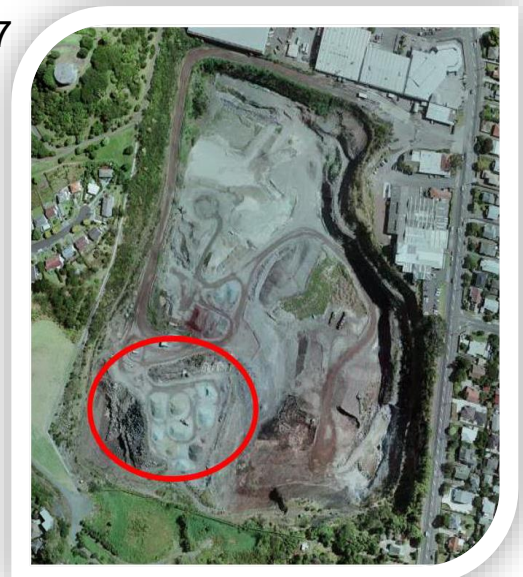
- As part of our filling operation, we will be undertaking soakage infrastructure works in the area indicated in red. The works involve the handling, sorting and stockpiling of rock and concrete to fill the quarry and to construct a soakage hole, enabling stormwater discharge to ground.
